Re: Chaparral Water Company; Docket No. W-02393A-03-0312;  
Decision No. 66395, dated October 6, 2003; Compliance

Attached hereto please find 15 copies of the Leak Detection/Repair Report prepared by the Company's certified operator. The Company is of the opinion that completion of the items listed in the Report will result in the Test Year water losses of 11.7 percent being reduced to less than the target 10 percent.

Re: Chaparral Water Company's progress and findings.

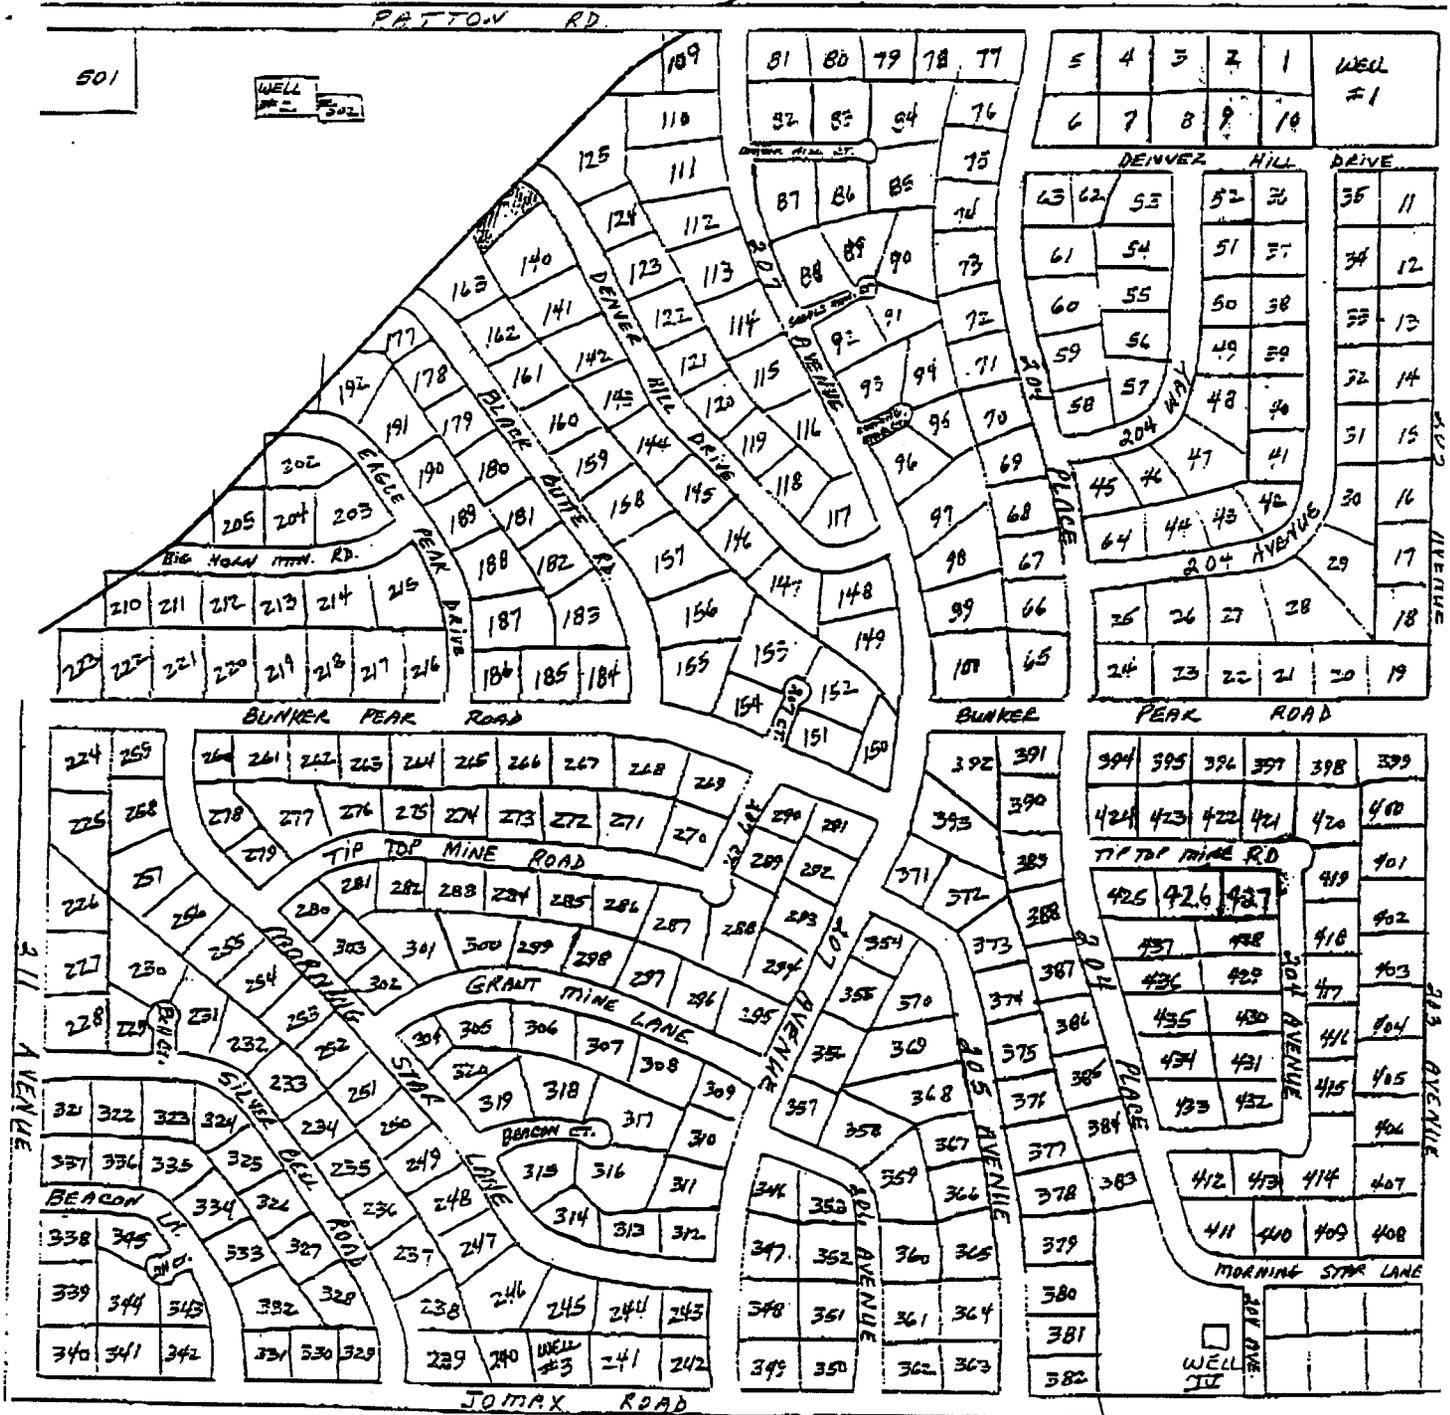
Enclosed please find the color coded map on the current water meter replacement (56) and the additional water meters that should be replaced. The meters replaced were in very bad shape and all appear to be quite old and that follows trend with the ones that should be replaced.

#  
OF WATER METERS CHANGED

WATER METERS TO BE CHANGED
