Re: LSP Arlington Valley, LLC  
2006 and Management Plan Annual Report  
Docket No: L-00000P-99-0098

# Duke Energy Arlington Valley Project

## Spring Moist Soil Wetland Monitoring Report

March 2006

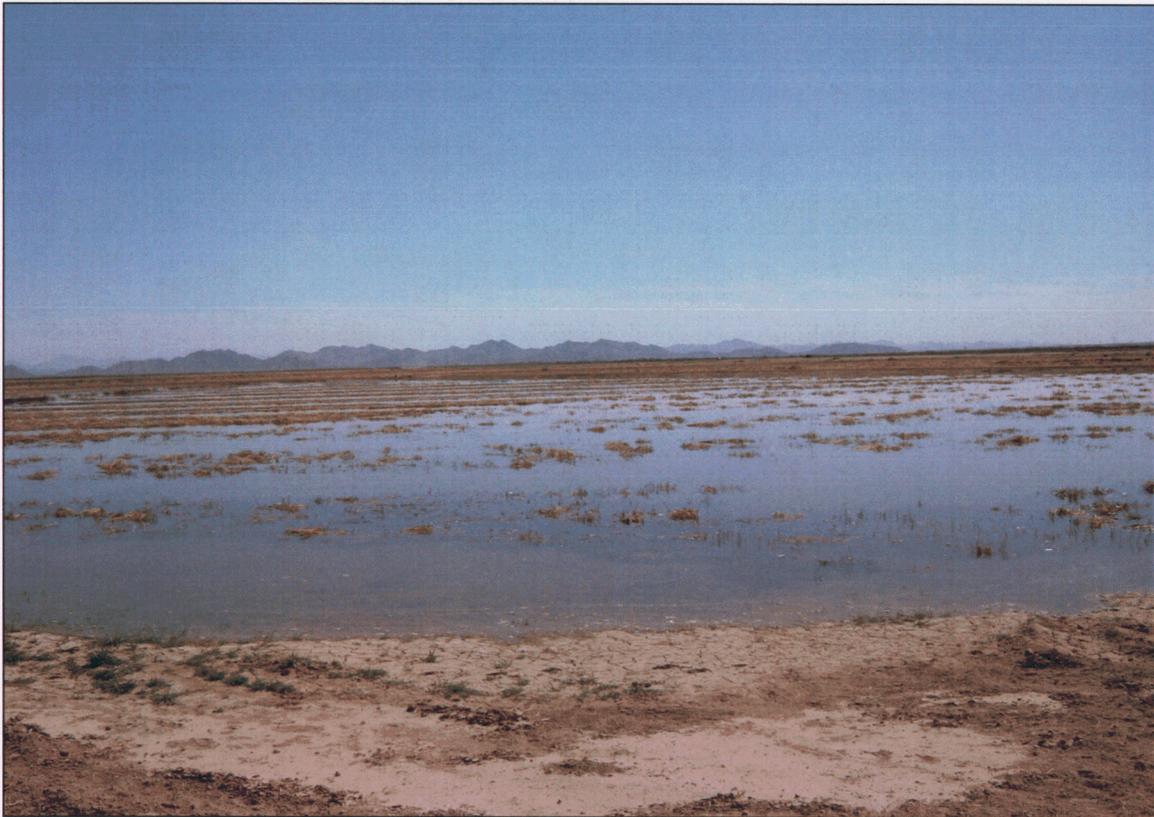
Unit 2 - Main body of unit looking SE from NW corner.

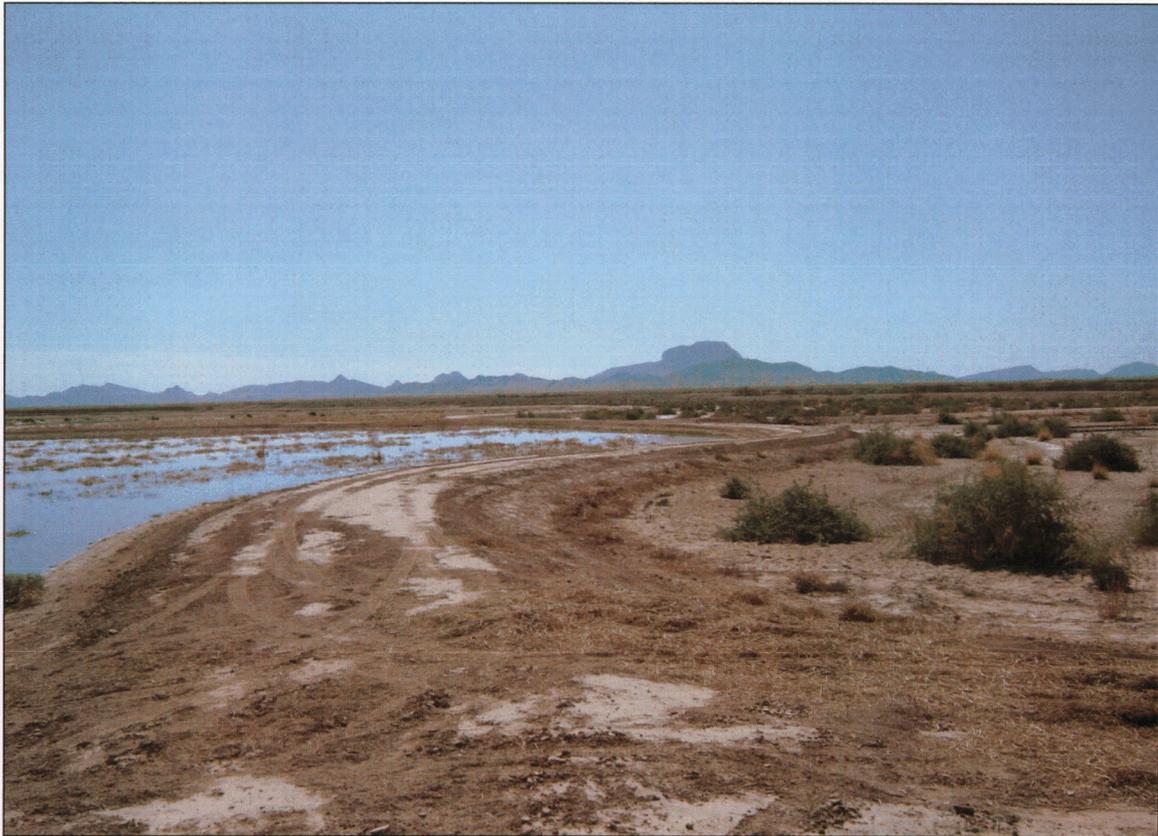
Unit 2 - Levee Bravo looking south (\*note: lack of vegetation on levee slopes).

**Levee Side Slopes** – The grass seed mix designated for the levee side slopes has still **not** been planted. Establishment of these grass species along the levees will help reduce erosion along the levees, as well as reduce weed growth. This should be done in the fall as soon as temperatures and soil moisture conditions warrant.

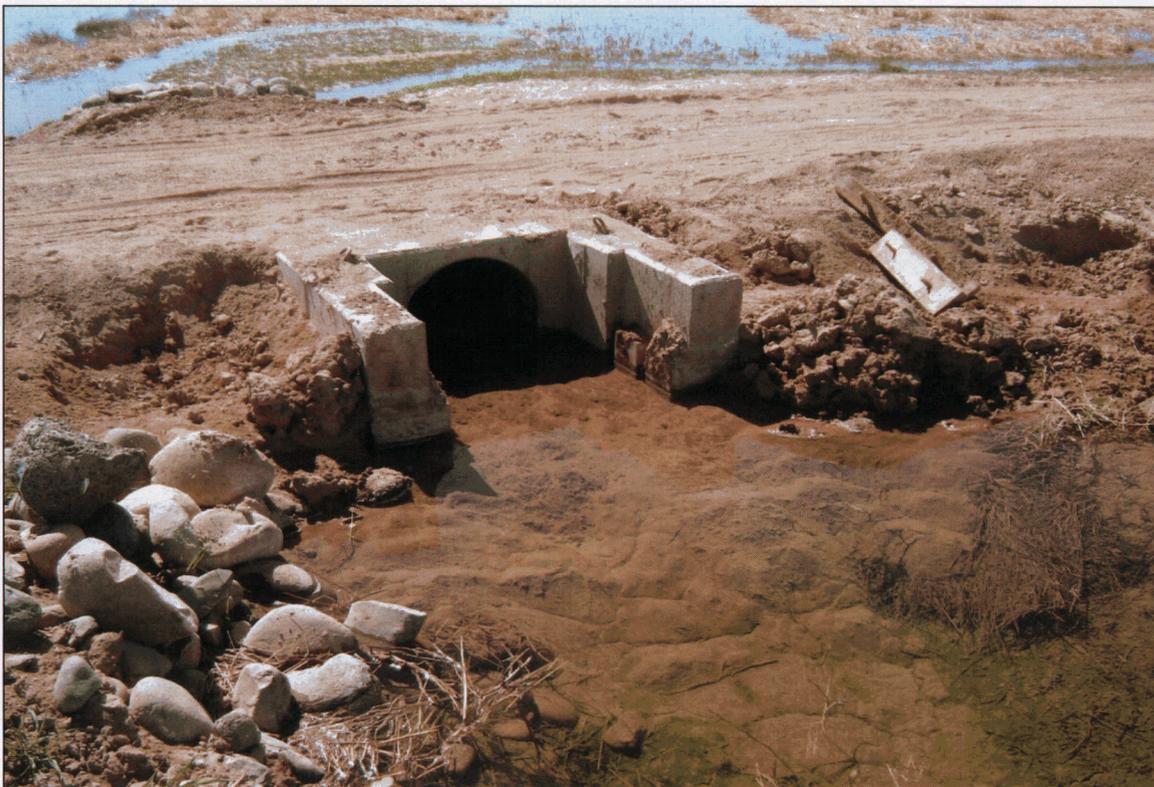
Unit 2 - Water control structure # 5 looking south, slowly draining water into Unit 6 (\*note: minor erosion/soil disturbance around structure).

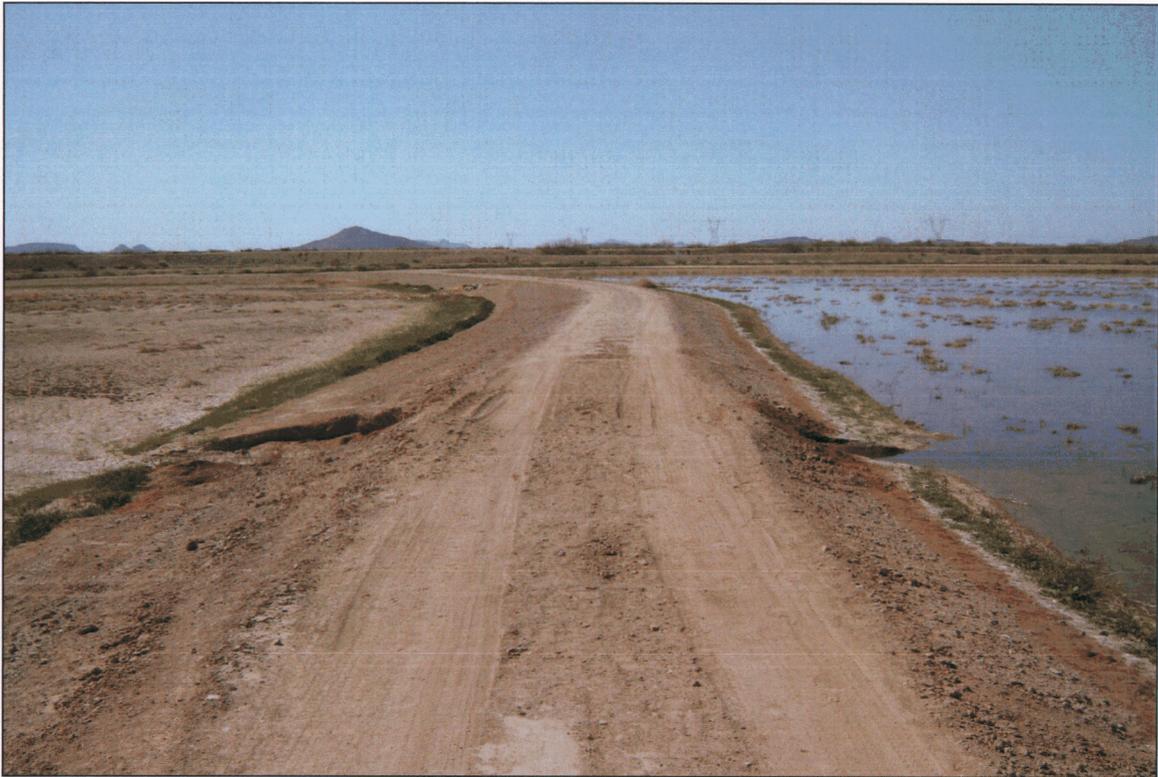
Unit 2 - Levee Foxtrot (between Unit 2 & 6) looking west. This area was breached and has been repaired (\*note: minor levee shaping needed on both sides after unit is de-watered).

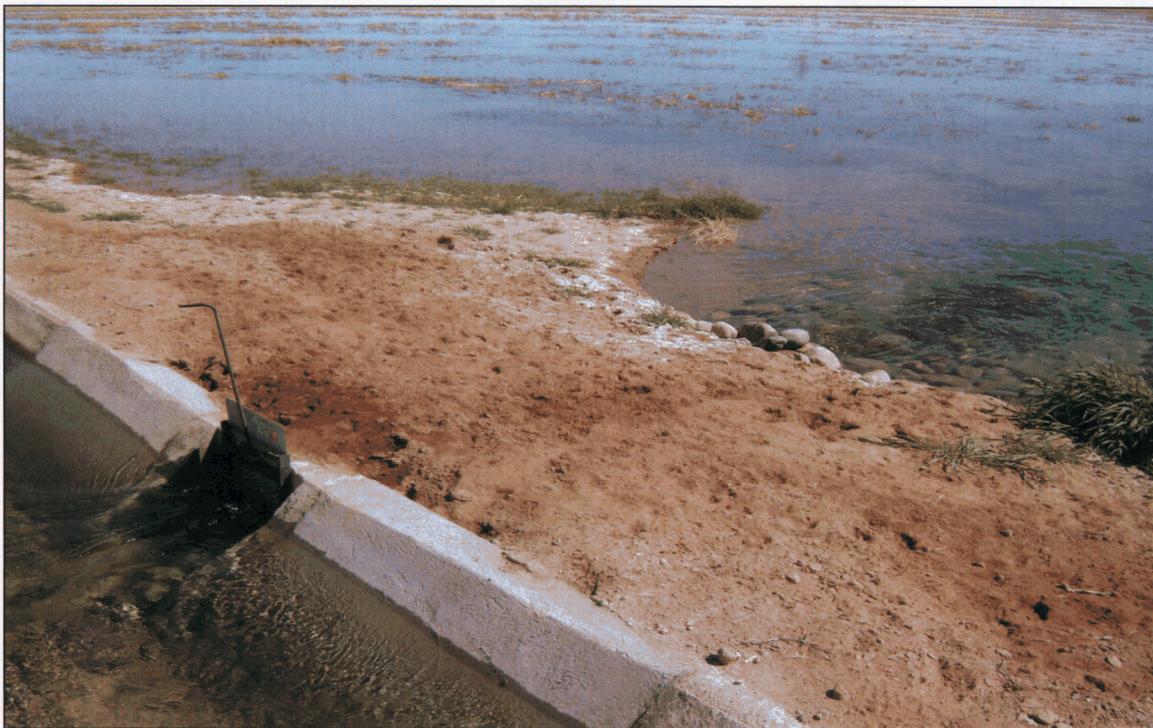
Unit 2 - Slide-gate (water control structure #2) off concrete feeder ditch that has been repaired from previous visit (\*note: smooth slope and no exposed pipe).

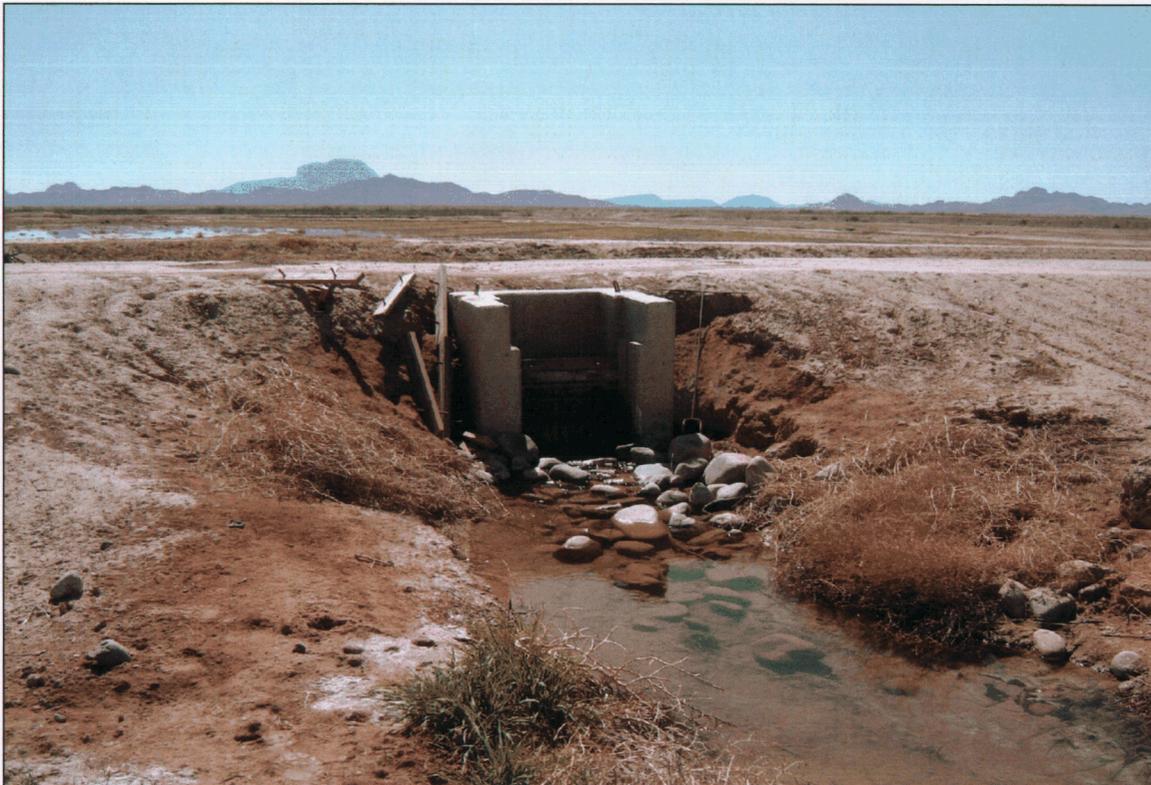
Unit 4 – Water control structure #9 looking south from inside the unit (\*note: minor erosion around structure and water back-filling into unit from CSD).

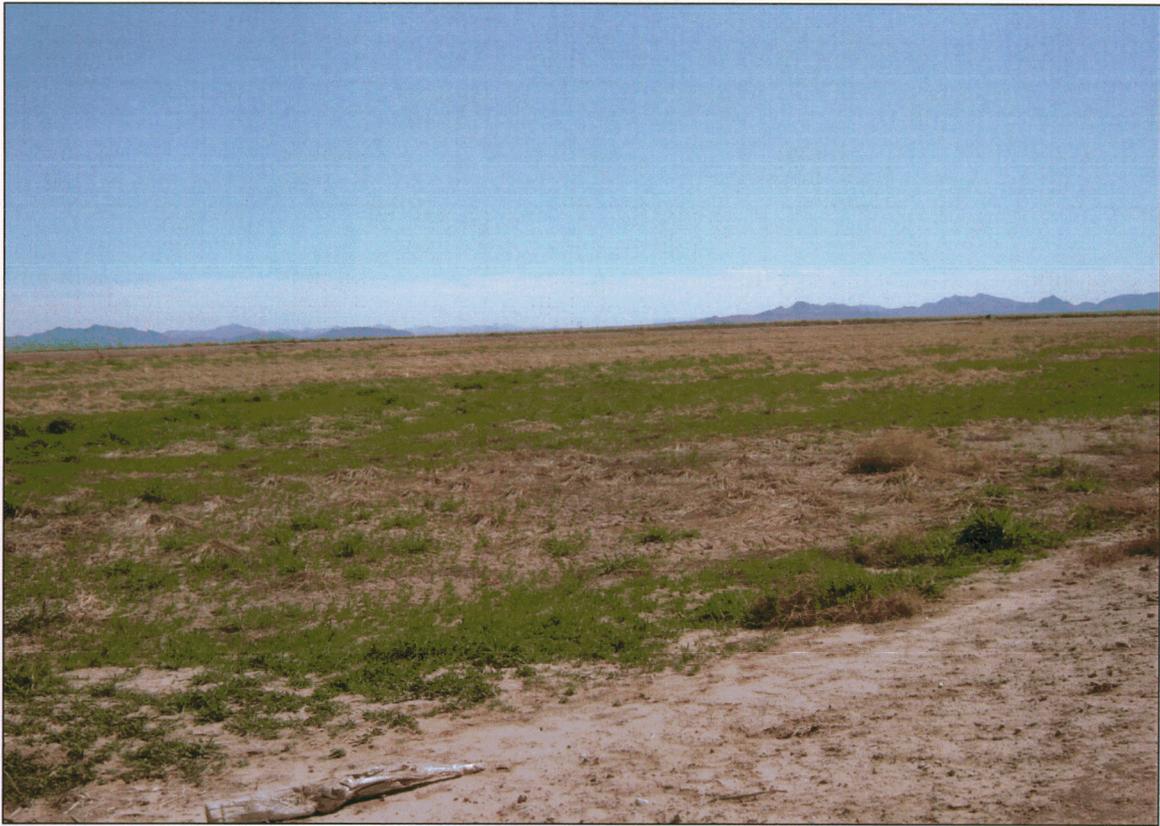
Unit 4 – Main body of unit looking SE from NW corner (\*note: large amount of green vegetation).

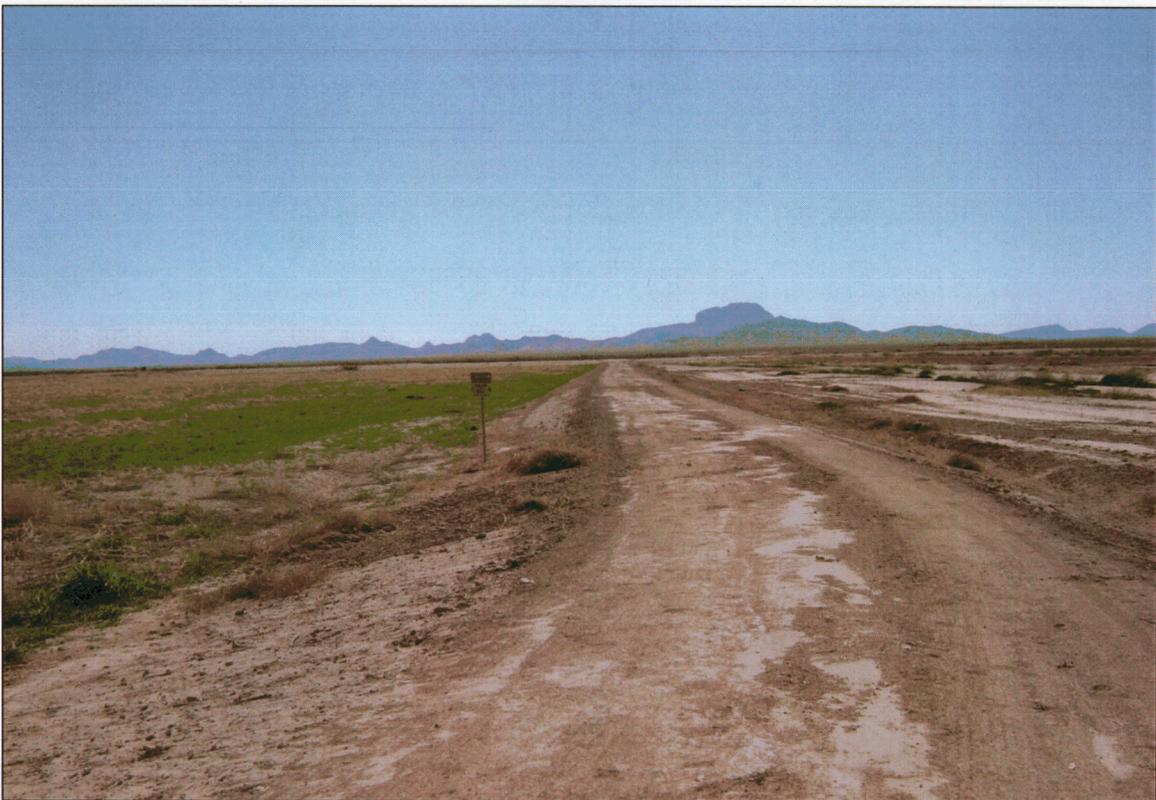
Unit 4 – Levee Echo looking south (\*note: lack of vegetation on levee slopes).

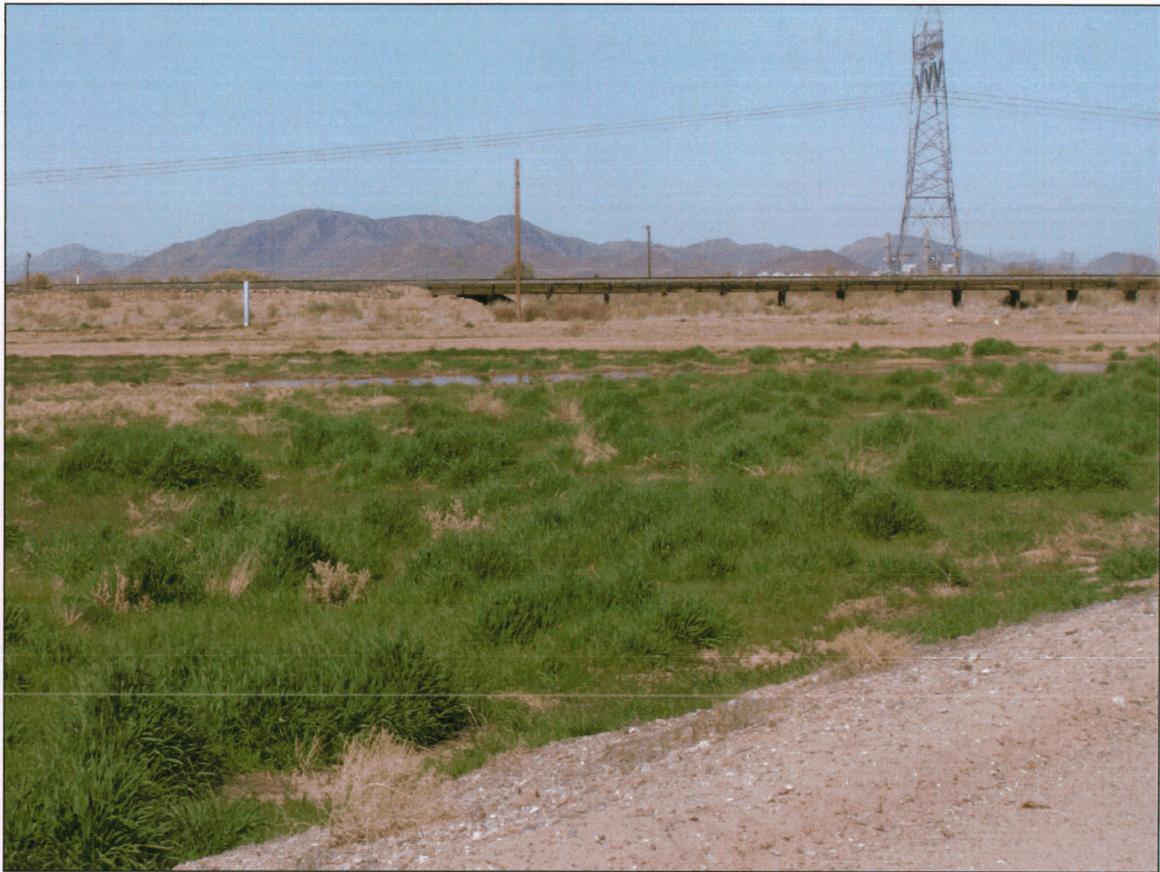
Unit 4 – Germination of water grass inside the unit (from east road looking NW).

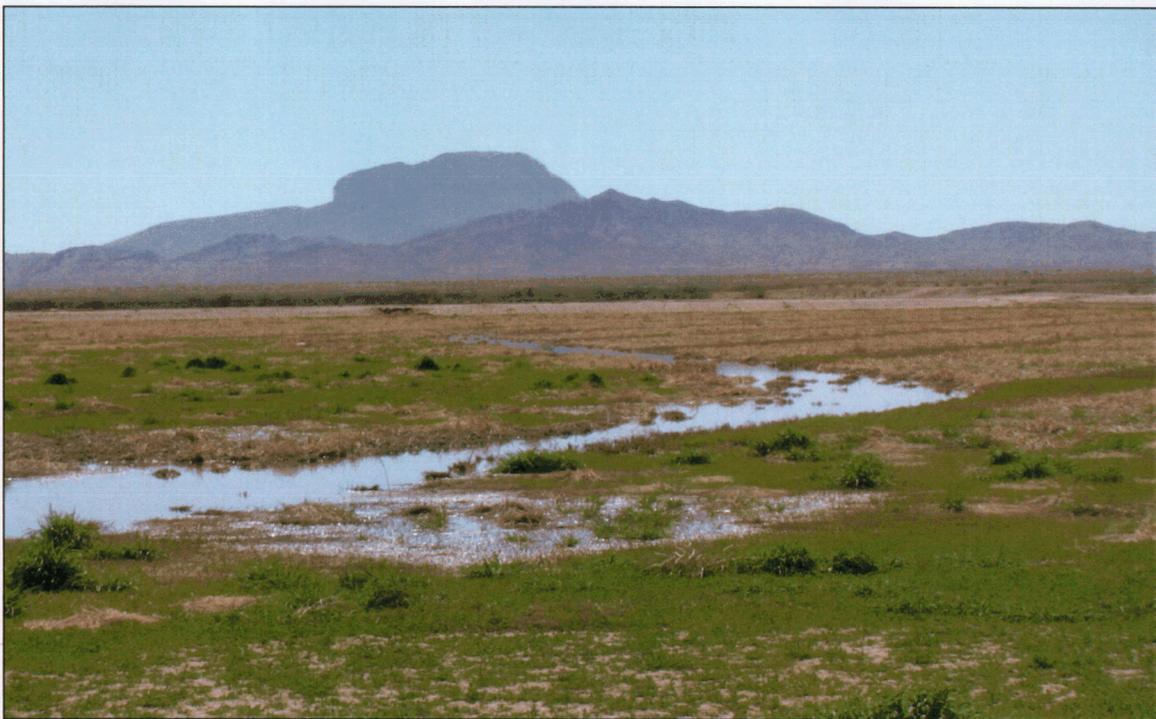
Unit 4 – Central drainage swale inside unit looking south (\*note: water gathering in swale and good moist soil plant germination).

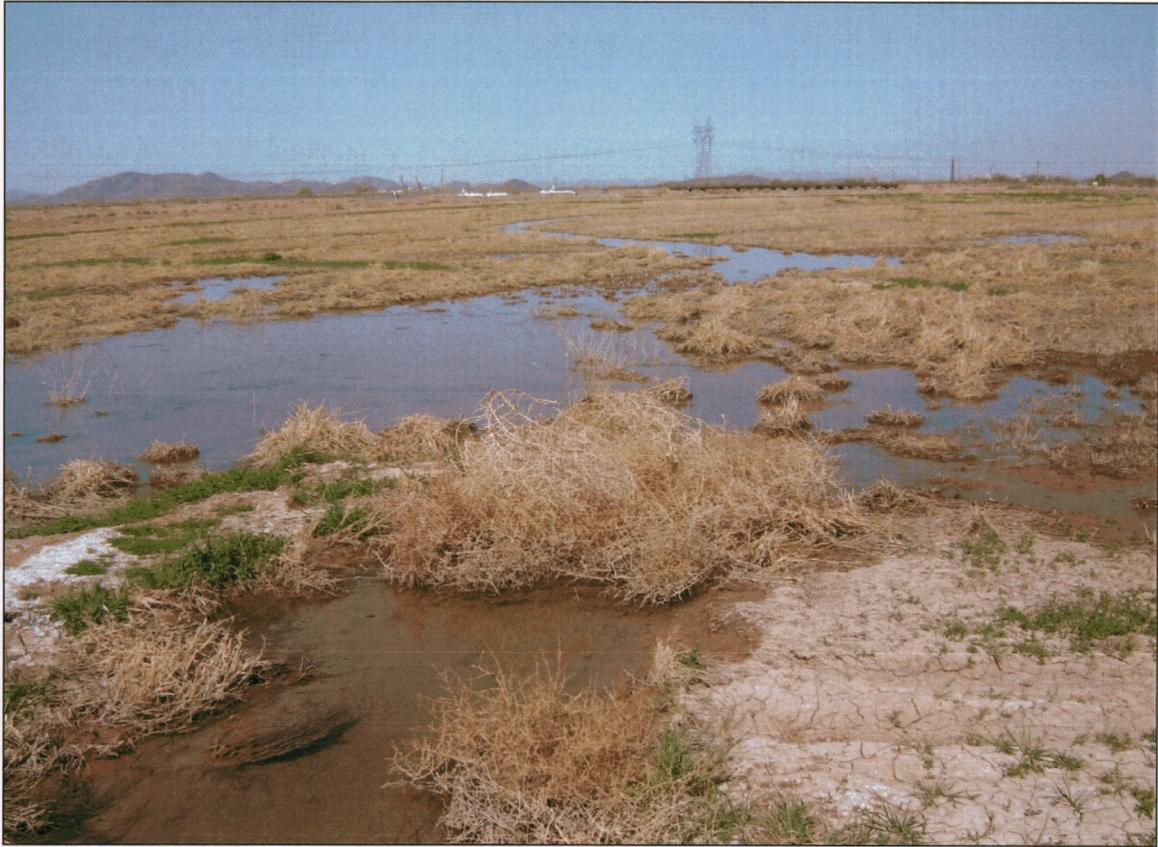
Unit 4 – From water control structure #9 looking north into unit (\*note: vegetation gathering in front of structure, potentially impeding drainage).

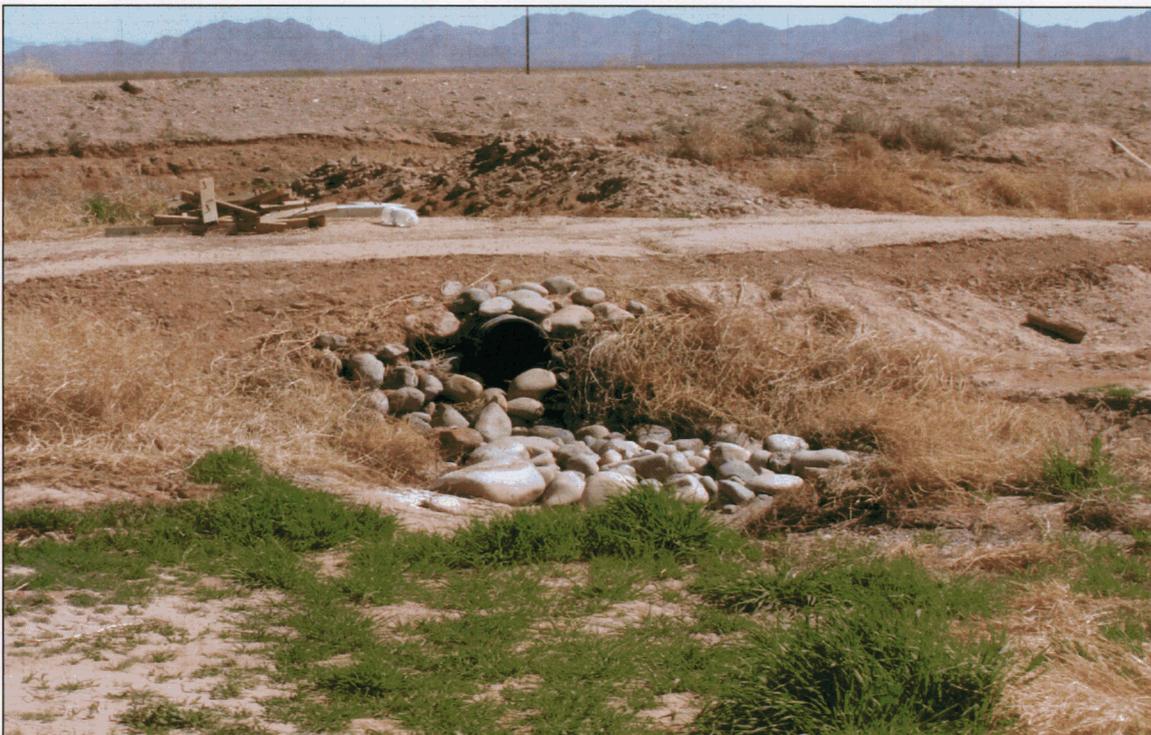
Unit 4 – Water delivery structure for unit in NE corner (\*note: everything is in excellent shape).

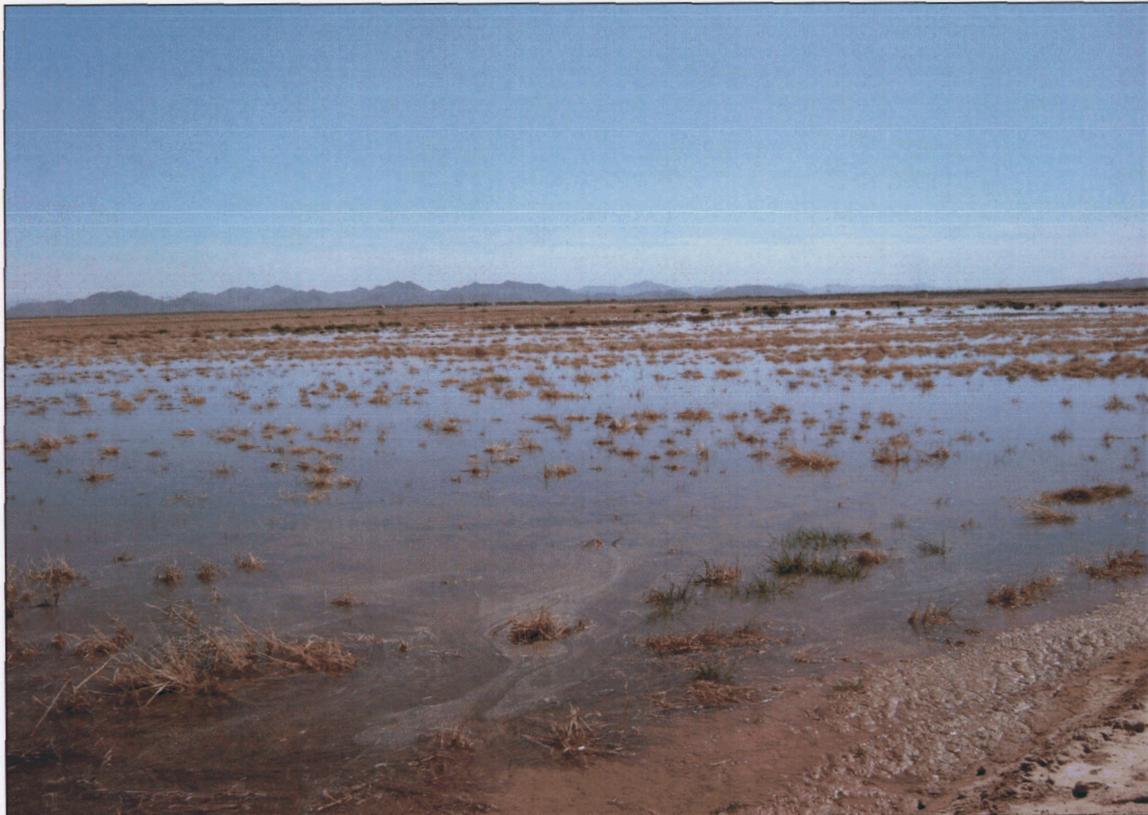
Unit 6 – Main body of unit looking SE from NW corner (\*note: very shallow water throughout the unit and moist soil germination in the foreground).

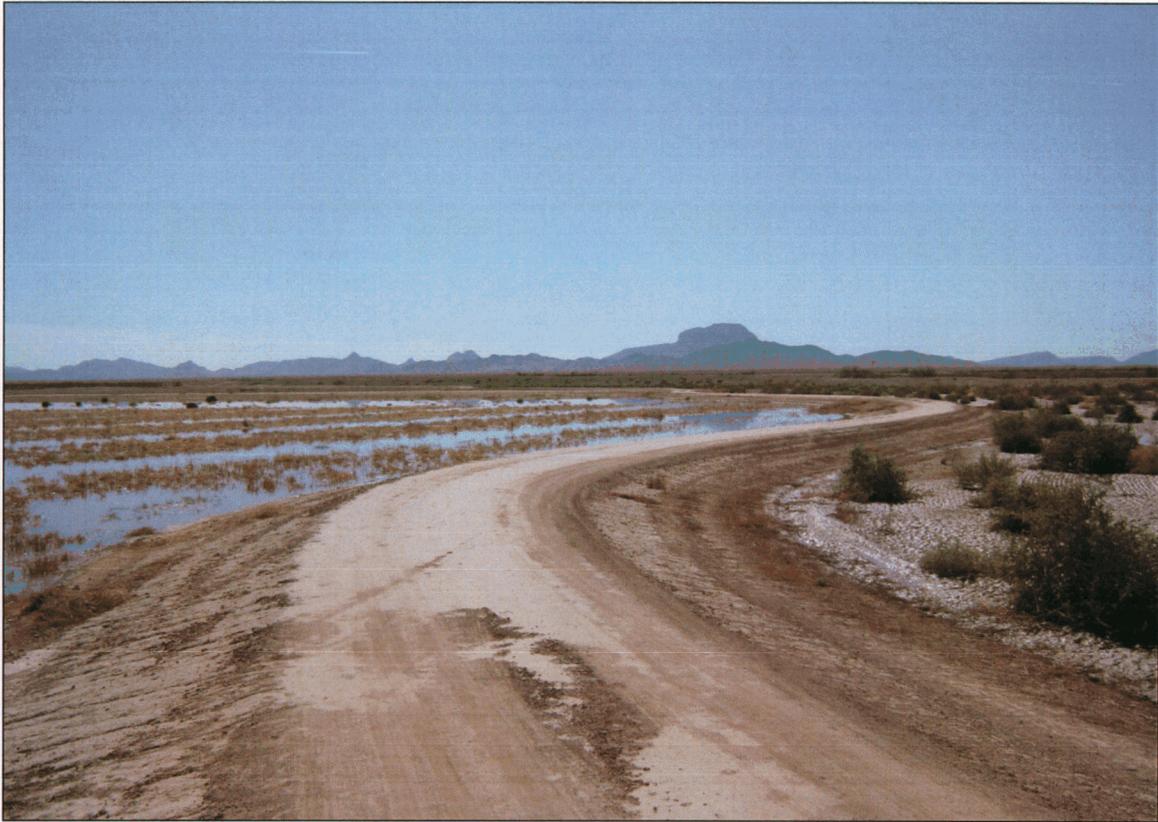
Unit 6 – Levee Bravo looking south from NW corner of unit (\*note: lack of vegetation on levee slopes).

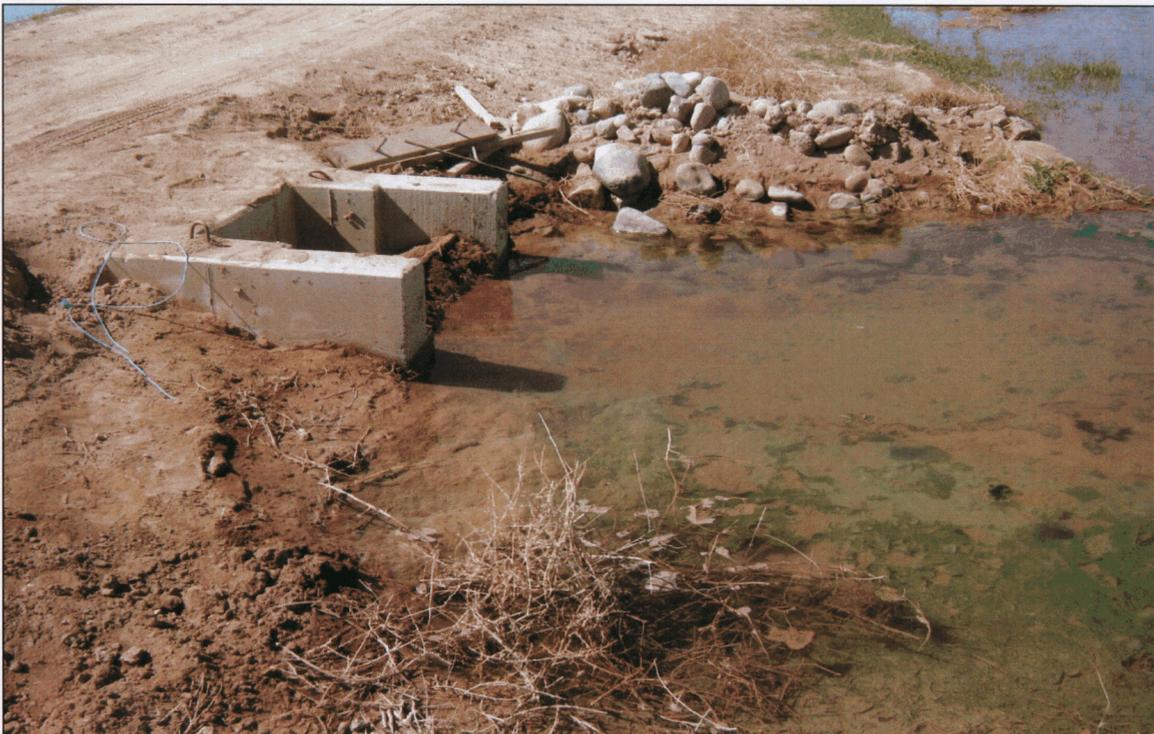
Unit 6 – Water control structure #6 (\*note: boards are installed with mud piled in front to prevent leakage).

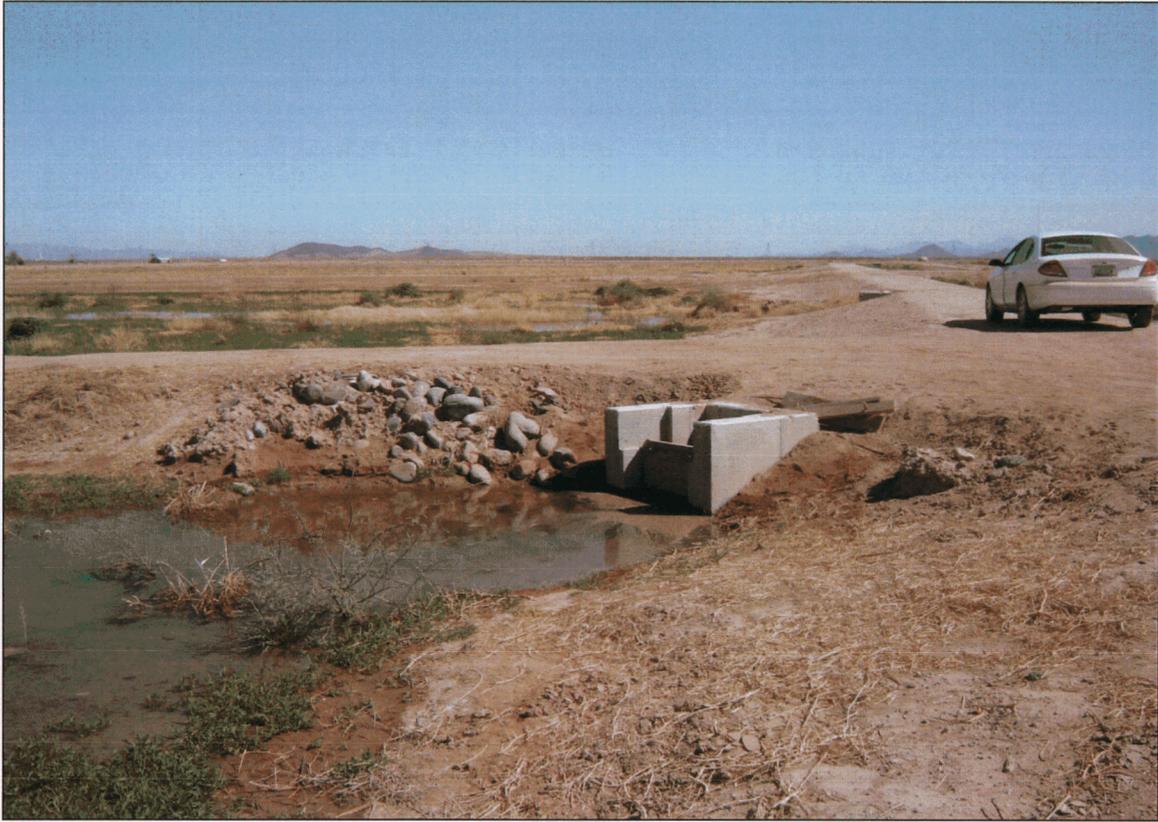
Unit 6 – Water control structure #7 which drains into Central Supply Ditch (\*note: looks to be functioning as designed and in excellent shape).

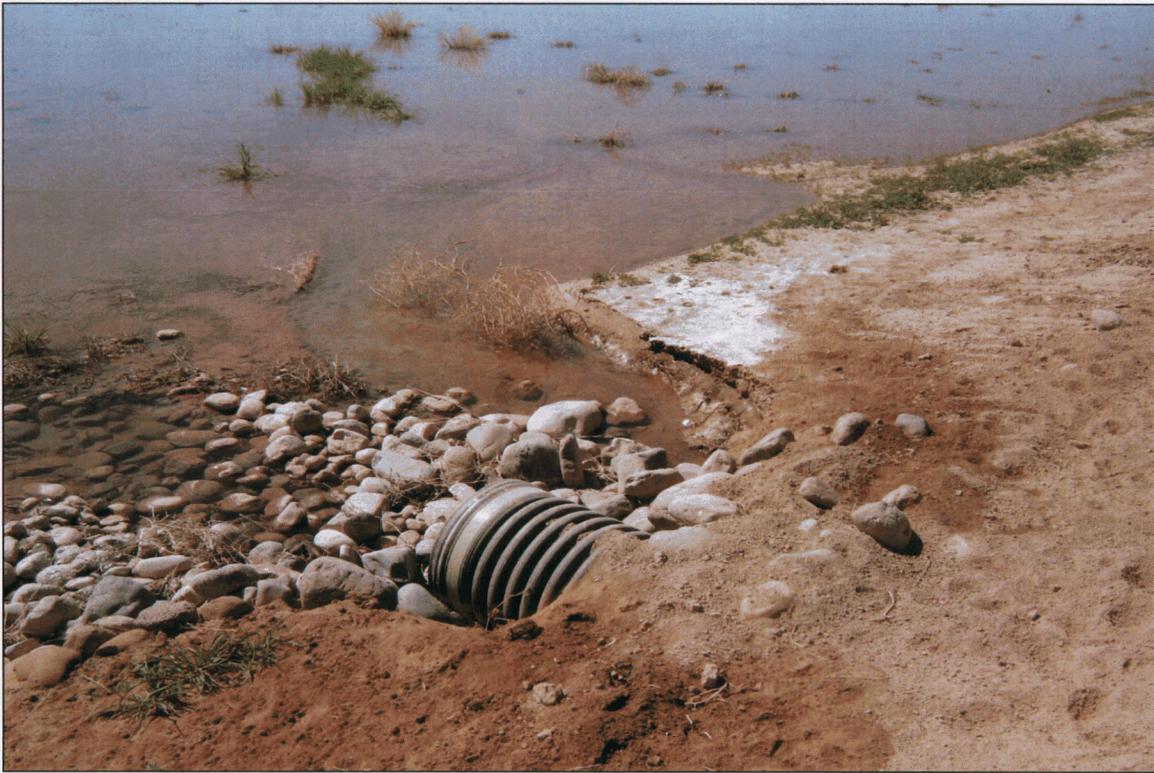
Unit 6 – Outlet end of water control structure #6 into Unit 8 (\*note: minor erosion that looks to have been repaired and rip-rap added, looks to be functioning as designed).

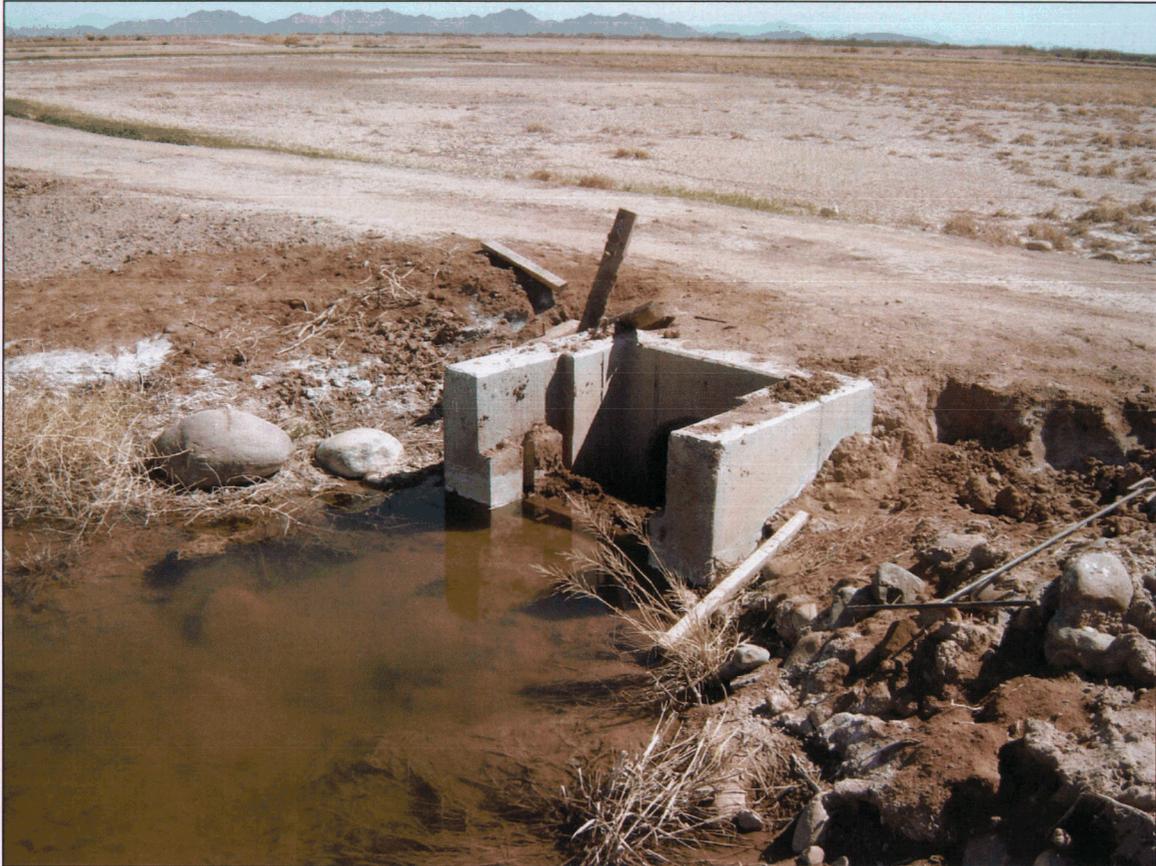
Unit 8 – Water control structure #13 looking SE (\*note: minor soil disturbance around structure and mud behind boards to prevent water leakage).

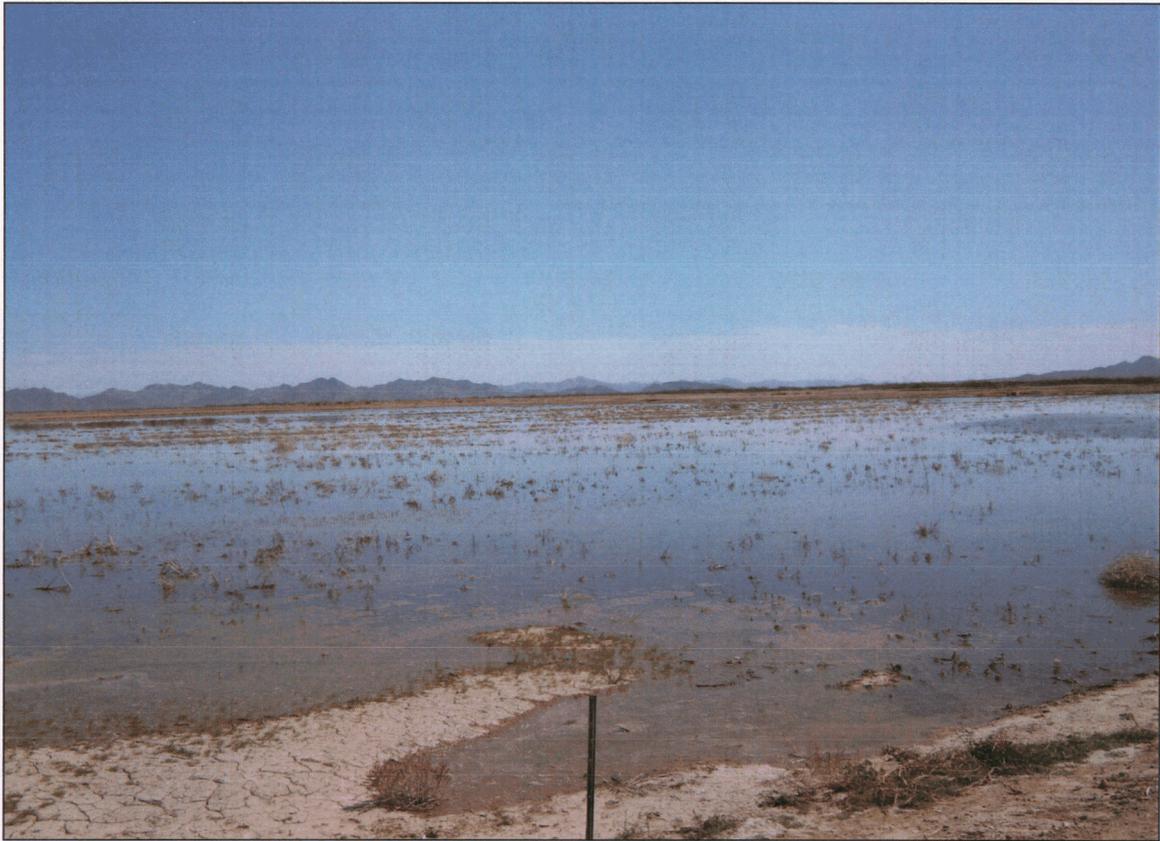
Unit 8 – Main body of unit looking SE from NW corner.

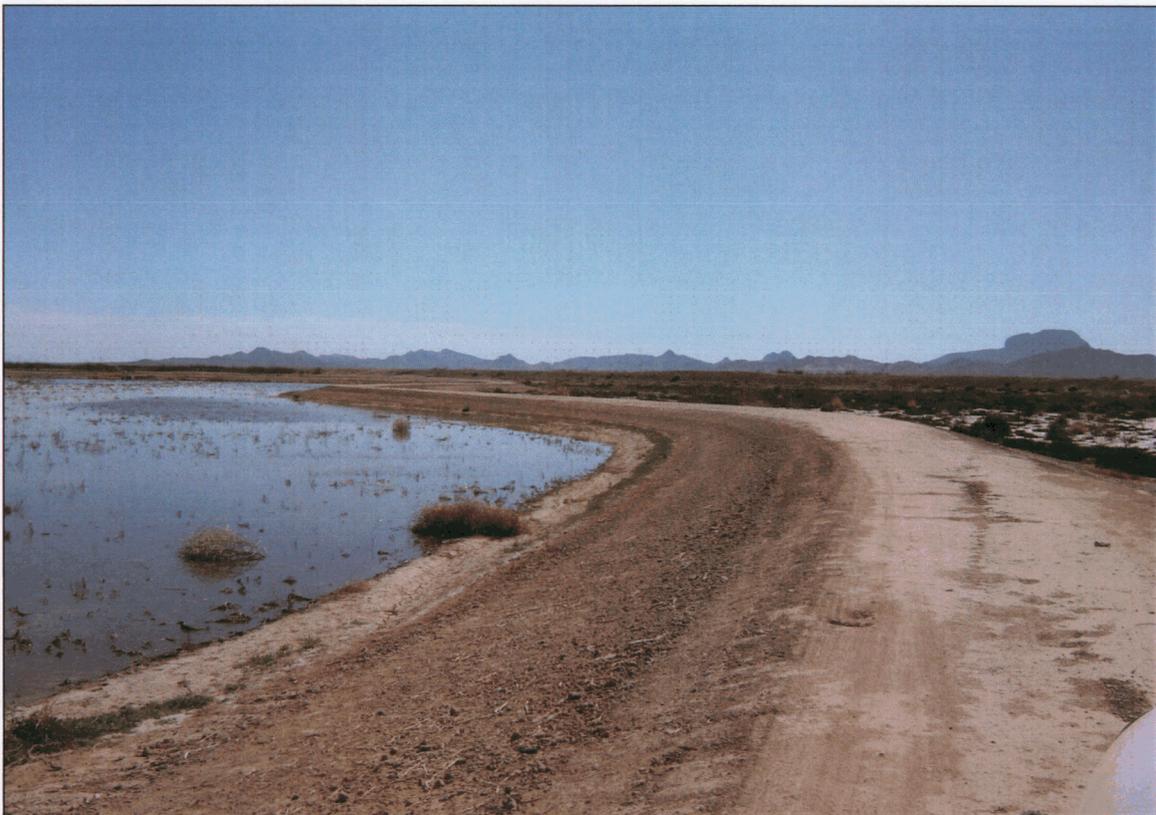
Unit 8 – Levee Bravo looking south (\*note: levee side slopes need to be planted).

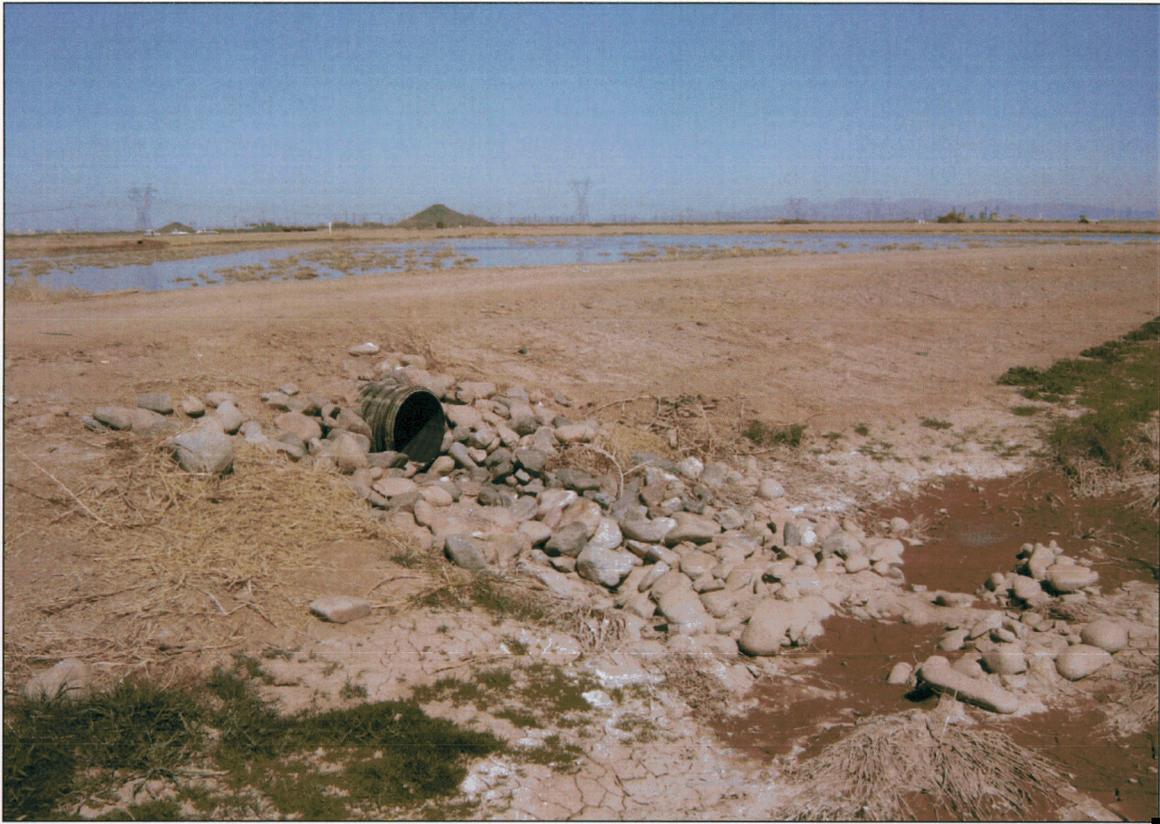
Unit 8 – Water control structure outlet into Unit 11 (\*note: no erosion and rip-rap in place, looks great).

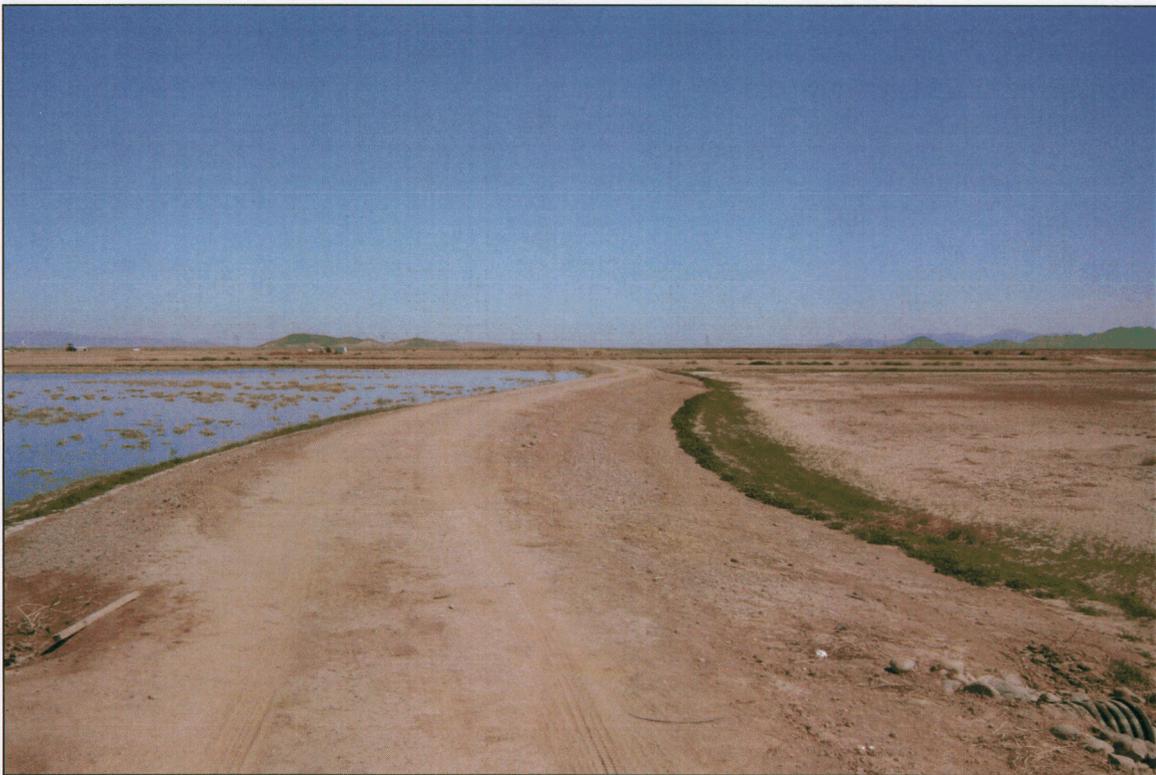
Unit 8 – Levee Golf between Unit 8 and Unit 11 (\*note: levee side slopes need to be planted, levee is in excellent shape).

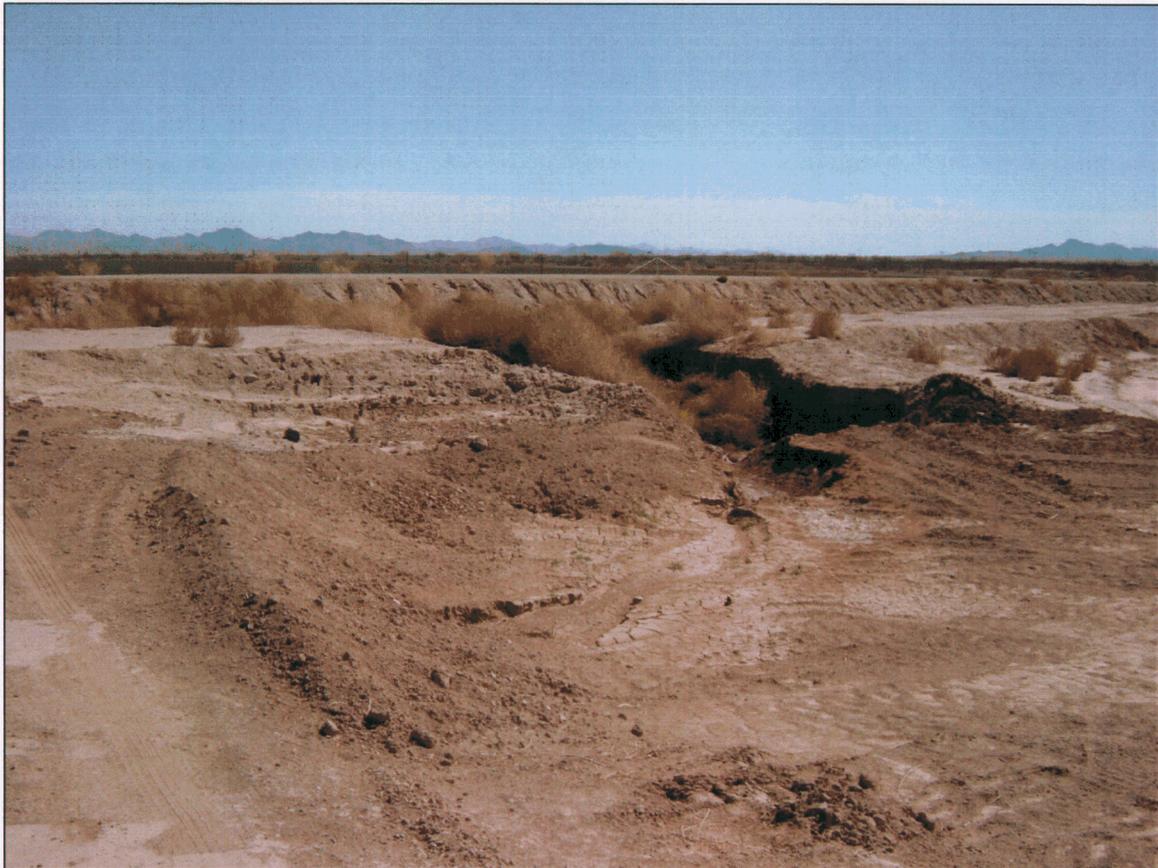
Unit 9 – Former outlet end of water control structure #19 looking SE as it drained to the East Ditch that needed major repairs, as per the last monitoring report (\*note: structure and pipe were removed to prevent additional back-cutting and erosion, looks good).

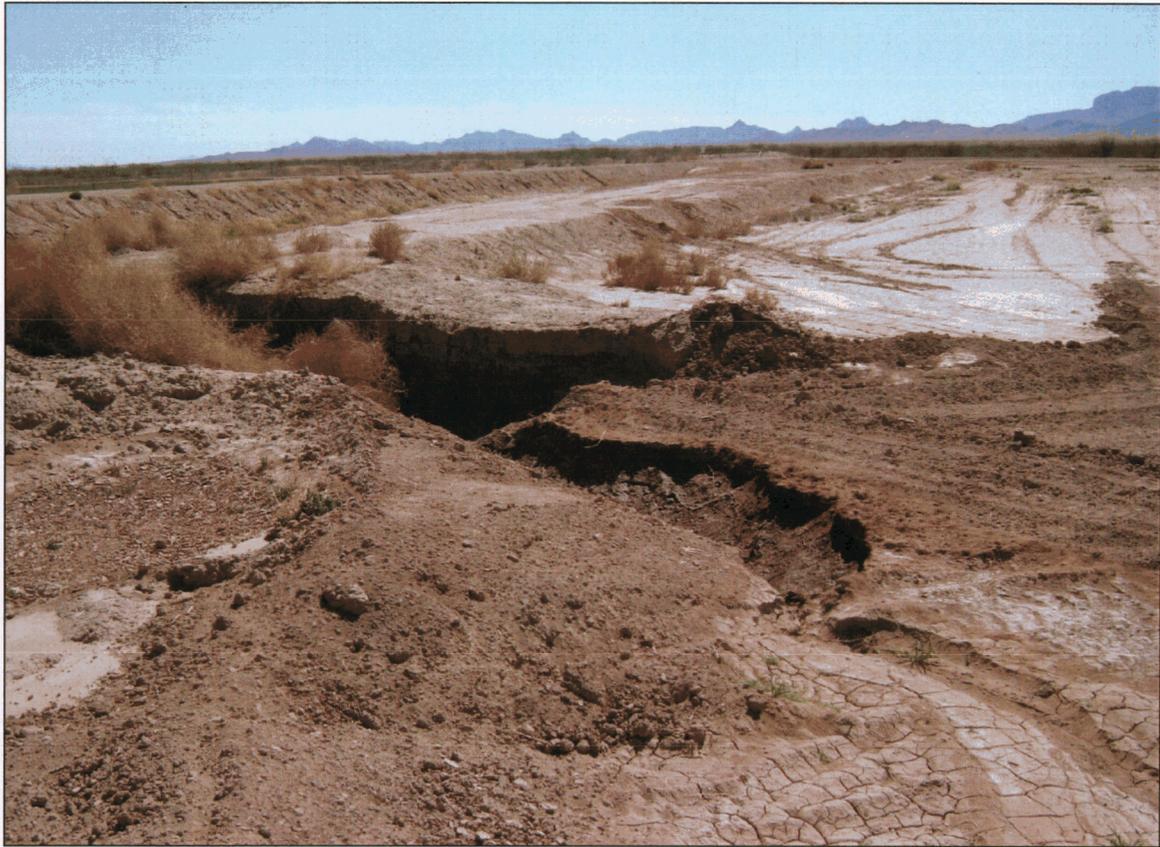
Unit 9 – Outlet of water control structure #19 into ditch before emptying into sump area (\*note: erosion of ditch area before water enters the East Ditch).
