Re: LSP Arlington Valley, LLC  
2006 and Management Plan Annual Report  
Docket No: L-00000P-99-0098

# Duke Energy Arlington Valley Project

## Spring Moist Soil Wetland Monitoring Report

March 2006

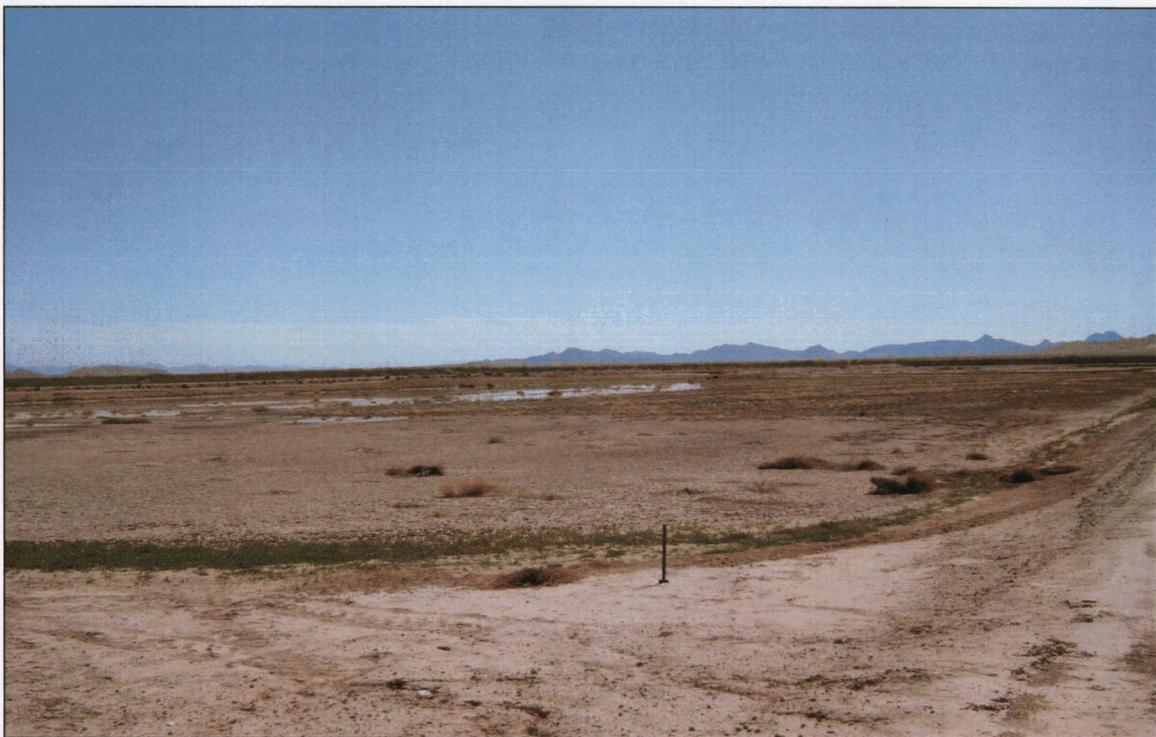
Unit 9 – Main body of unit looking SE from NW corner (\*note: less germination compared to other management units).

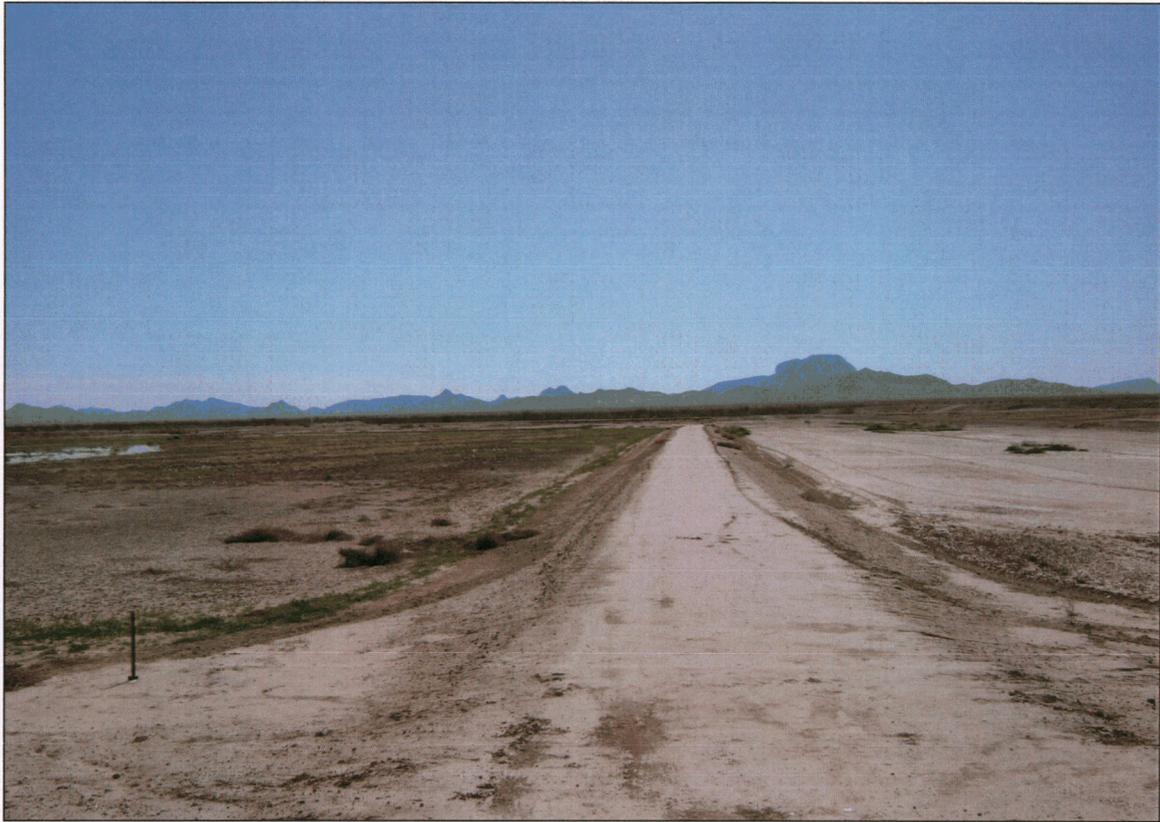
Unit 9 – Levee Mike looking south (\*note: lack of vegetation on levee slopes and poor germination of vegetation inside the unit).

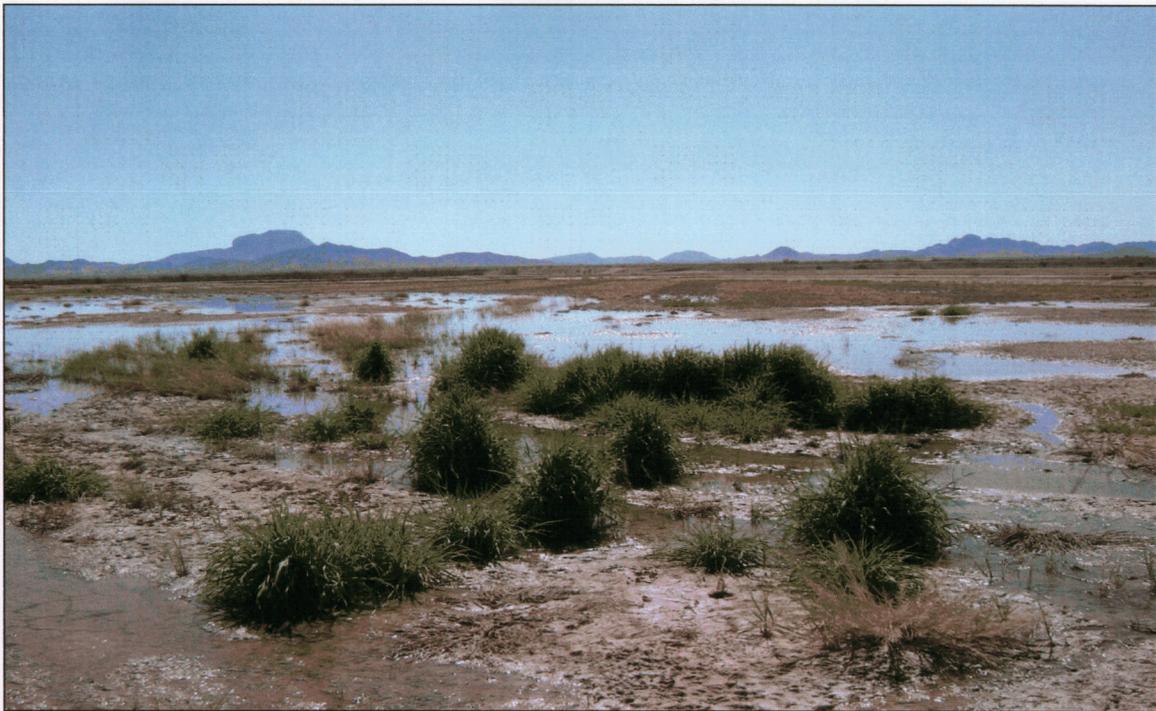
Unit 9 - Moist soil vegetation growing inside the unit along the central swale.

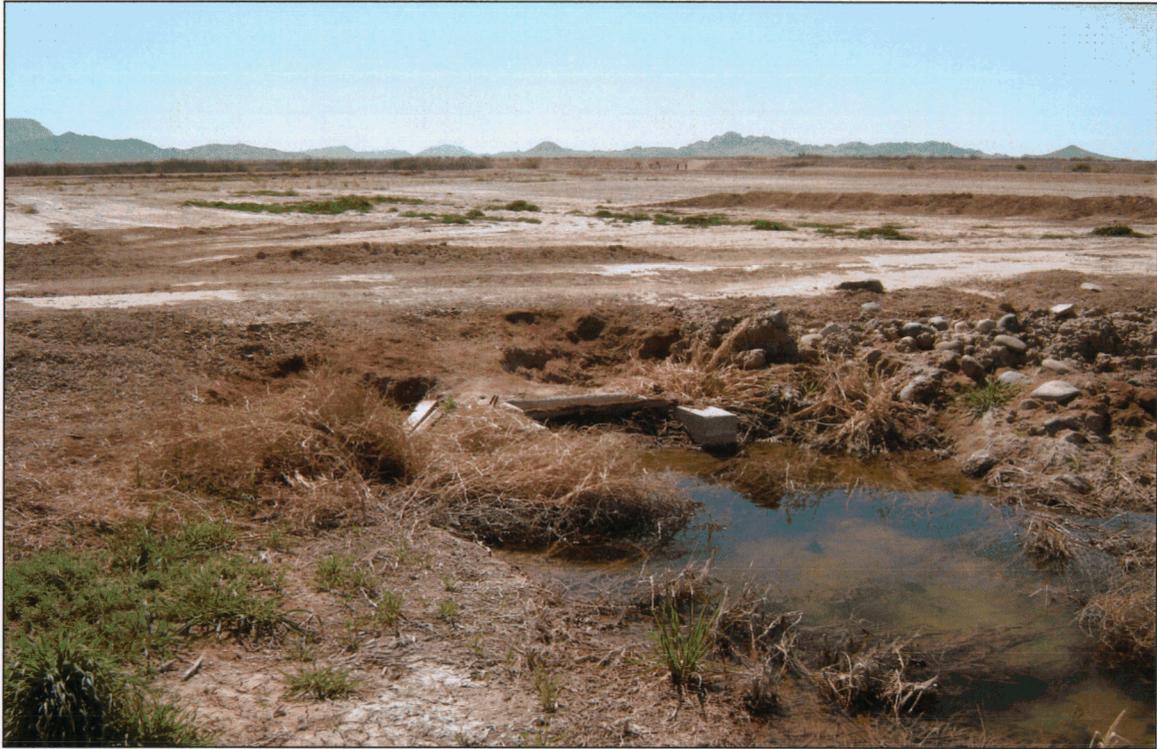
Unit 9 - Water control structure #19 from inside the unit looking south (\*note: fresh dirt, which indicates the structure was moved to the west from its original position to decrease erosion as it entered the East Ditch).

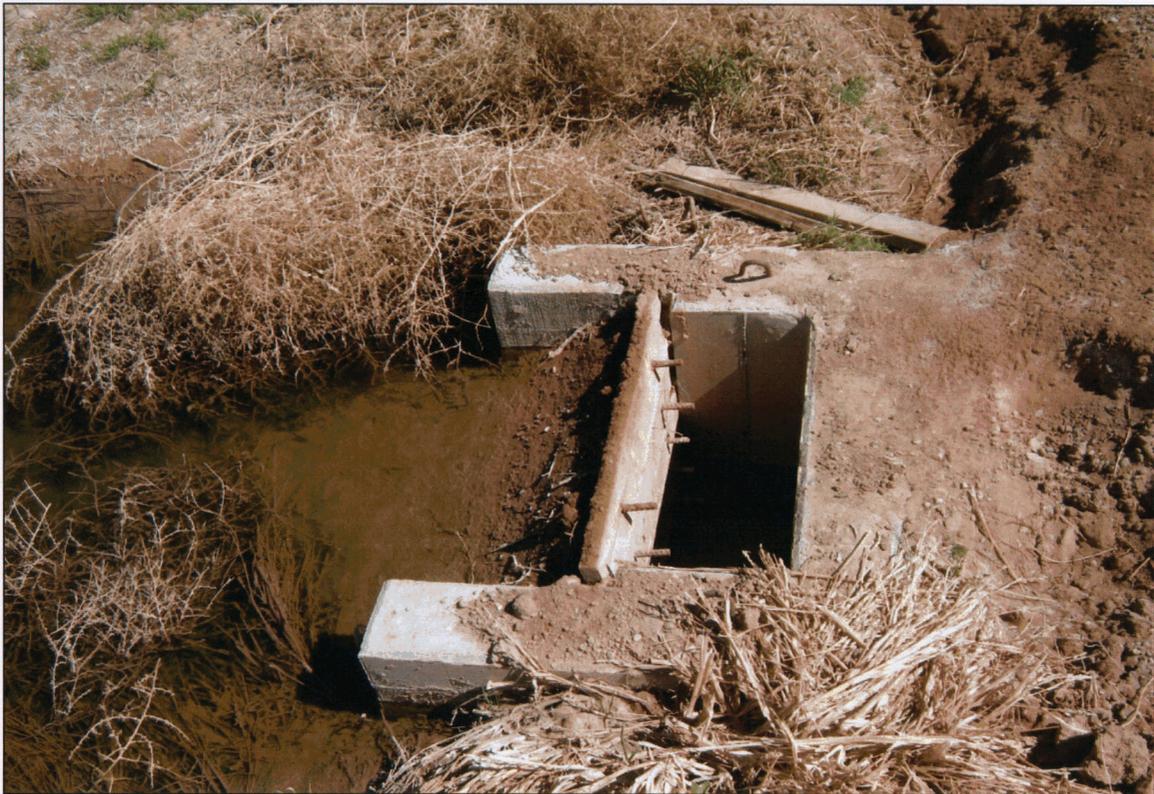
Unit 9 – Water control structure #19 (close-up) (\*note: mud in front of boards and some vegetation in front of structure that should be removed).

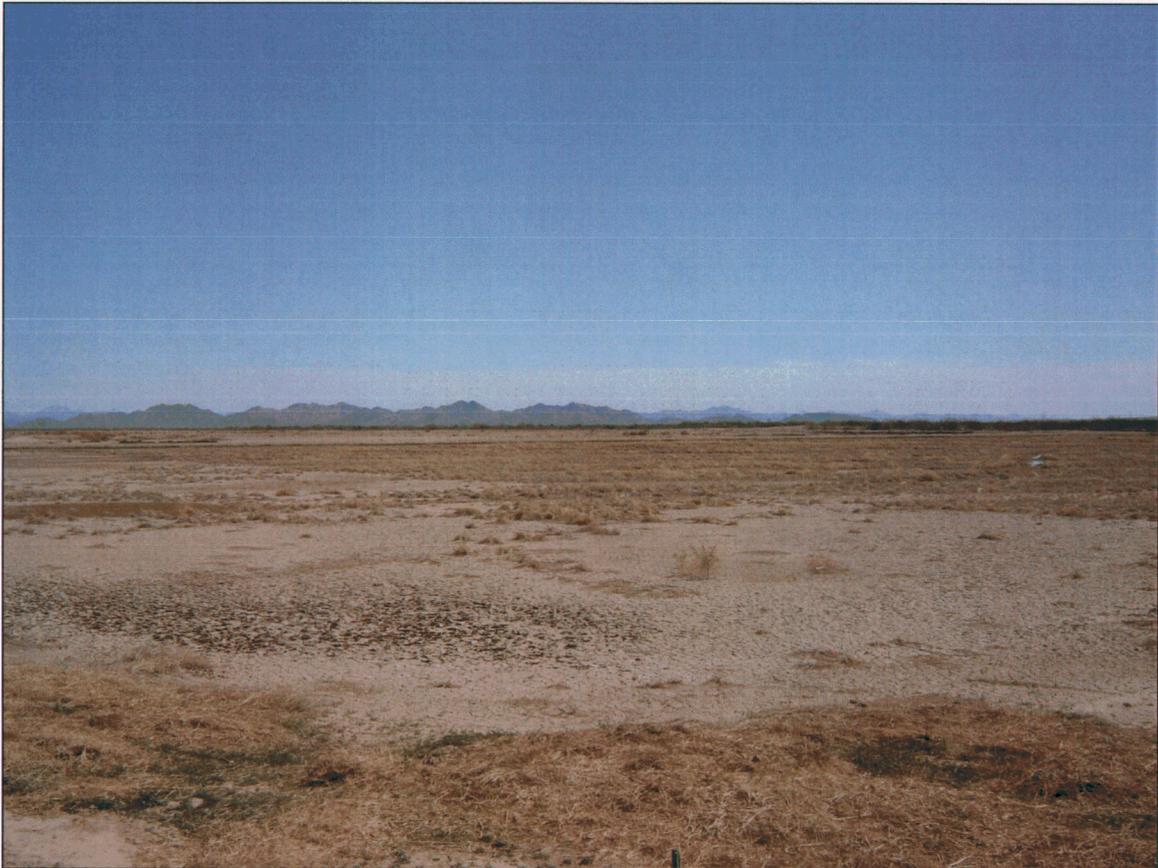
Unit 11 – Main body of unit looking SE from NW corner (\*note: lack of germination and mud flats).

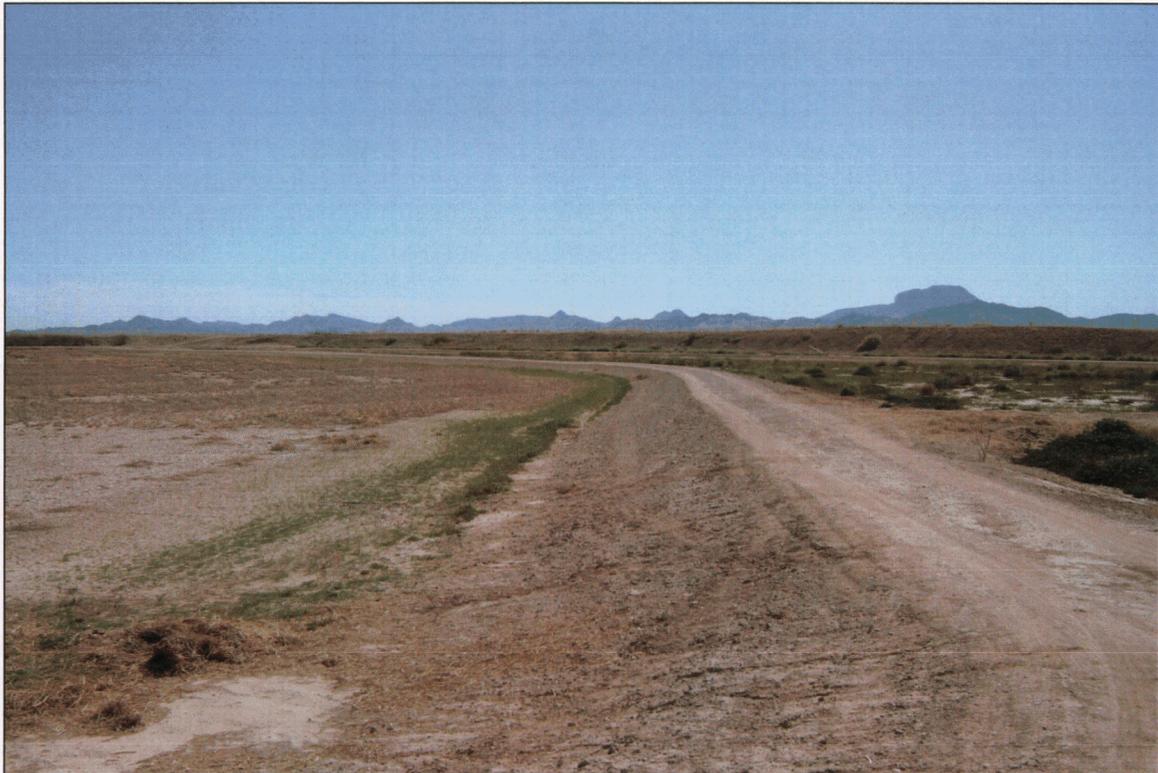
Unit 11 – Levee Bravo looking south (\*note: lack of vegetation on levees).

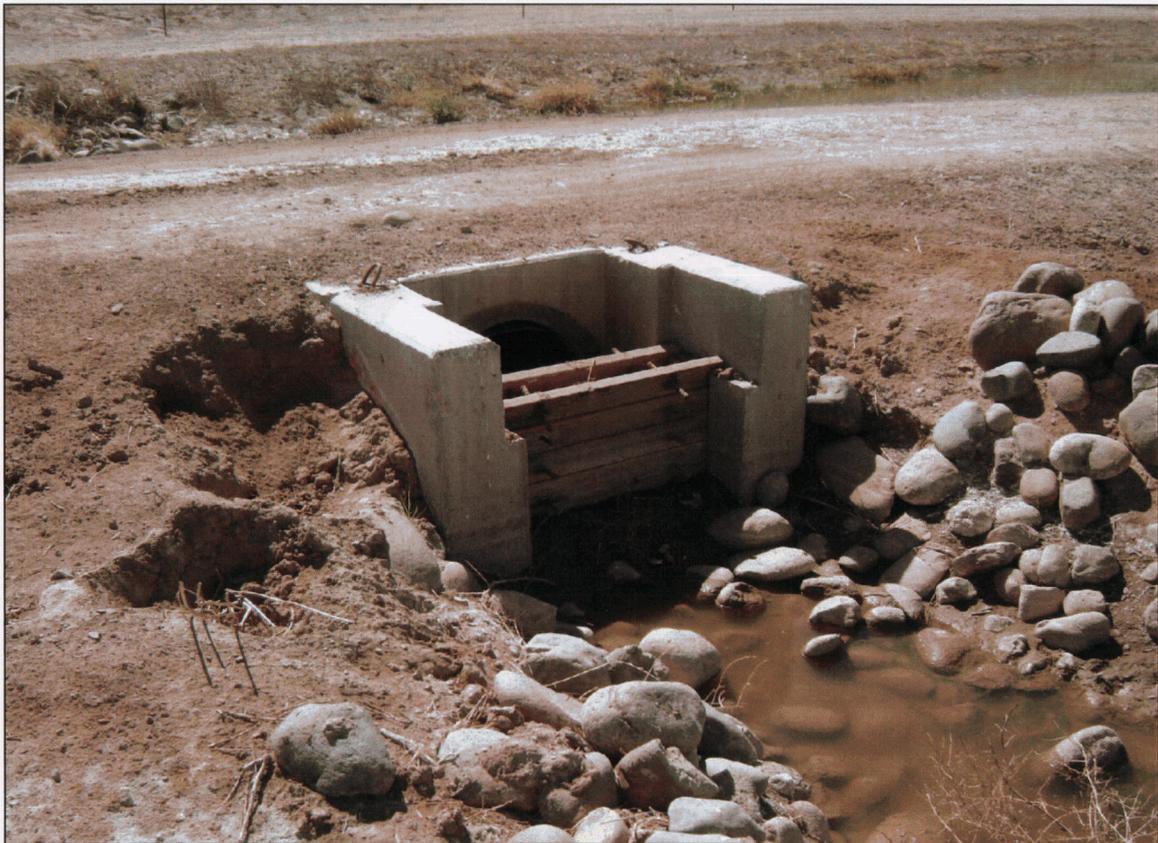
Unit 11 – Water control structure #14 looking south (\*note: boards still in the structure with mud piled in front).

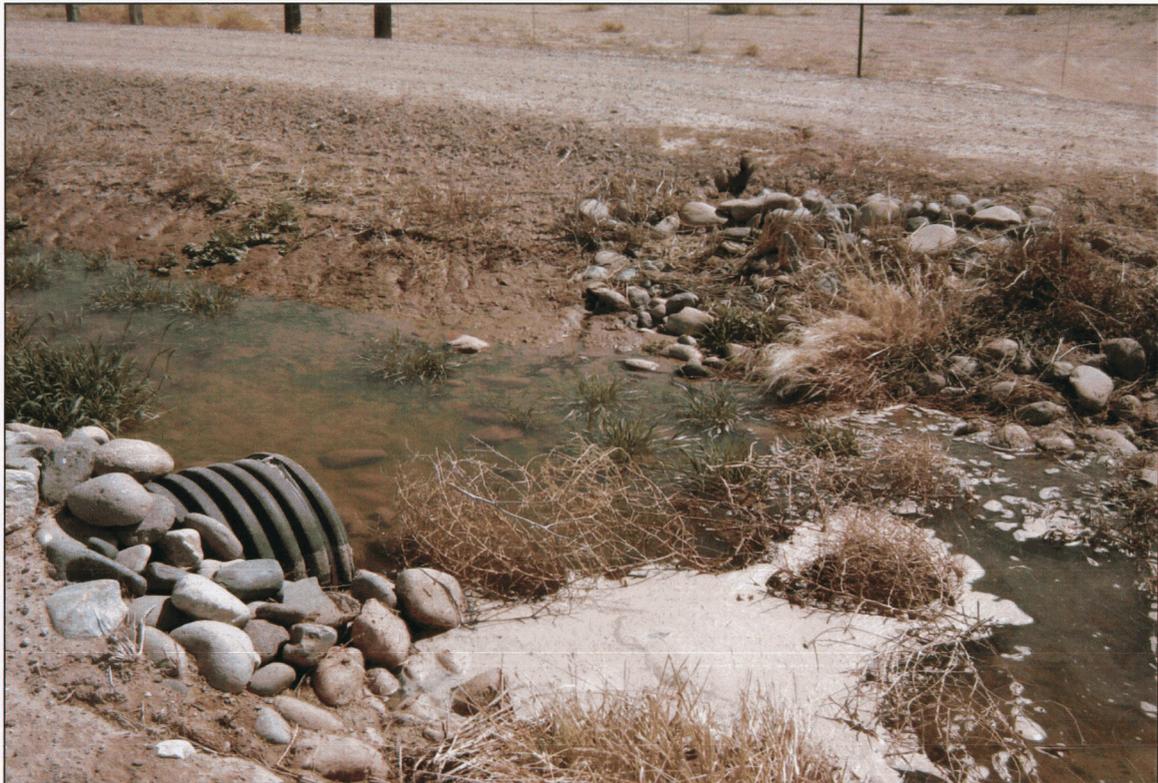
Unit 11 – Water control structure #14 outlet that drains into final ditch (\*note: vegetation and silt building up in ditch).

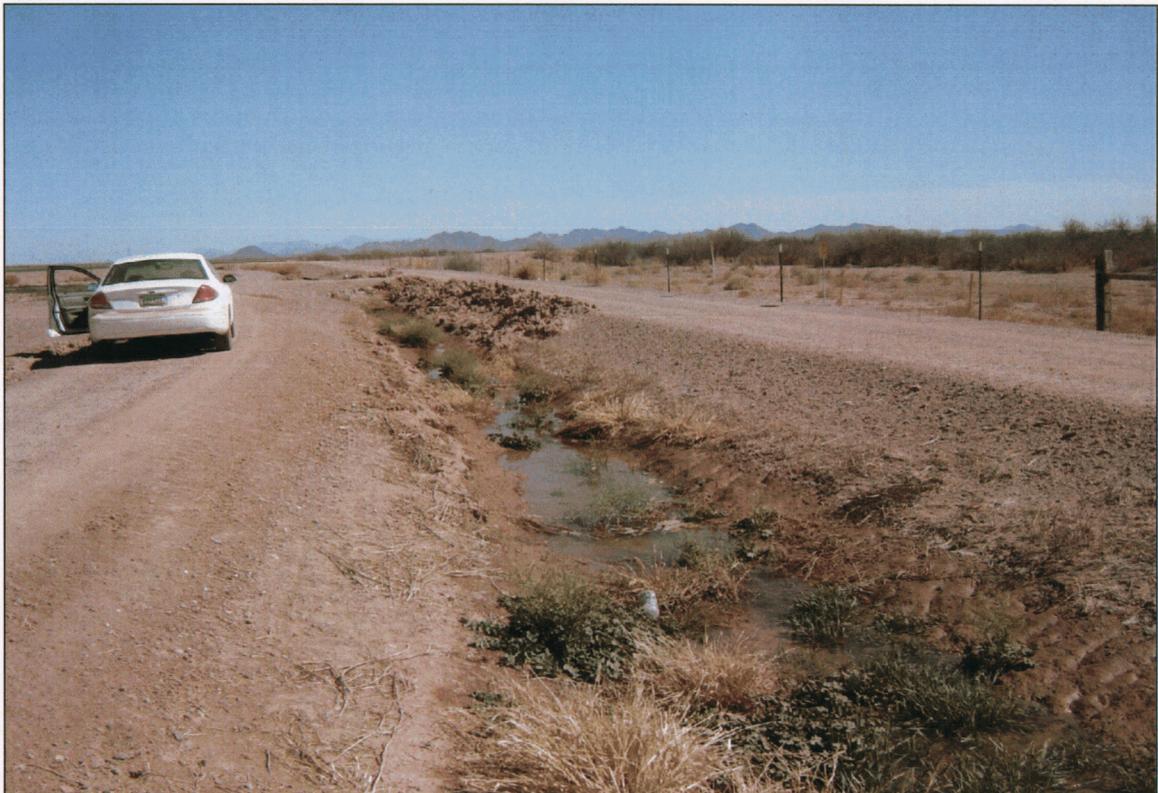
Unit 11 – Final ditch looking east (\*note: vegetation and silt building up, maintenance needed to keep clear of obstructions).

**Final Ditch** – This area must be kept clear of excessive silt and vegetation. An annual maintenance regime will prevent any blockages in the drainage of water and assist in maintaining positive flow through the entire system.

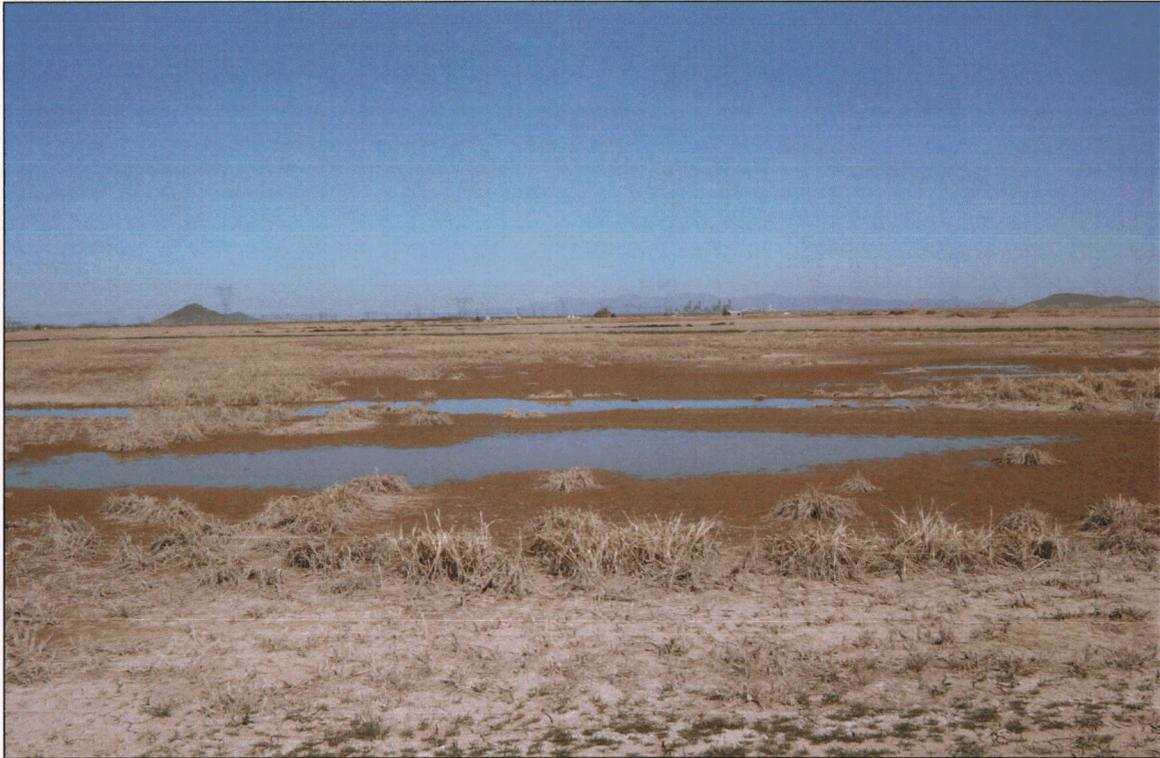
Unit 11 – Small ephemeral pool and mud flats within unit (\*note: excellent germination across mud flats and great shorebird habitat).

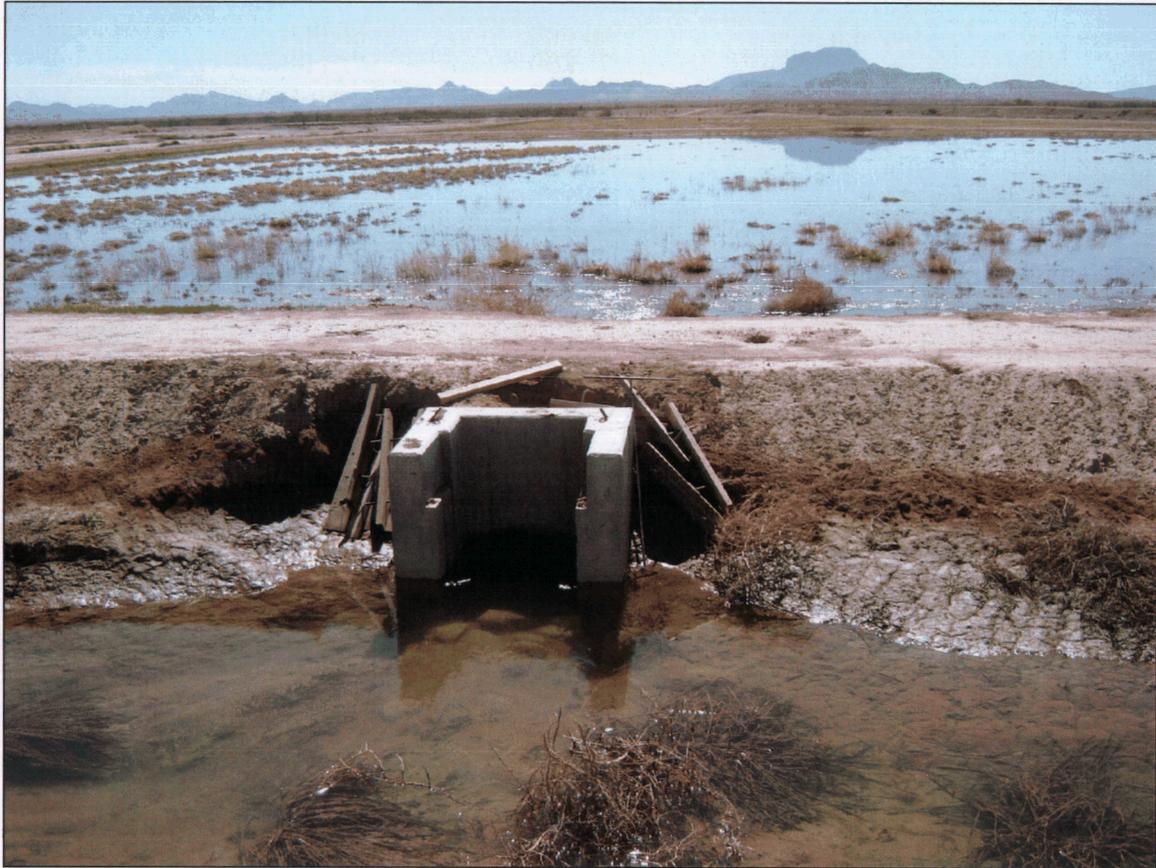
Central Supply Ditch – Water control structure #11 that feeds Unit 8, looking south (\*note: minor erosion around the riser, functioning as designed).

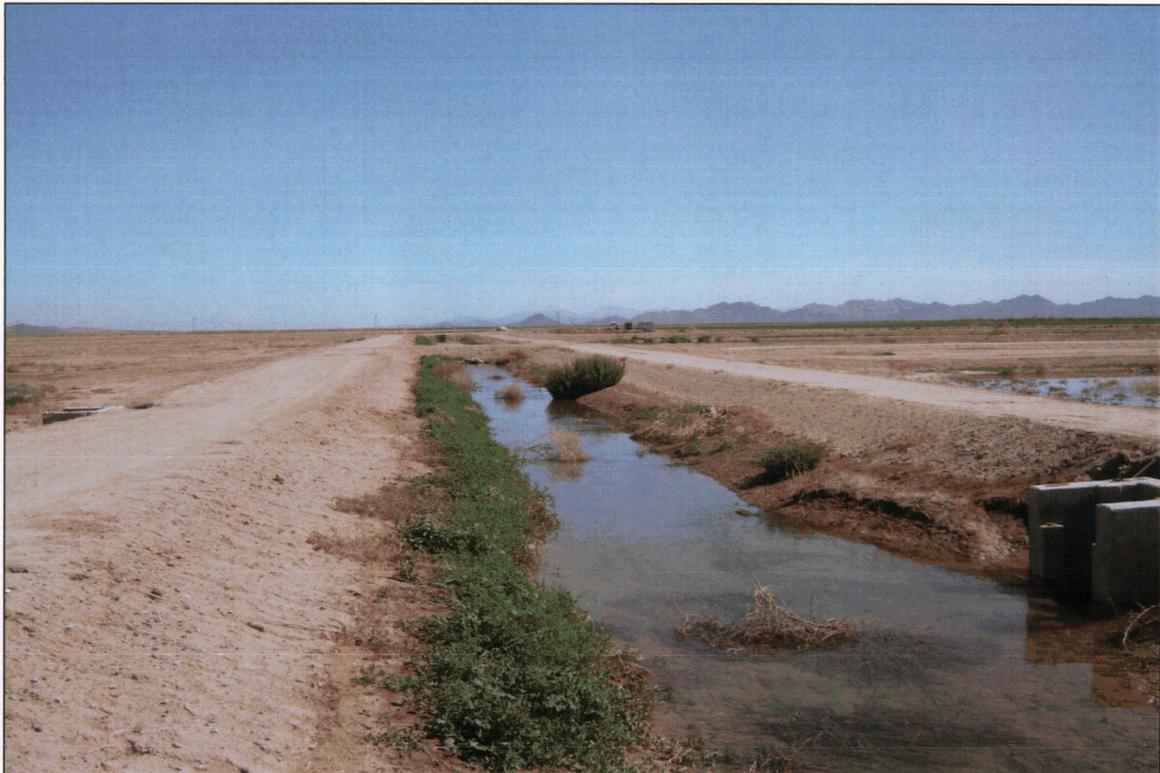
Central Supply Ditch – Looking from west to east (\*note: small amounts of vegetation that will eventually need to be removed to keep the ditch clear of obstructions).

**Central Supply Ditch** – This area should always be kept drained when not irrigating. It is important to keep the ditch clear of any obstructions (*i.e.*, excessive vegetation, etc.) and silt build-up. If this occurs, water will be allowed to stand in the ditch and impede drainage from the adjacent cells. In addition, the area directly across from the irrigation inlet (large plastic pipe) should be fixed once irrigation of the area is complete (between Units 3 & 4). The back-cutting of the levee, if not repaired, may render the road unusable.

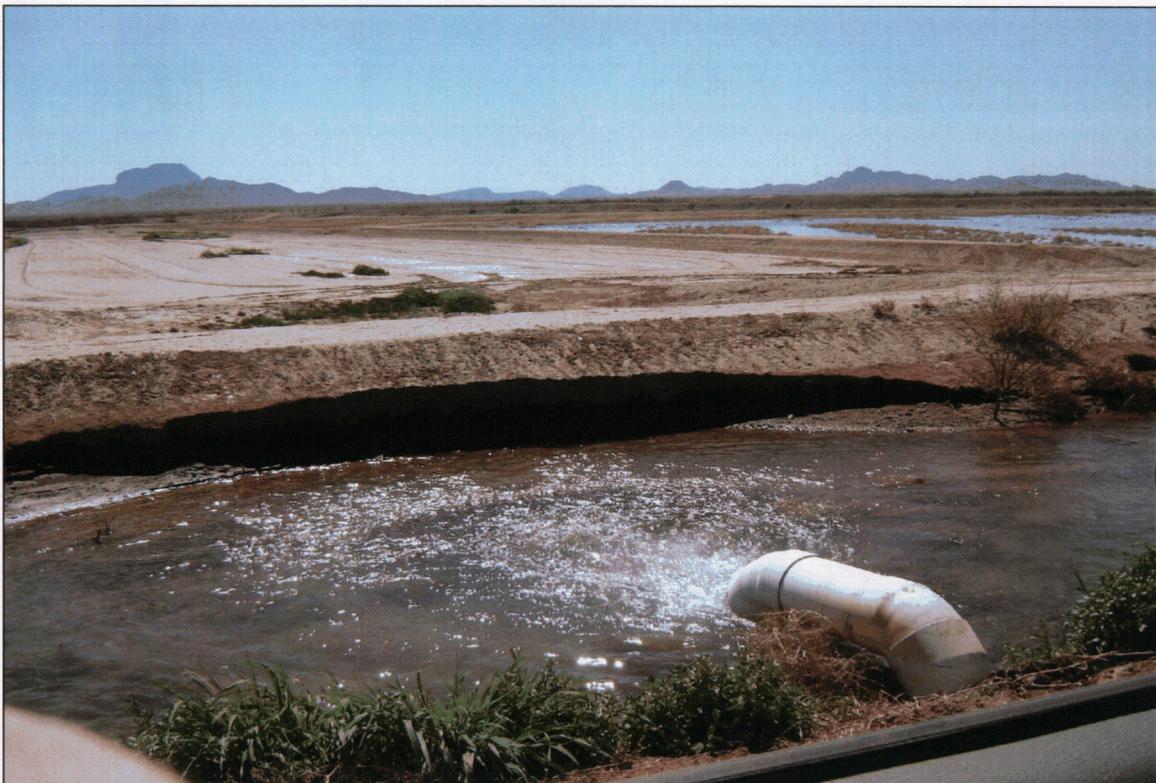
The central supply ditch and associated water control structures were in good structural condition. During the site visit, erosion directly opposite the water in-flow pipe was observed and appeared to be back-cutting substantially into the levee between the ditch and Cell 8. This issue should be addressed once the irrigation has stopped and the units have been de-watered.

Central Supply Ditch – Erosion/back-cutting caused by water between Units 3 & 4 (\*note: need for something to dissipate water's energy as it enters the ditch, fabric and rip-rap recommended).

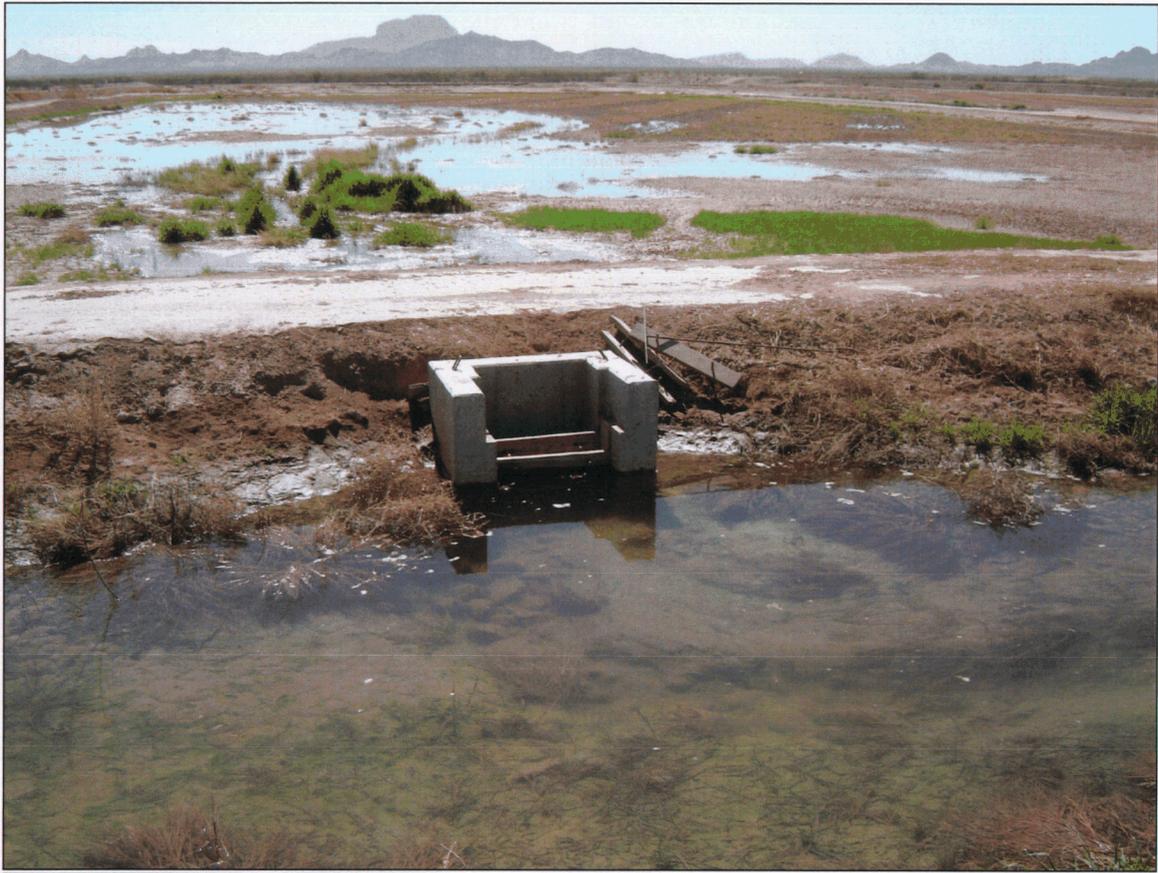
Central Supply Ditch – Water entering Unit 9 from the ditch (\*note: it is recommended to remove the boards and let the water flow freely into Unit 9 to help with vegetation growth).

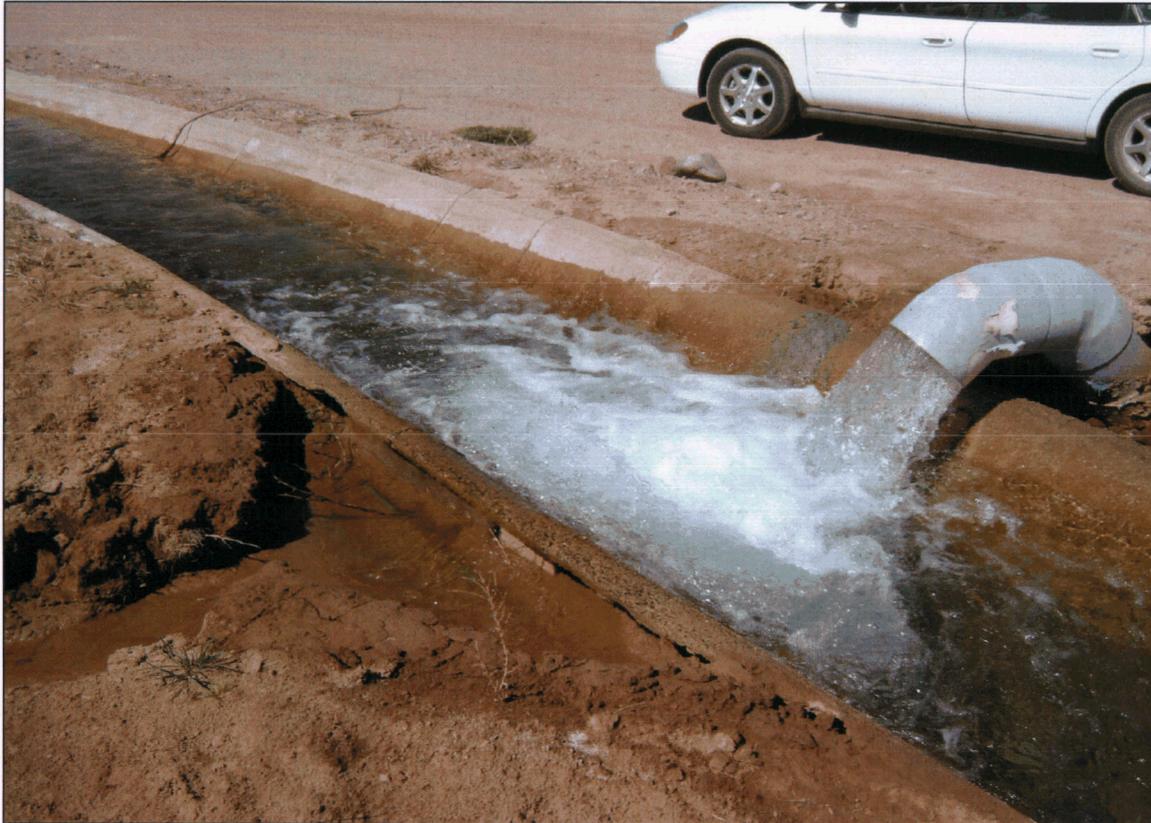
The concrete-lined water delivery ditch (north end of project) is leaking immediately adjacent to the water in-flow. The dirt behind the concrete is gone and the water is slowly leaking into the area directly north of Cell 4. This needs to be addressed as soon as irrigation of the area is completed. Without attention, the concrete will cave in and repairs to the ditch will be much more costly.

Concrete Feeder Ditch – NE corner of project site where water enters the ditch north of Unit 4 (\*note: erosion along concrete and water leaking out of ditch).

**Concrete Supply Ditch** – This ditch needs to be monitored regularly for any potential problems. If erosion adjacent to the ditch and slide-gates is not addressed then the concrete may eventually cave in and cause a much more expensive problem to fix, as well as hinder irrigation of the wetland units.

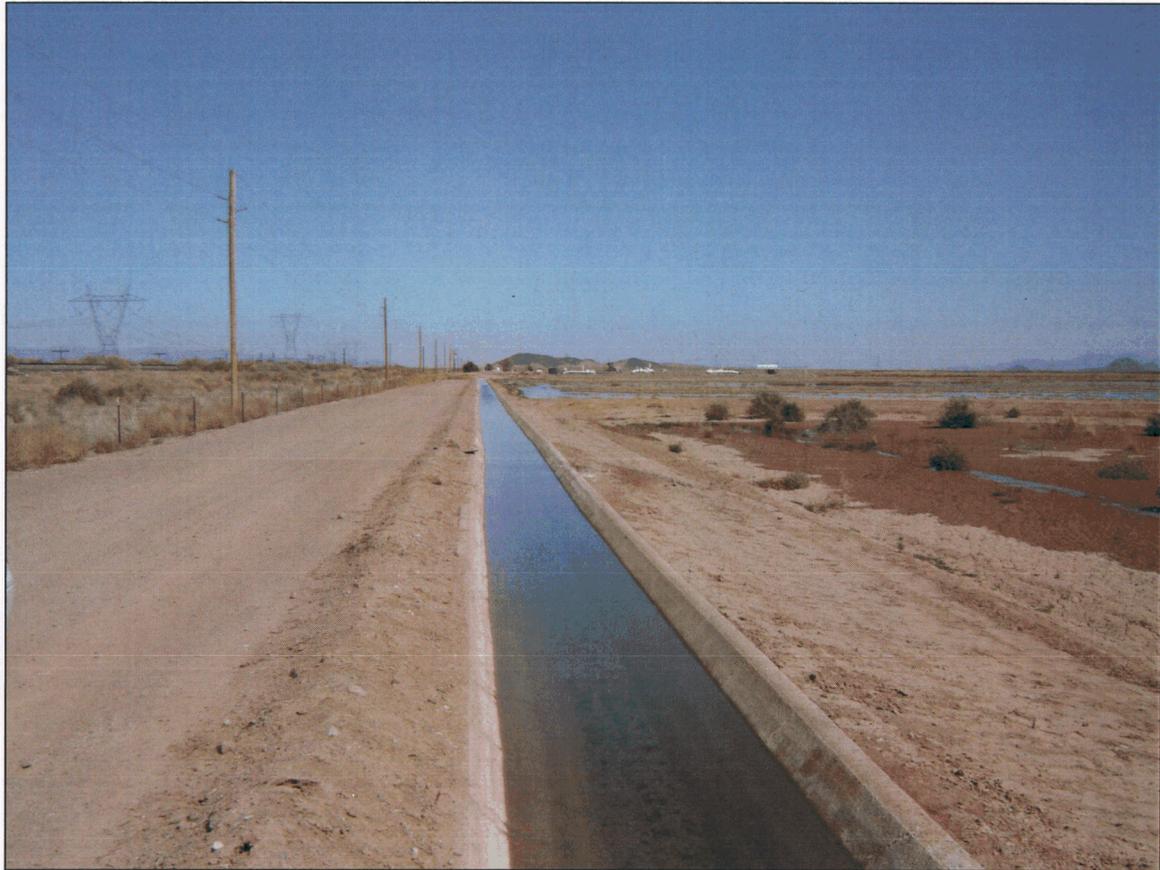
Concrete Feeder Ditch – From west end of project site looking east (\*note: in excellent shape and working as designed).
