Allegheny Energy Supply Company, LLC
Docket No. L-00000AA-01-0116
Case No. 116

Duke Energy Arlington Valley Facility II
Decision No. 64495
Docket No. L-00000P-01-0117
Case No. 117

A NEW EARTH FISSURE
NEAR WINTERSBURG,
MARICOPA COUNTY, ARIZONA

Arizona Geological Survey
Open-File Report 01-10

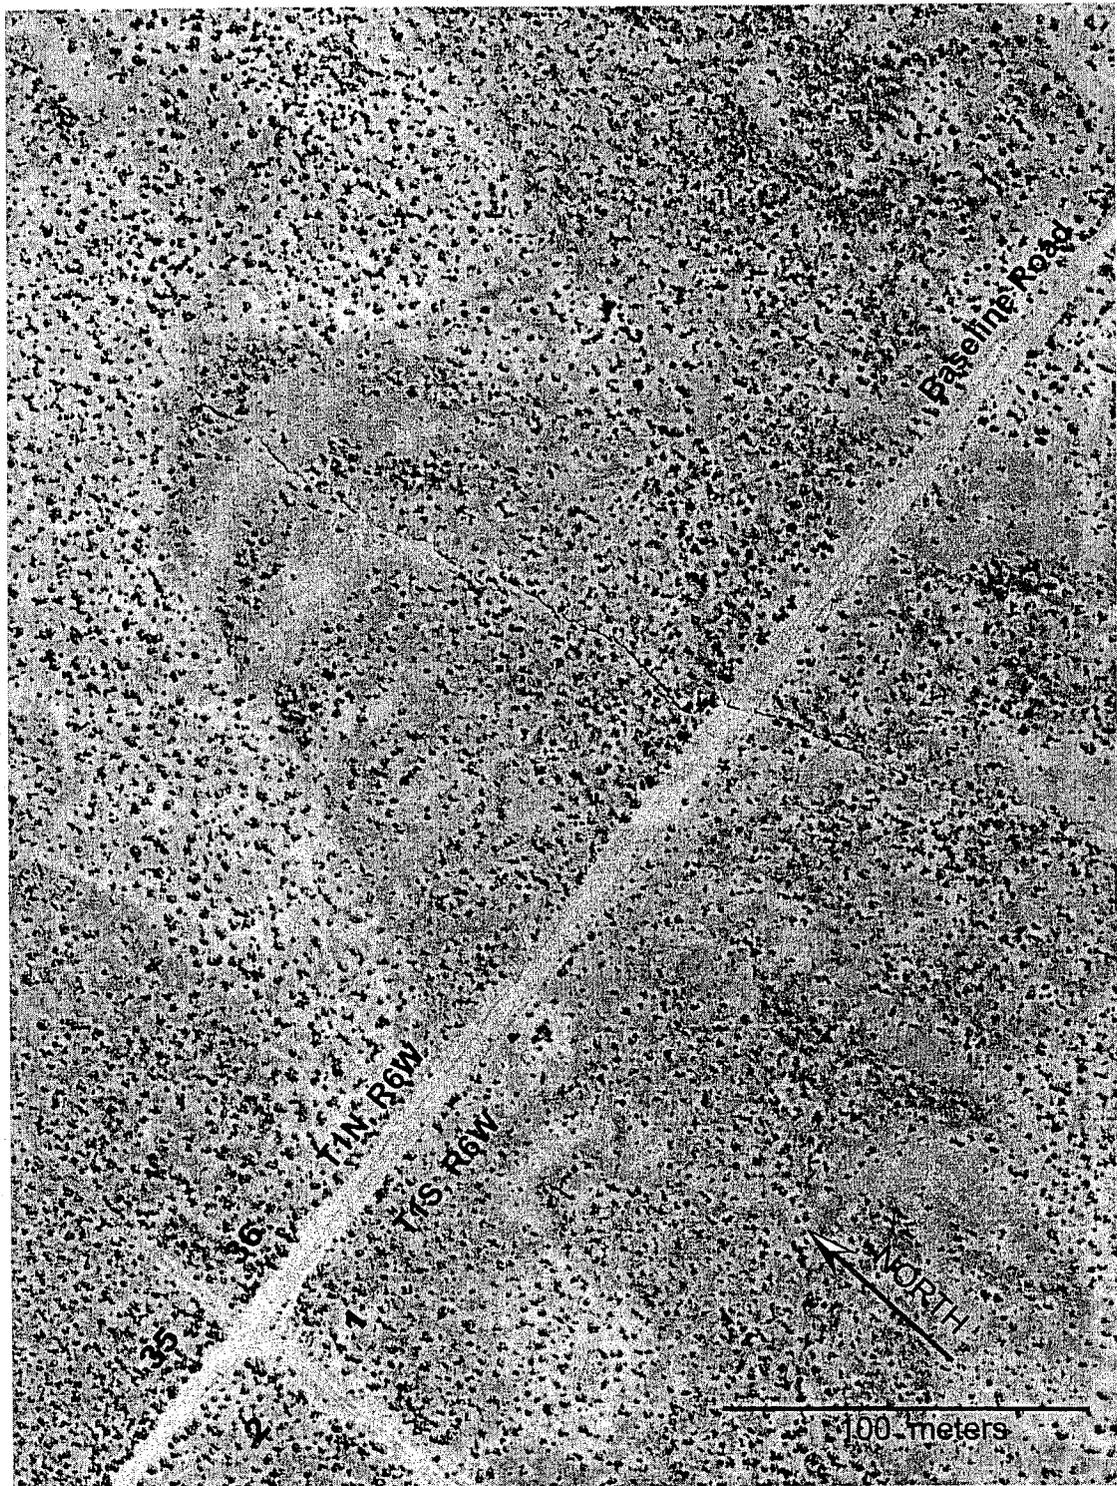
The fissure is nearly north-south and is 307 m (1007 ft) long (Figure 4). The fissure is very young, with narrow, steep sides and a highly irregular apparent depth ranging from <1 foot to >8 feet over short distances. In two locations the fissure is en echelon (Figure 5), with NW-SE steps. There is no discernable vertical offset across the fissure.

Figure 4. Detailed aerial view of new earth fissure.

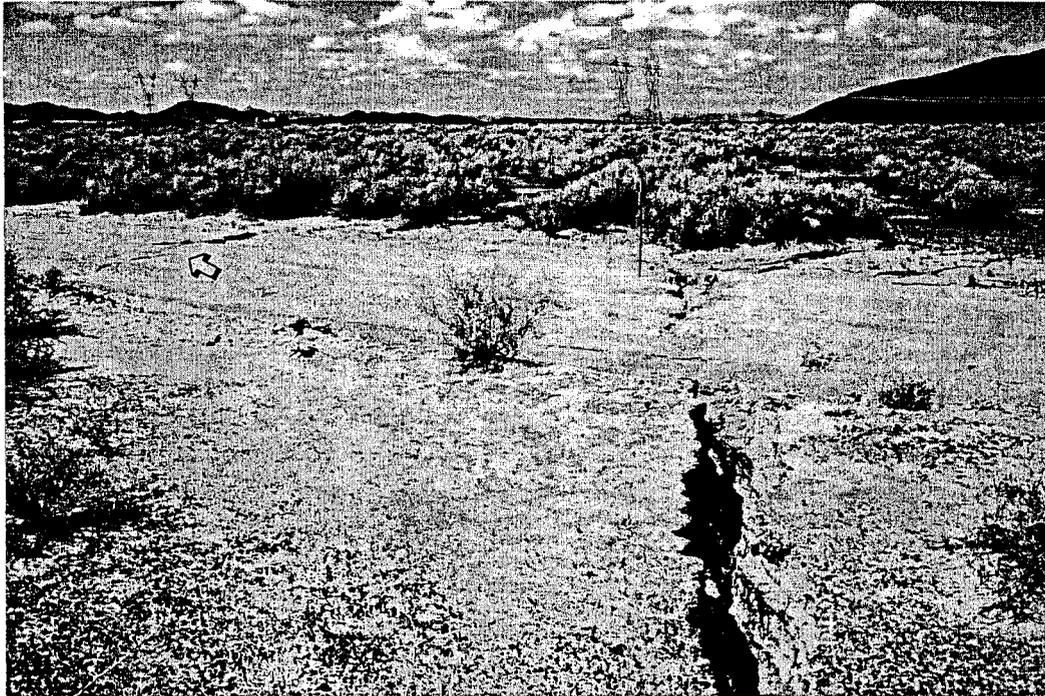
Figure 5. En echelon section of earth fissure crossing Baseline Road, looking NW. Fissure is 6-12 inches wide here. Second earth fissure crosses road at far left (arrow).

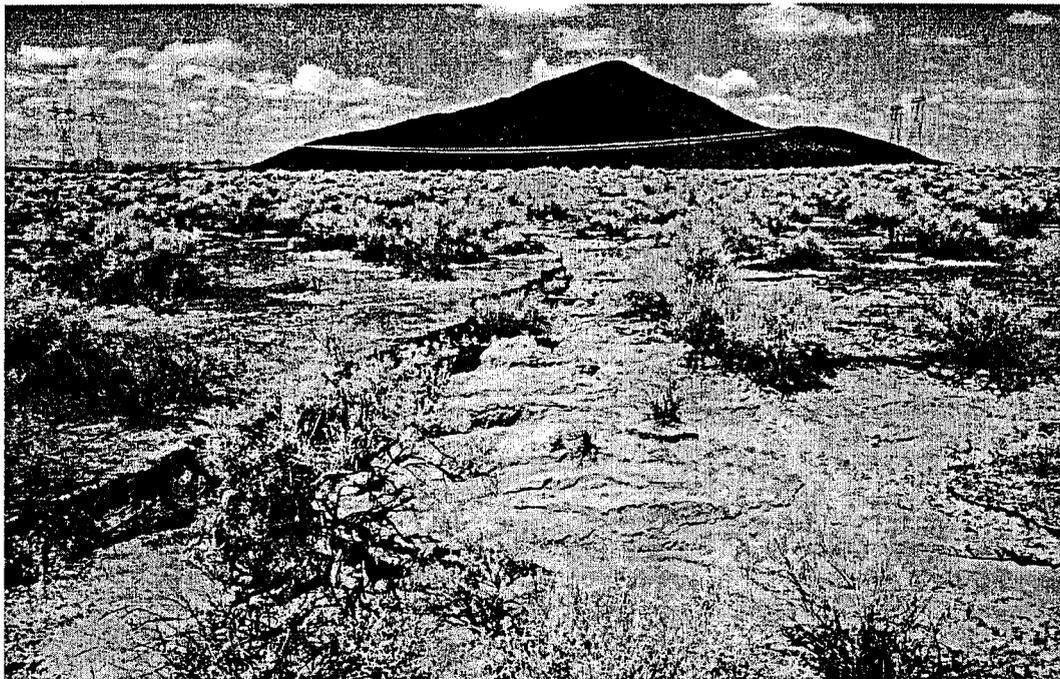
At the time of the first visit in mid September, little material had sloughed off into the fissure, only enough to open a narrow trench. Erosional downcutting of 4-12 inches has created miniature badlands up to 10 feet wide on the uphill (east) side of the crack (Figure 6). At the time of a follow-up visit in early November, the edges of fissure were noticeably rounded off from a small rainstorm the previous day. Much of the fissure had been partially filled in but there had not been enough runoff to enlarged it.

Figure 6. Section of earth fissure north of Baseline Road, showing erosion on uphill (east) side. Fissure is 12-18 inches wide, 1-6 feet deep in this section.

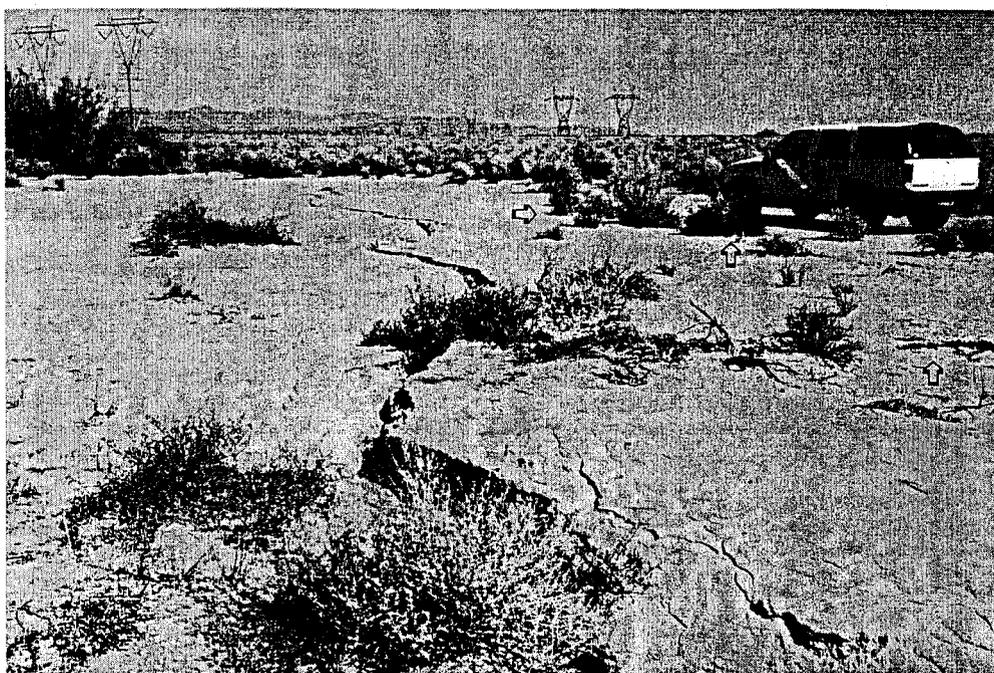
There appears to be at least two generations of desiccation cracks at this site. New cracks have opened as both extensions of older ones and as separate cracks. Traces of older cracks are marked by distinct alignments of thick vegetation within shallow, curvilinear depressions. New cracks, which appear to have opened during the past summer, were very fresh looking when visited in September 2001. Some had vertical sides showing no erosion. At the time of a follow-up visit to the site November 5, 2001, the day after a rainstorm, the edges of the cracks had been noticeably rounded off.

Figure 10. New generation desiccation crack (center), with lack of vegetation. An older, reactivated crack is defined by the alignment of mature vegetation on the left side of the vehicle. A third crack (center right edge) joins the large crack at the center of the photo.

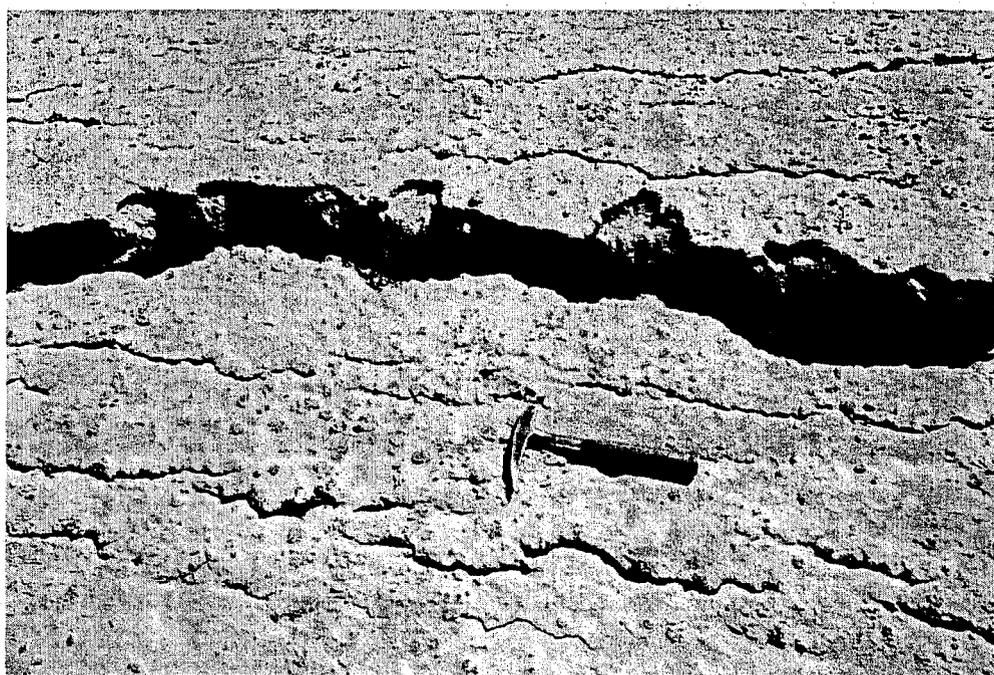
Figure 11. Close up of large, new crack shown in Figure 10, above. Parallel small cracks indicate further collapse and enlargement of the crack is likely in the event of another heavy rain.

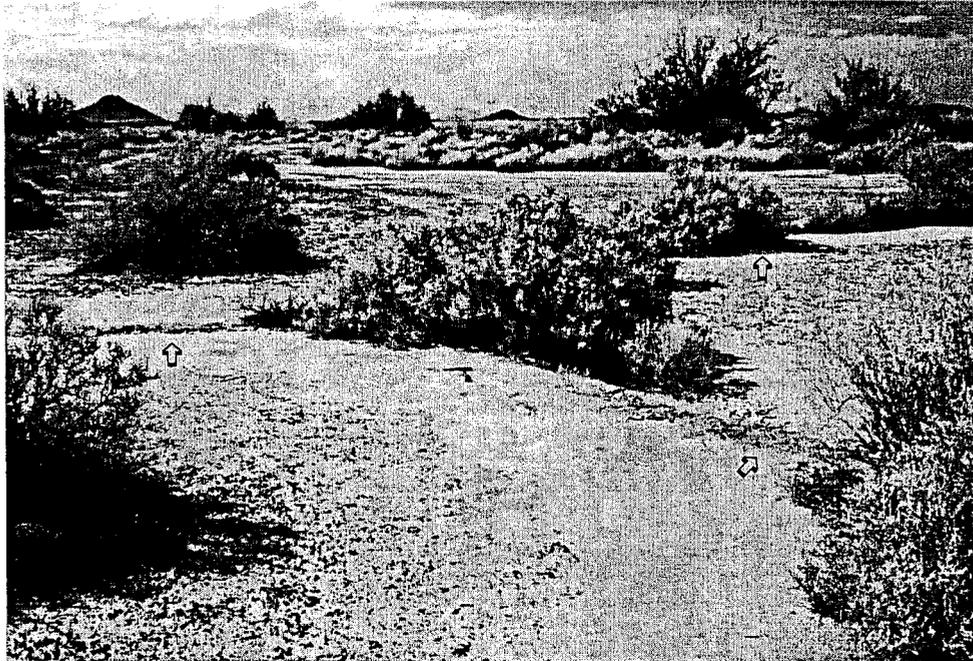
Figure 14. Junction of desiccation cracks by hammer at center of photo. Arrows point to three separate cracks. Note alignment of mature vegetation in the cracks, indicating that the cracks are old features, recently reactivated.

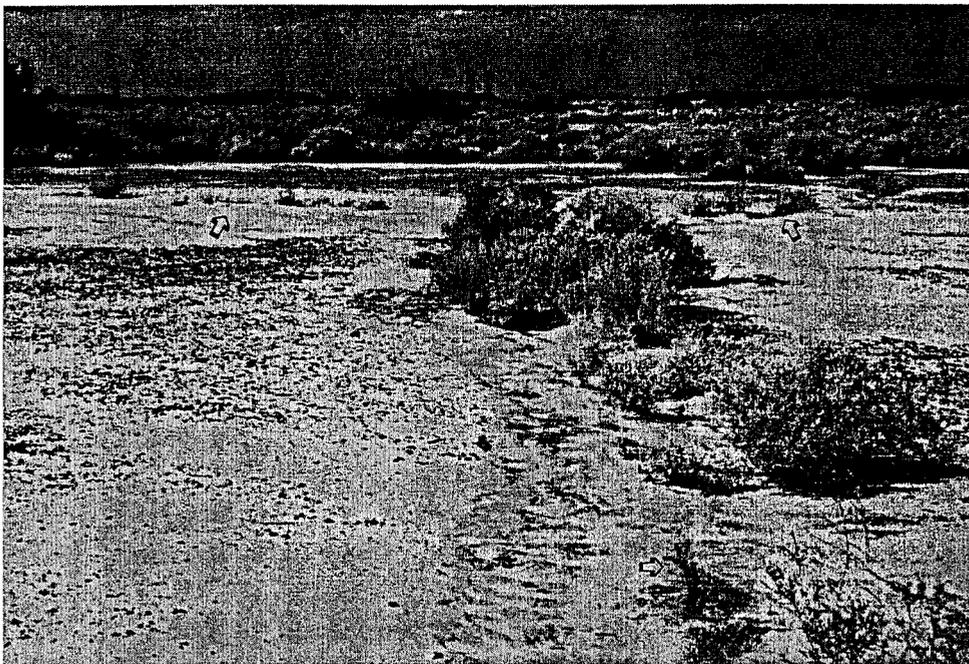
Figure 15. Junction of three cracks (arrows) at center of photo. Alignment of mature vegetation indicates this is at least the second cycle of cracking.

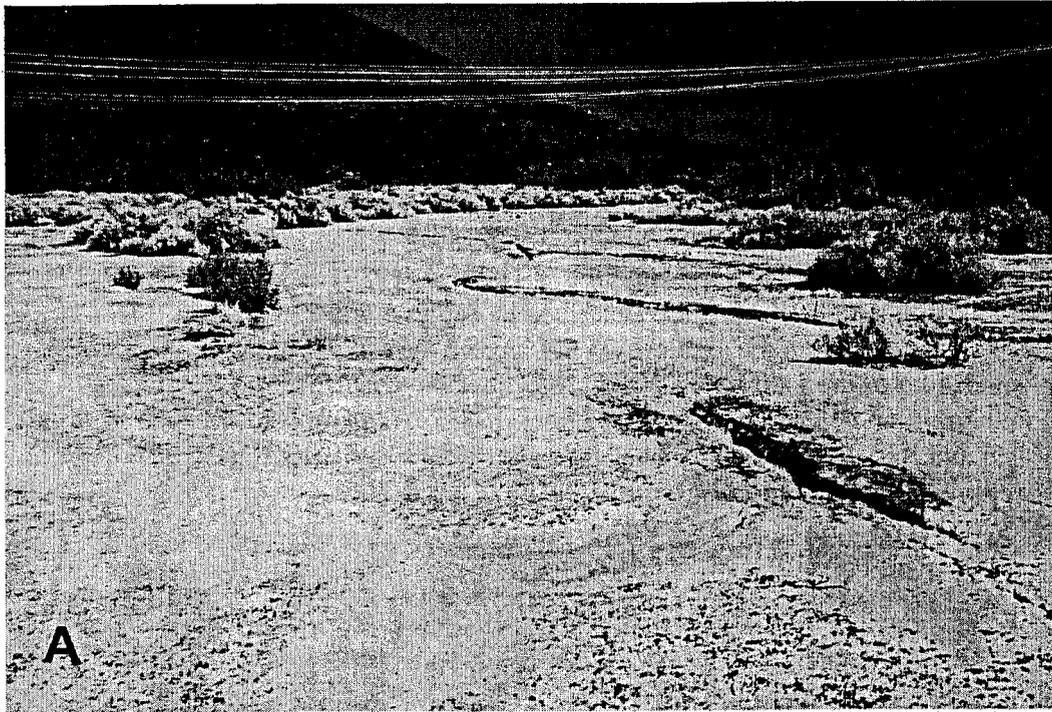
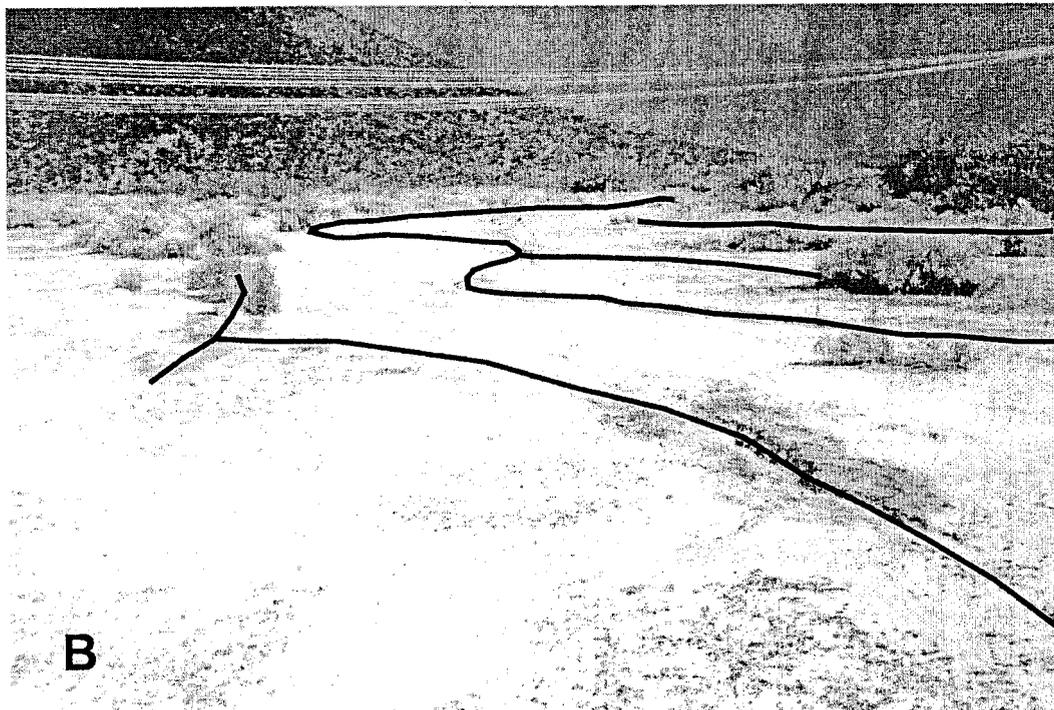
Figure 16. (A) View of northern-most group of desiccation cracks. (B) Trace of cracks plotted. Note new cracks in foreground lack vegetation, whereas older cracks in background are marked by very mature vegetation alignments.
