Stephen Norris Inc.

Re: Recent Pipe Failures On Current System

EXPLANATION OF PHOTOS

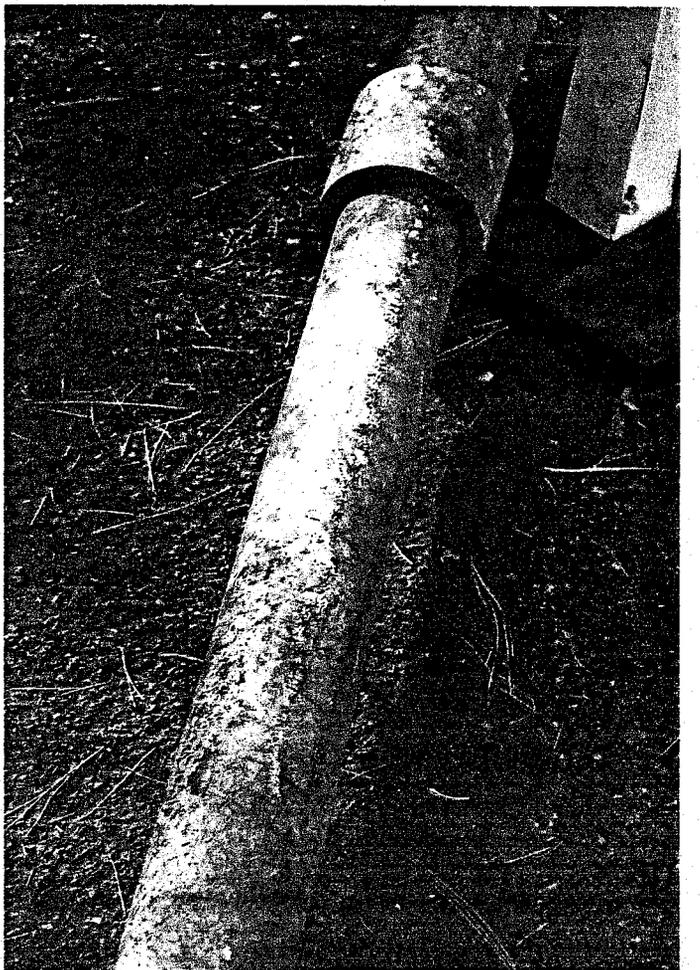
8

- #8. Removed transite pipe with hairline crack, indications of leakage.
- #9. Newly installed "T" coupling, with new isolation valves.
- #10. Another view showing pressure block (kicker).

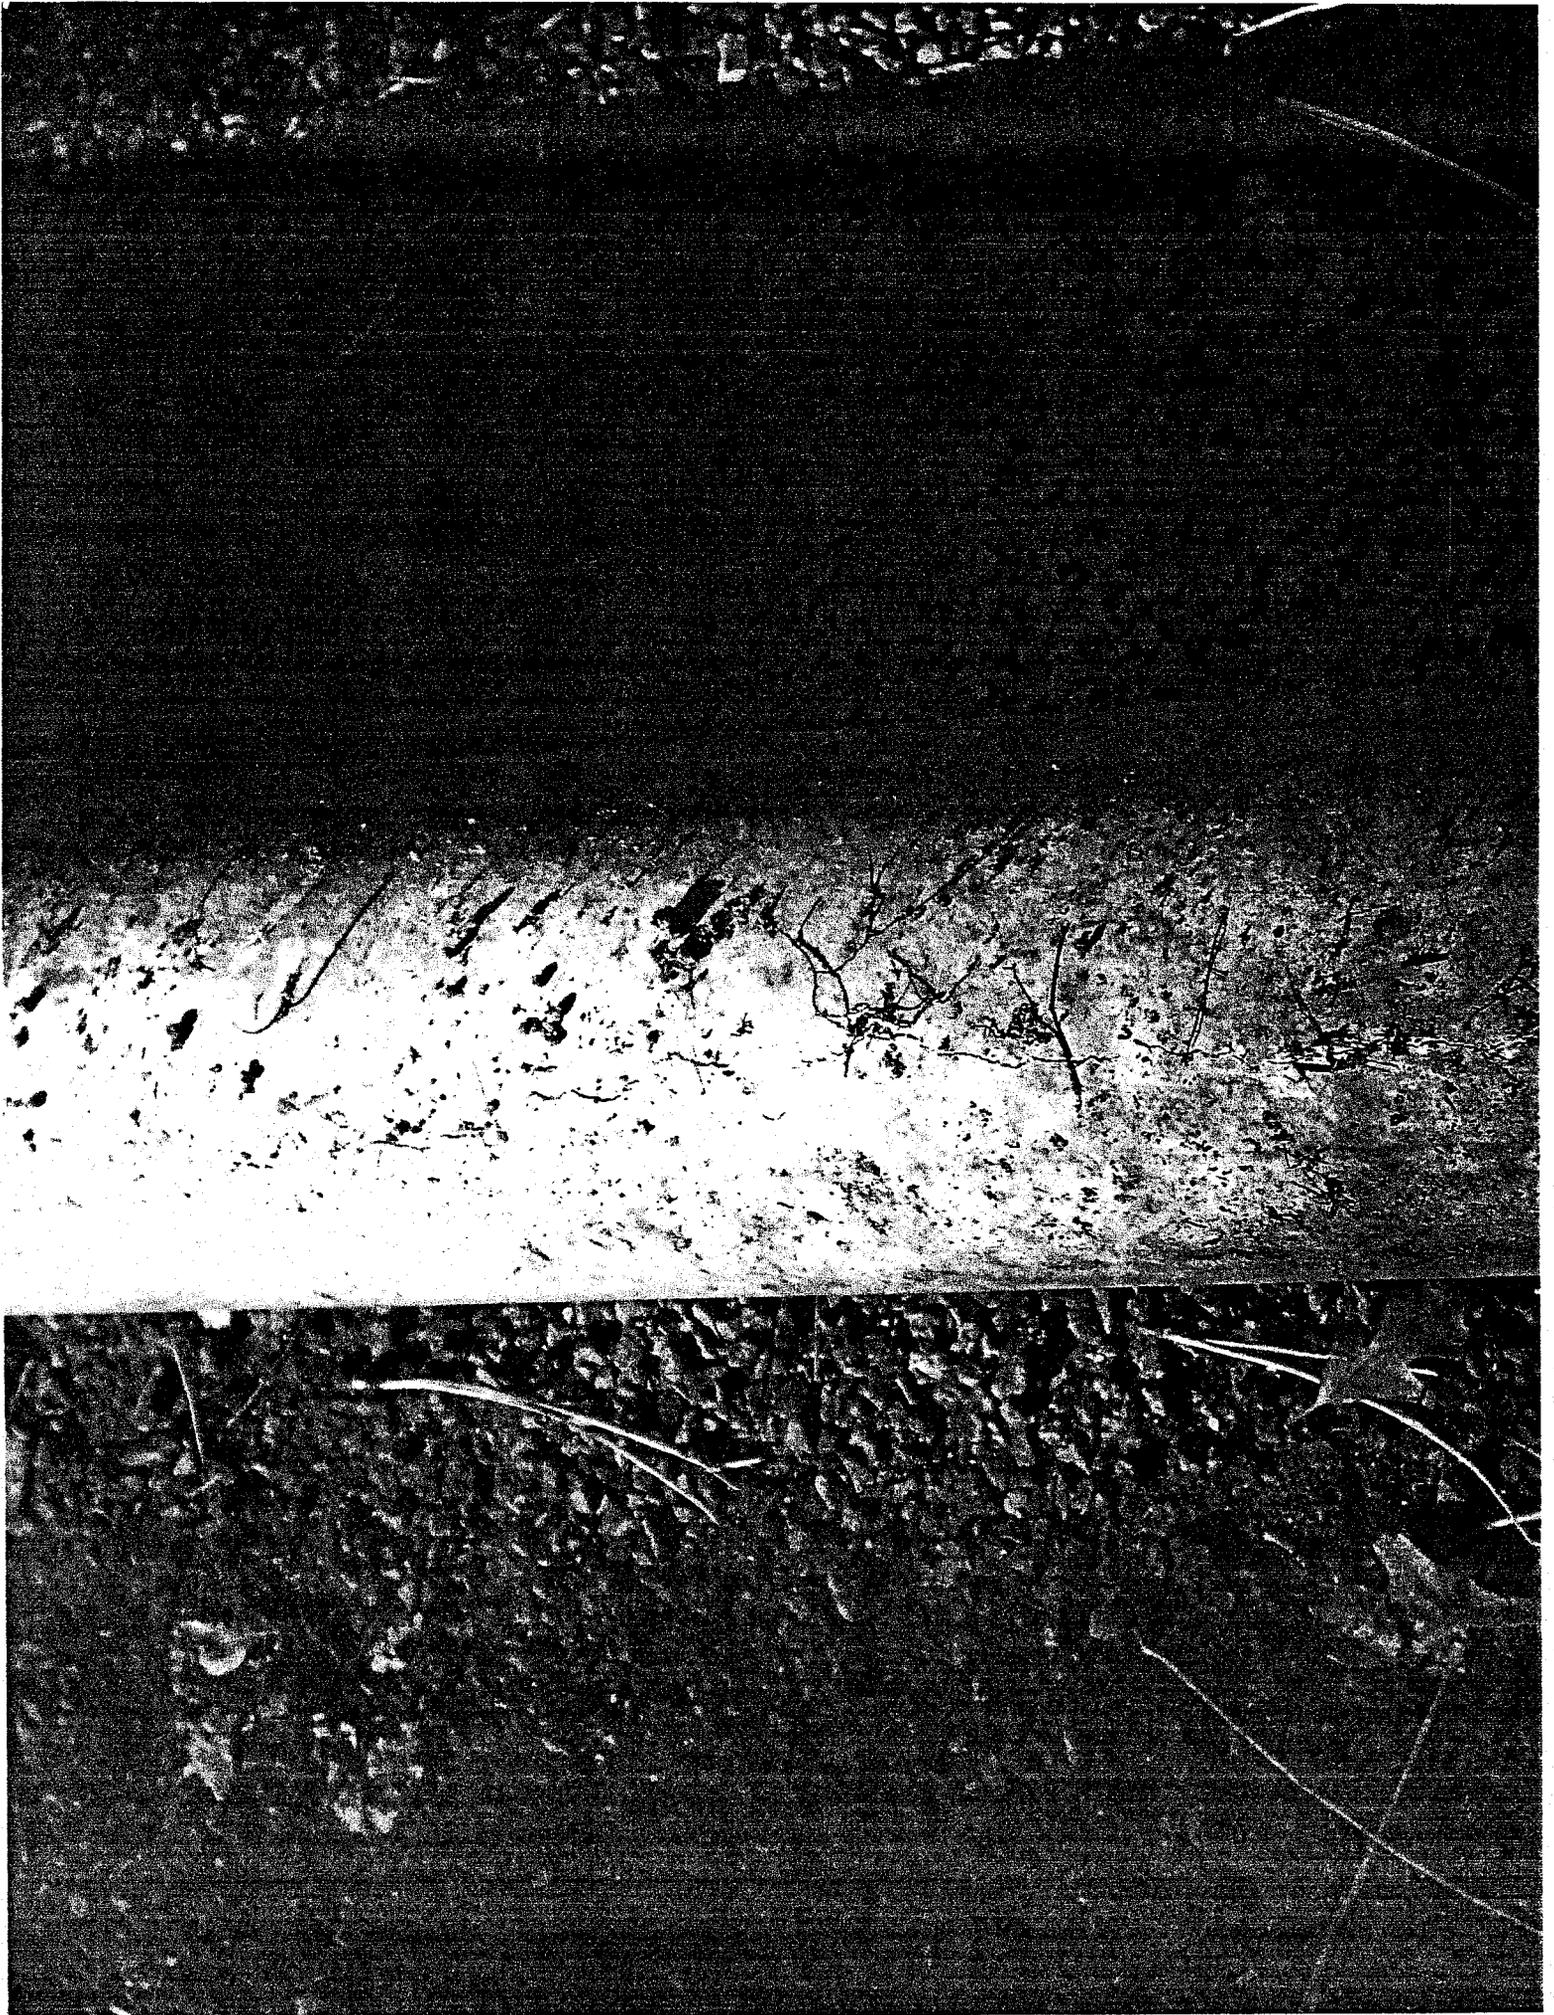
- #14. Enlargement of Photo #2, which more clearly shows the crack, the source of the leak.
- #15. Enlargement of Photo #7 which more clearly shows the reduction coupling.
