**Mount Tipton
Water Co, inc.**

RE: Docket W-02105A-07-0510
ADEQ Report 123663

In reference to ADEQ Report Inspection ID # 123663

Facility: Mt. Tipton W. C.	System # 08-059
Inspected By: A. T. Wilson	Date: 7/09/08 IID:123663
Accompanied By: Bob Martinez-MCHD, Frank Soto-ASUA, John Janak, others	County: Mohave
Recommendations By: A. Wilson	Report Date: 8/19/08
Number of Plants: 0	Wells: 9
Population: 3900	Service Connections: 898

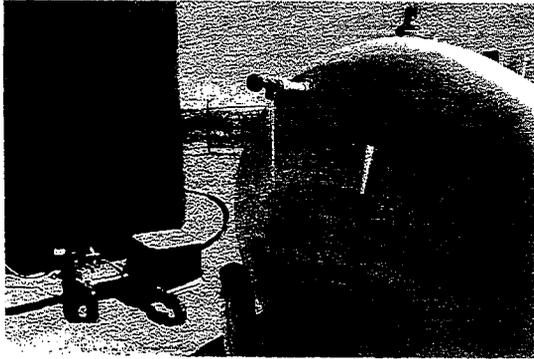
A weather tight box was also built over the pump to keep it out of the elements. There was a leak at this pump but it was not coming from the pump it was coming up from under the ground at a 90, and was repaired sometime back.
