A NEW EARTH FISSURE
NEAR WINTERSBURG,
MARICOPA COUNTY, ARIZONA

Arizona Geological Survey
Open-File Report 01-10

Raymond C. Harris
Arizona Geological Survey

November 2001

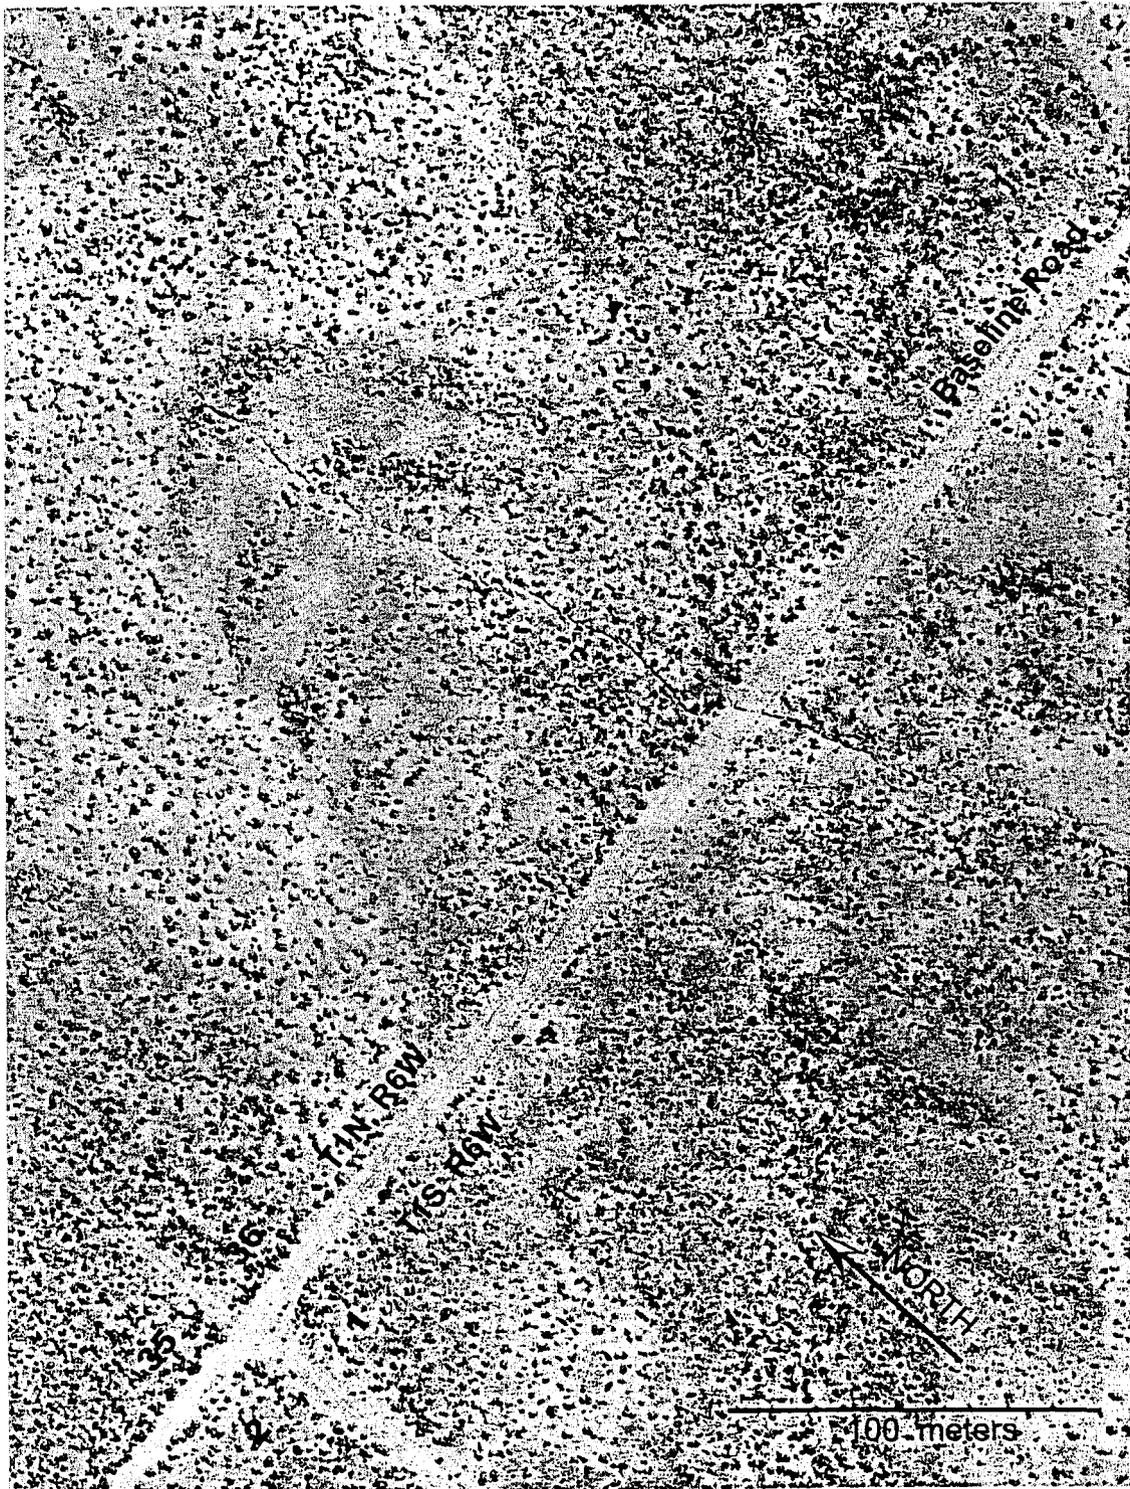
The fissure is nearly north-south and is 307 m (1007 ft) long (Figure 4). The fissure is very young, with narrow, steep sides and a highly irregular apparent depth ranging from <1 foot to >8 feet over short distances. In two locations the fissure is an echelon (Figure 5), with NW-SE steps. There is no discernable vertical offset across the fissure.

Figure 4. Detailed aerial view of new earth fissure.

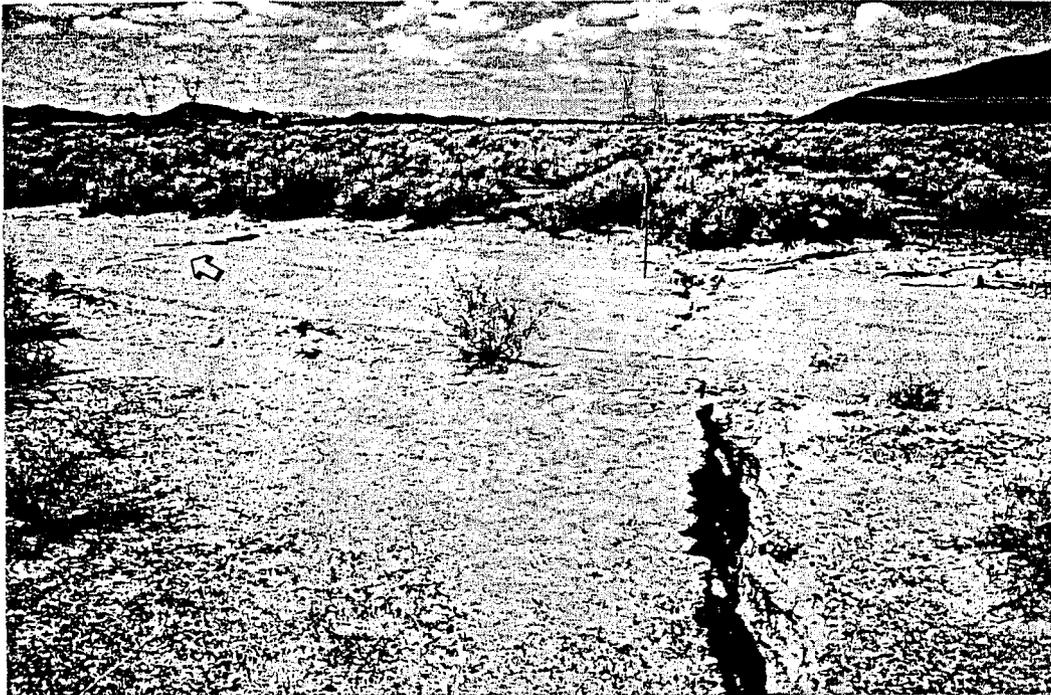
Figure 5. En echelon section of earth fissure crossing Baseline Road, looking NW. Fissure is 6-12 inches wide here. Second earth fissure crosses road at far left (arrow).

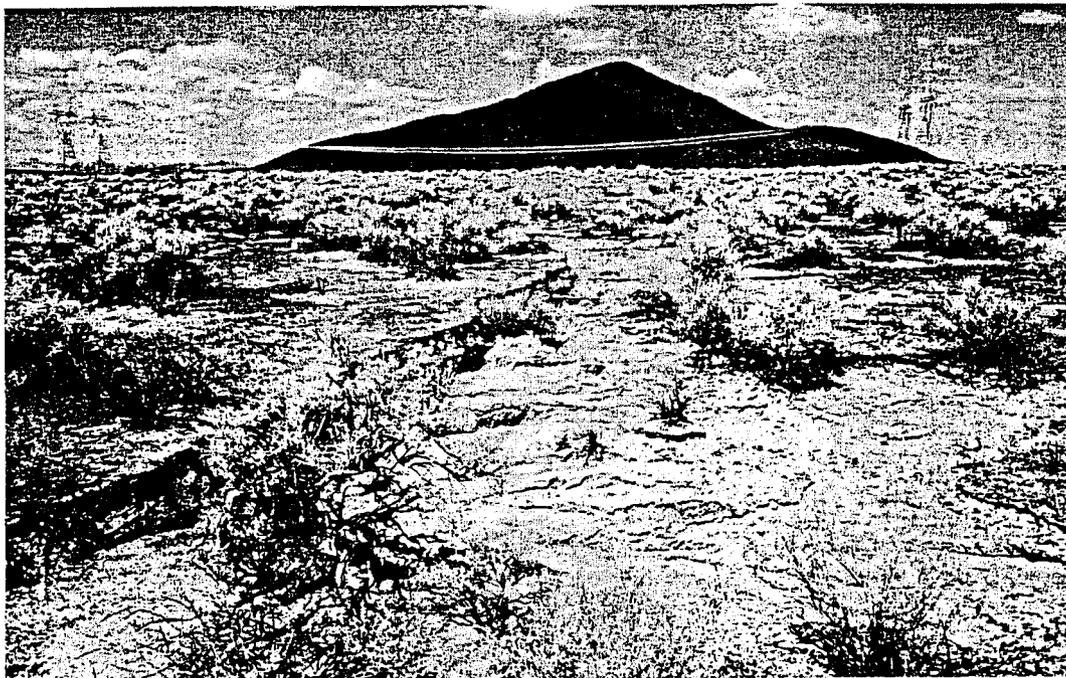
At the time of the first visit in mid September, little material had sloughed off into the fissure, only enough to open a narrow trench. Erosional downcutting of 4-12 inches has created miniature badlands up to 10 feet wide on the uphill (east) side of the crack (Figure 6). At the time of a follow-up visit in early November, the edges of fissure were noticeably rounded off from a small rainstorm the previous day. Much of the fissure had been partially filled in but there had not been enough runoff to enlarge it.

Figure 6. Section of earth fissure north of Baseline Road, showing erosion on uphill (east) side. Fissure is 12-18 inches wide, 1-6 feet deep in this section.

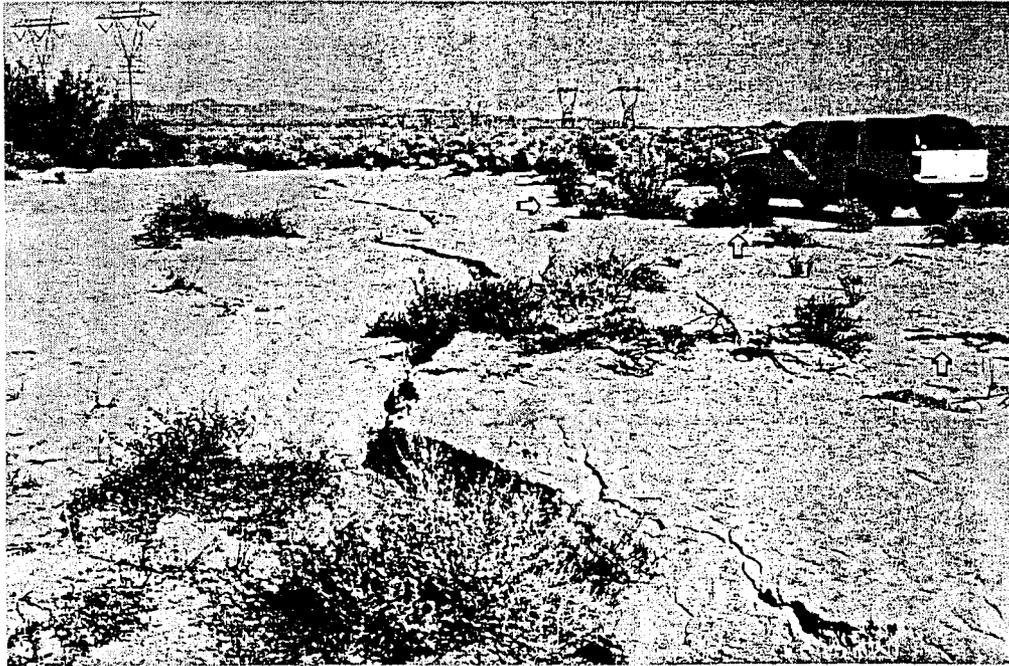
Figure 10. New generation desiccation crack (center), with lack of vegetation. An older, reactivated crack is defined by the alignment of mature vegetation on the left side of the vehicle. A third crack (center right edge) joins the large crack at the center of the photo.

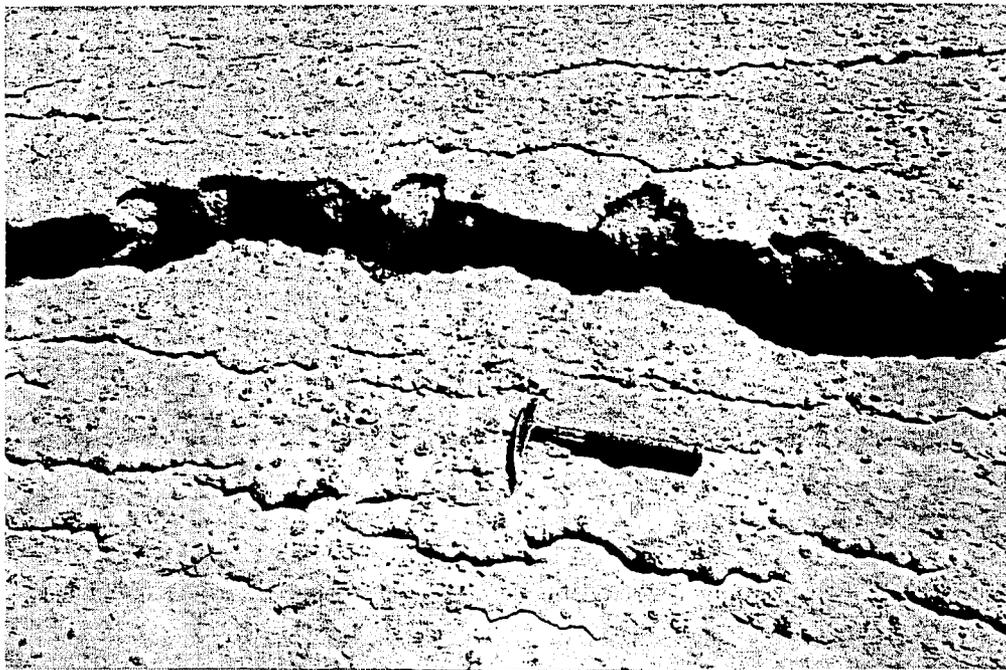
Figure 11. Close up of large, new crack shown in Figure 10, above. Parallel small cracks indicate further collapse and enlargement of the crack is likely in the event of another heavy rain.

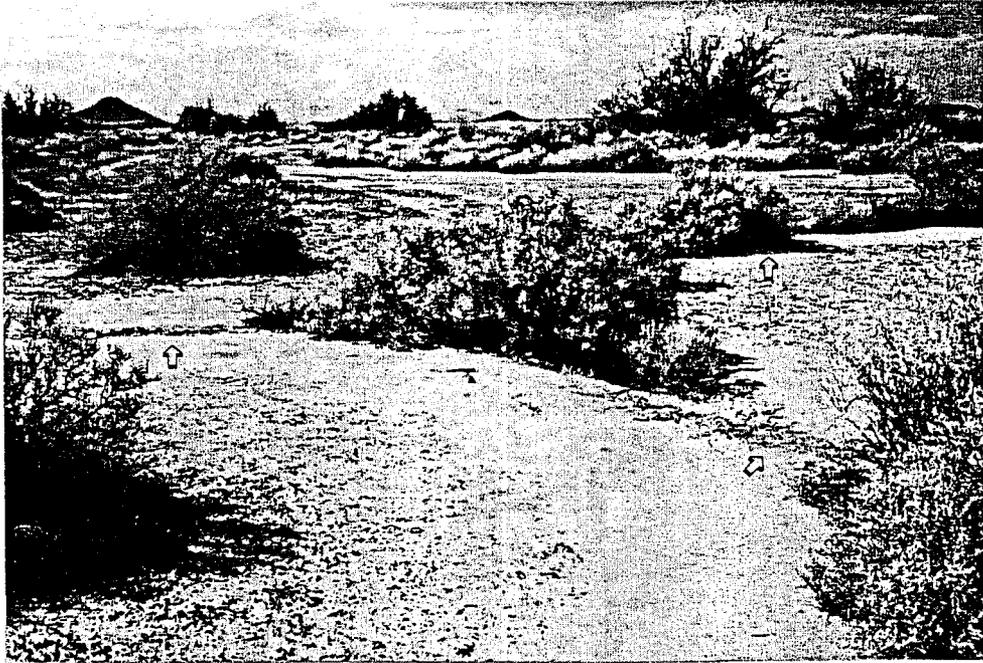
Figure 14. Junction of desiccation cracks by hammer at center of photo. Arrows point to three separate cracks. Note alignment of mature vegetation in the cracks, indicating that the cracks are old features, recently reactivated.

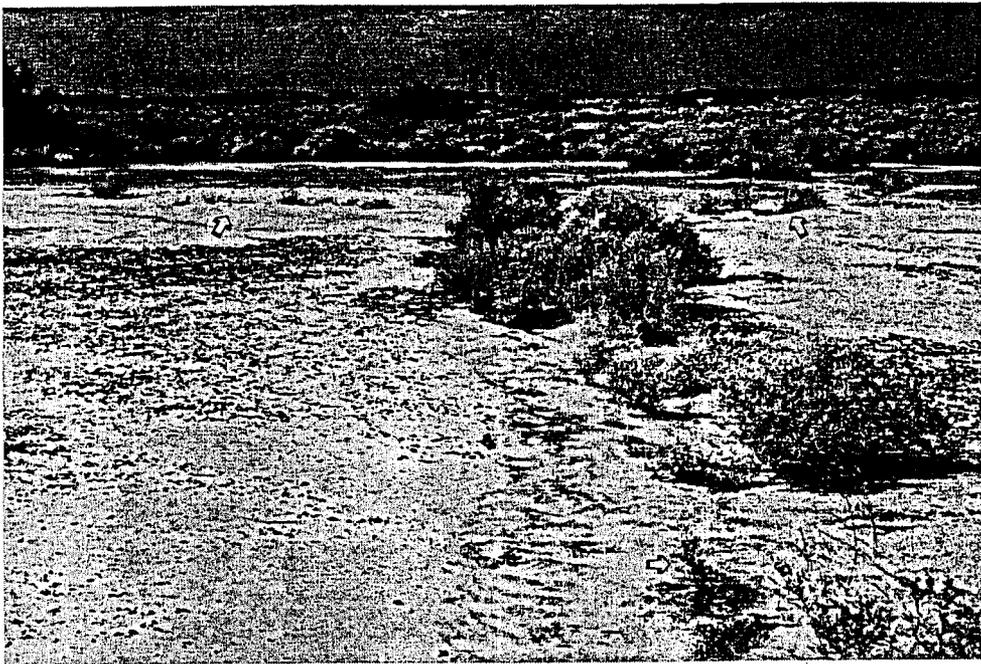
Figure 15. Junction of three cracks (arrows) at center of photo. Alignment of mature vegetation indicates this is at least the second cycle of cracking.

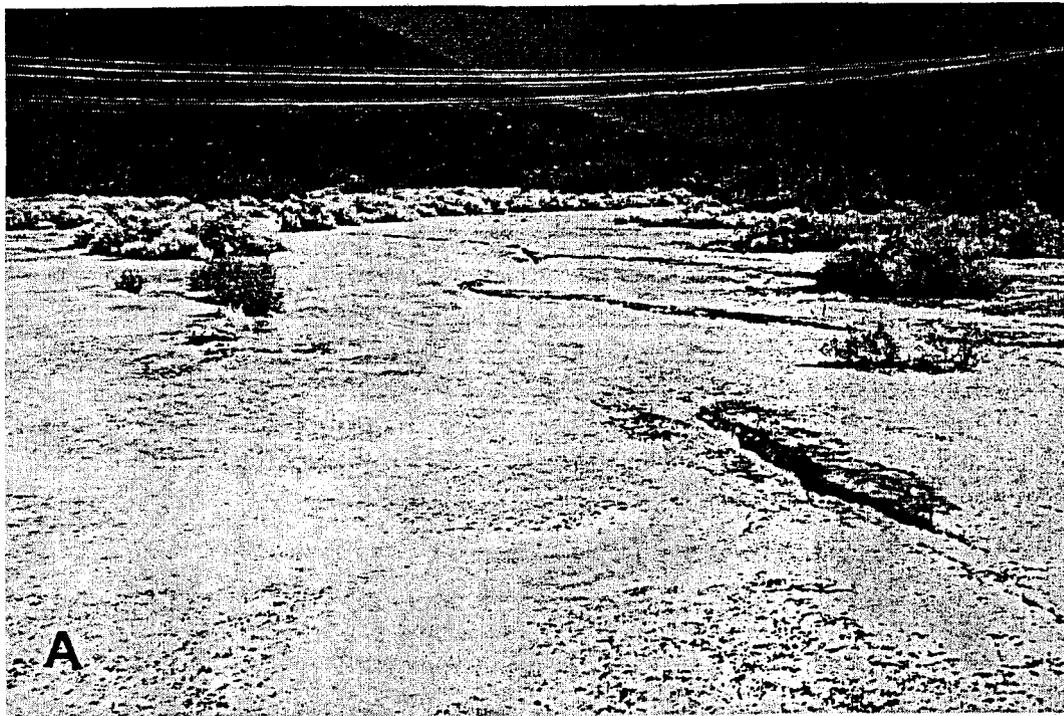
Figure 16. (A) View of northern-most group of desiccation cracks. (B) Trace of cracks plotted. Note new cracks in foreground lack vegetation, whereas older cracks in background are marked by very mature vegetation alignments.
