RE: Johnson Utilities, L.L.C.: Decision No. 71854
RE: Water Compliance with ADEQ regulations.
WS-02987A-08-0180

RE: Inspection Results for the Johnson Utilities
Public Water System (PWS) AZ0411128
ICE Database Inspection Identification Number 167450

ARIZONA DEPARTMENT OF ENVIRONMENTAL QUALITY
WATER QUALITY DIVISION - COMPLIANCE SECTION
FIELD SERVICES UNIT
INSPECTION REPORT-DRINKING WATER

Re: Compliance Inspection of the Johnson Utilities-Anthem at Merrill Ranch
Public Water System (PWS) 11-136
ICE Database Inspection Identification Number 167453

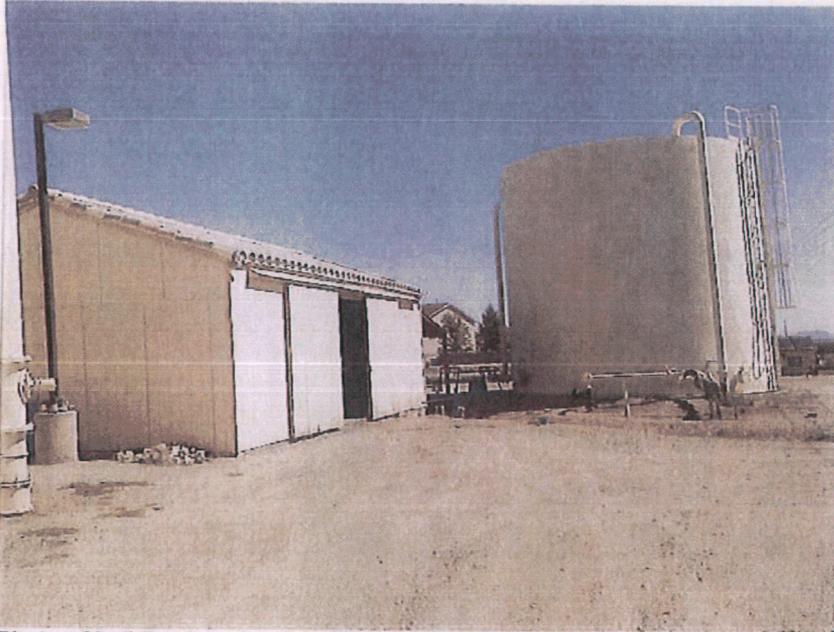
Photo of building housing the Reverse Osmosis unit and the raw water tank at the Johnson Utilities Main Plant.

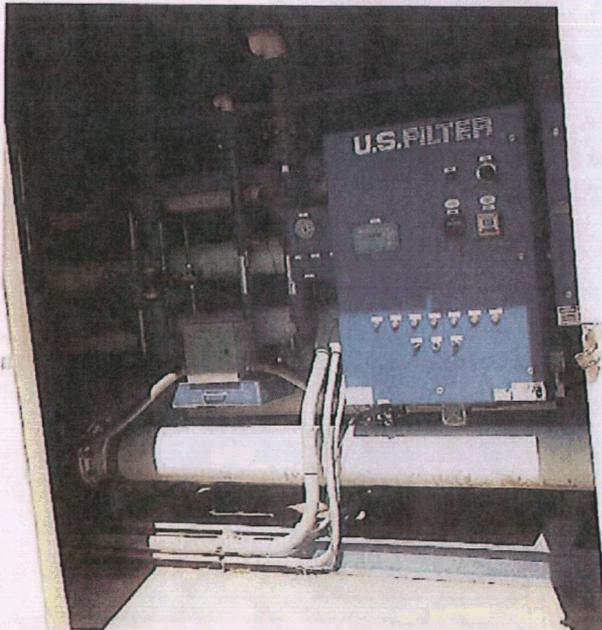
Reverse Osmosis Unit, which treats water from wells 4 and 5 (located offsite) to reduce the concentration of nitrates.

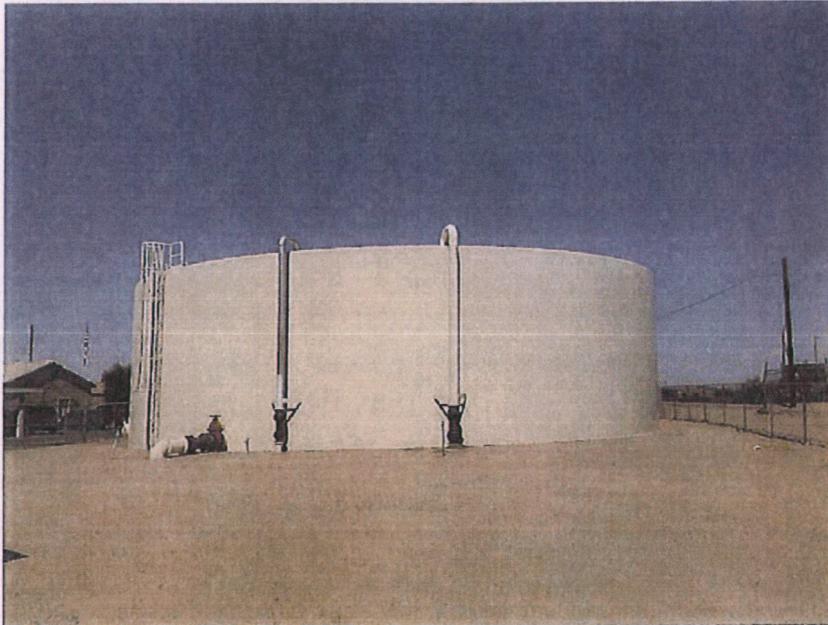
1 million gallon storage tank at the Johnson Utilities Main Plant

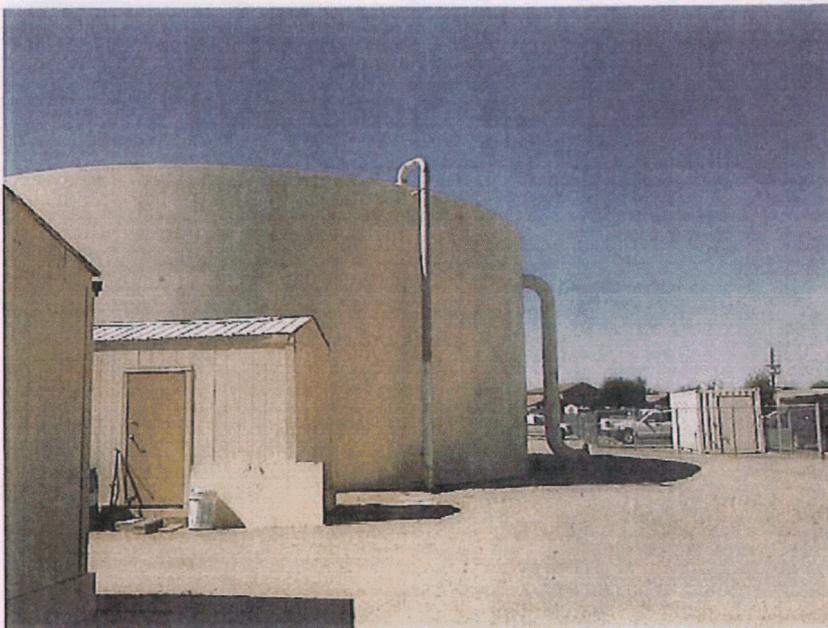
Second 1 million gallon storage tank at the Johnson Utilities Main Plant.

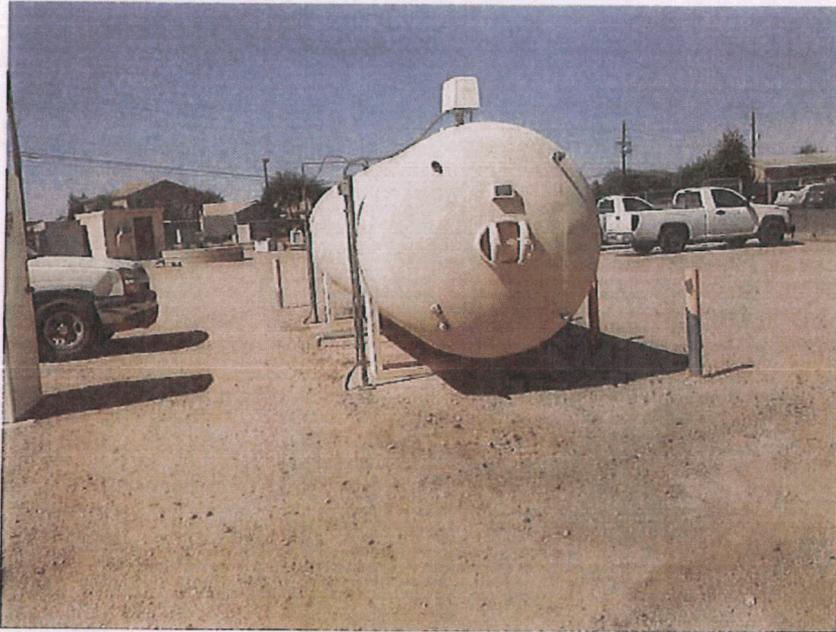
Hydropneumatic pressure tank at the Johnson Utilities Main Plant

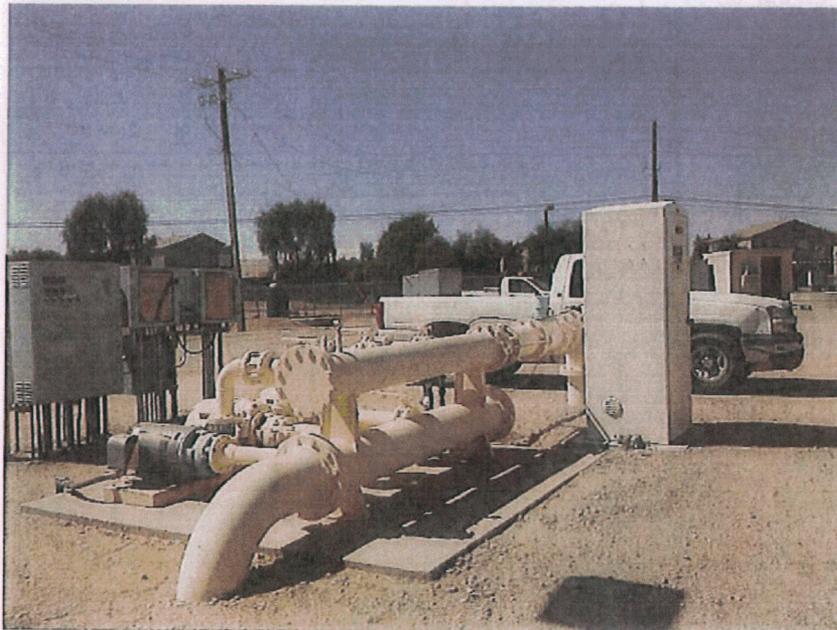
Pumps at the Johnson Utilities Main Plant

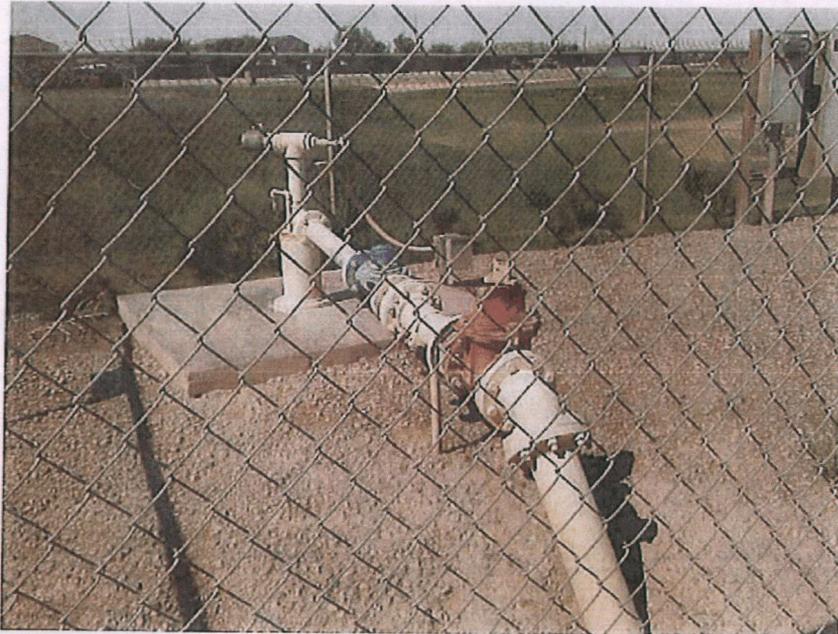
Oasis well # 2

The Oasis Water Plant consists of a 500,000 gallon storage tank, gas chlorination (to tank outlet), a hydropneumatic pressure tank, and three booster pumps. Oasis Wells 1, 2, and 3 (55-582086, 55-582087, and 55-582088) provide the water to this plant. Inspection of the Oasis Wells and Oasis Water Plant found no deficiencies. The water plant discharges to the distribution system.

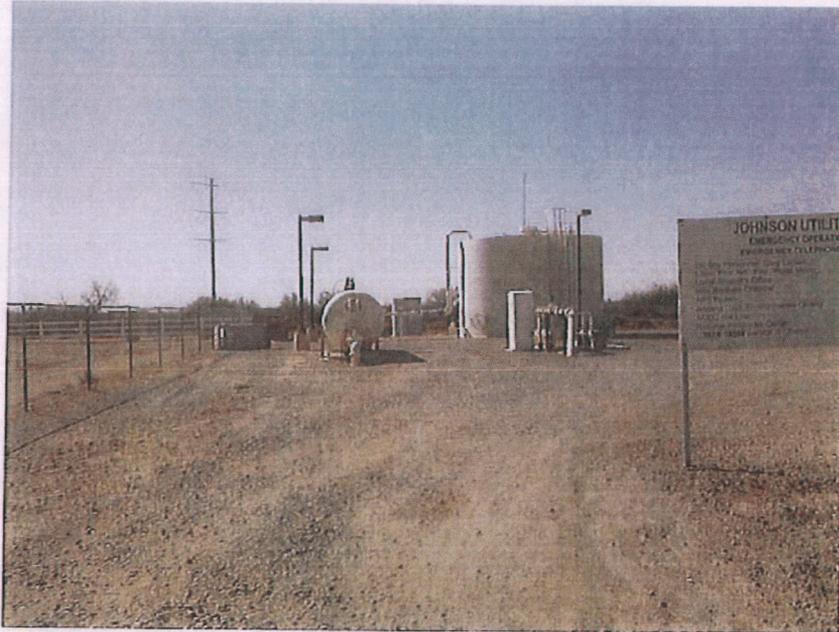
The Wildhorse Water Plant consists of well 55-571198, a 50,000 gallon storage tank, hydropneumatic pressure tank, 3 booster pumps, and a gas chlorination system. Inspection of the components found no deficiencies. The water plant is secured within a locked, fenced enclosure. The water plant discharges to the distribution system.

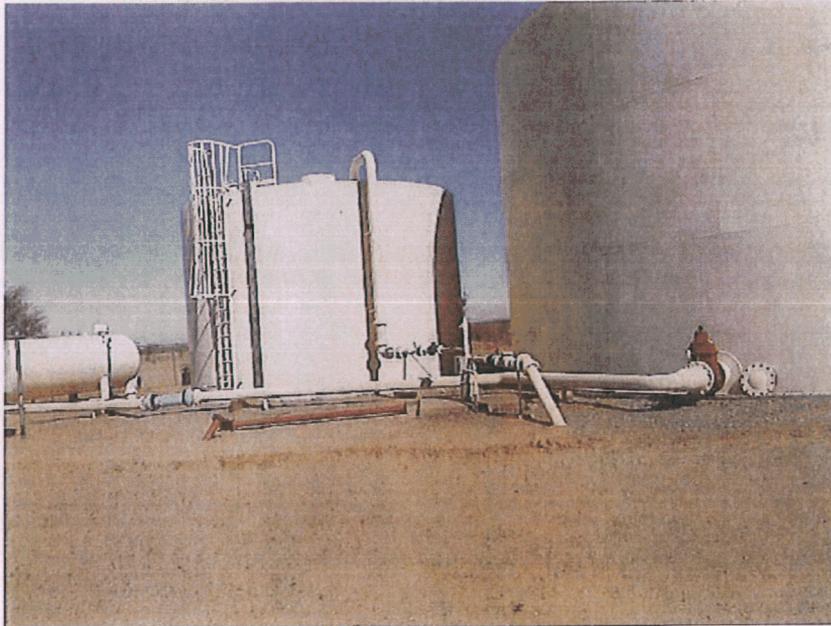
both wells is pumped to the storage tanks at the water plant. Inspection of the wells found no deficiencies. Two storage tanks (500,000 and 50,000 gallons) are located at the water plant, along with a hydropneumatic pressure tank and 3 booster pumps. The water is disinfected by gas chlorination at the storage tank outlet. At the time of inspection, the Rickie Well #3 had a cracked well slab. The slab was replaced after the inspection, and Johnson Utilities provided photographic documentation of the new slabs on October 4, 2010. No deficiencies were noted in the operation or maintenance of the water plant components. The Rickie Water Plant and Rickie Well # 3 are secured within locked, fenced enclosures. The water plant discharges to the distribution system.

Rickie Water Plant- Note Rickie Well 1 (55-570372) in foreground.

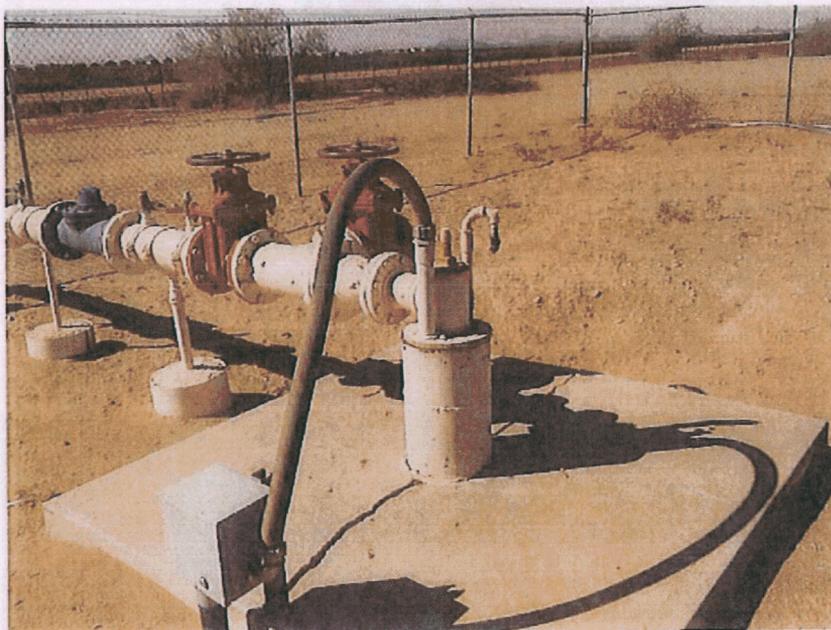
The Main Water Plant consists of a reverse osmosis water treatment unit, 100,000 gallon raw water tank, a 500,000 gallon and 1 million gallon treated water storage tank, gas chlorination, hydropneumatic pressure tank, booster pumps, and booster pumps. Water from wells 4 and 5 (55-558445 and 55-559843, both offsite) is treated to reduce the concentration of nitrate. Inspection of well 5 found the well within a secured, locked fence. No deficiencies were noted in the operation or maintenance of the well. Inspection well 4 found the well within a secured, locked fence. The well slab at well 4 was cracked. Johnson Utilities installed a new well slab subsequent to the inspection. Photos were provided of the new slab on October 4, 2010. The water plant discharges to the distribution system.

Rickie Well # 3- Note broken well slab. Slab was repaired, and photos provided by Johnson Utilities on October 4, 2010.

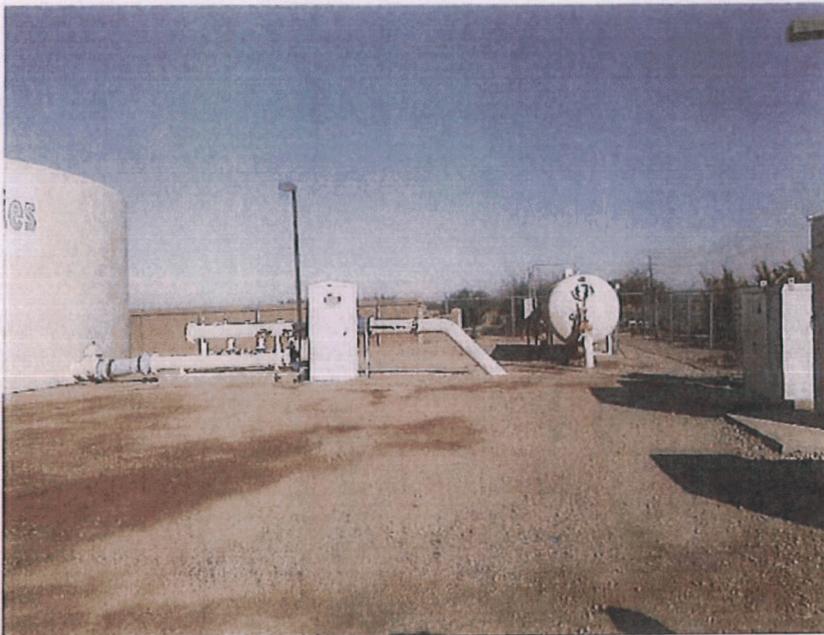
The Circle Cross Water Plant consists of well 55-599026, 1 million gallon storage tank, gas chlorination for disinfection injected into the tank outlet, hydropneumatic pressure tank, and booster pumps. Inspection of the water plant found no deficiencies. The water plant was located within a locked, secured fence. The water plant discharges into the distribution system.

Circle Cross Water Plant-1 million gallon storage tank, gas chlorination prior to entry in to the distribution system.

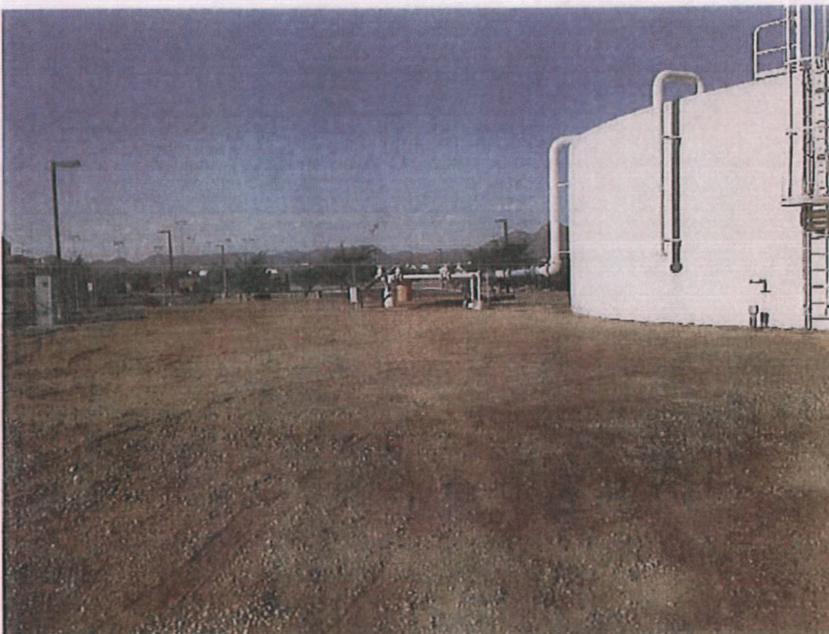
Circle Cross Water Plant- well 55-599026 in background.

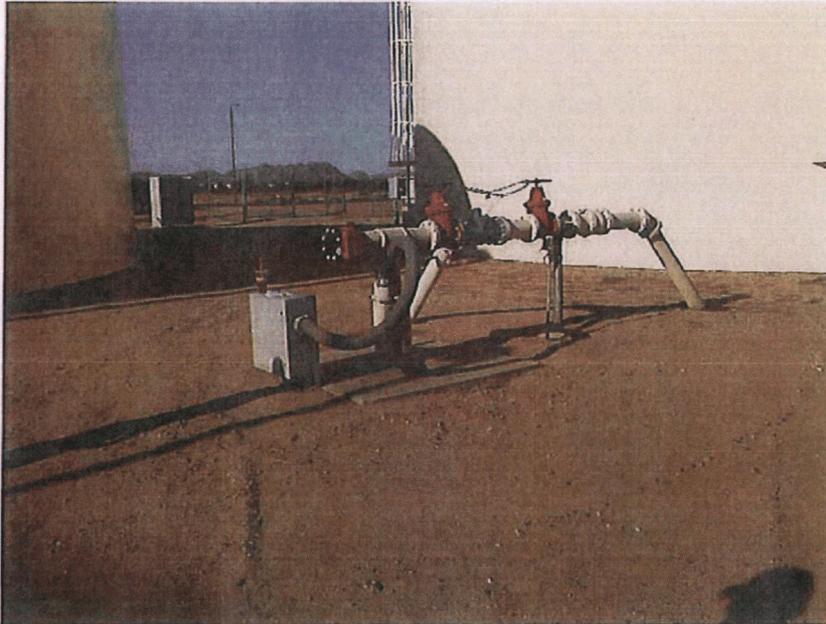
The Morning Sun Farms Water Plant consists of well 55-211012, two-1 million gallon storage tanks, five booster pumps, gas chlorination used for disinfection, injected into the storage tank outlet. Inspection of the water plant found no deficiencies. The water plant is secured within a locked, fenced enclosure. The water plant discharges to the distribution system.

Morning Sun Farms Water plant- Well 55-211012 in foreground

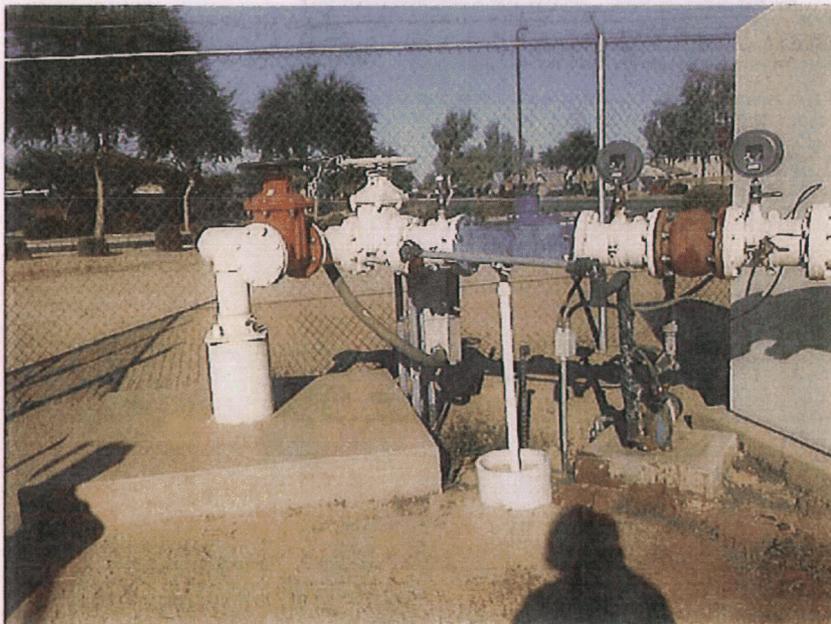
Morning Sun Farms Well 2- Well 55-201429

Morning Sun Farms Well # 2 (55-201429) is located within a locked, fenced enclosure in the Morning Sun Farms subdivision. The water from the well is disinfected by gas chlorination, which is injected into the well outlet pipe. The well discharges directly into the distribution system.

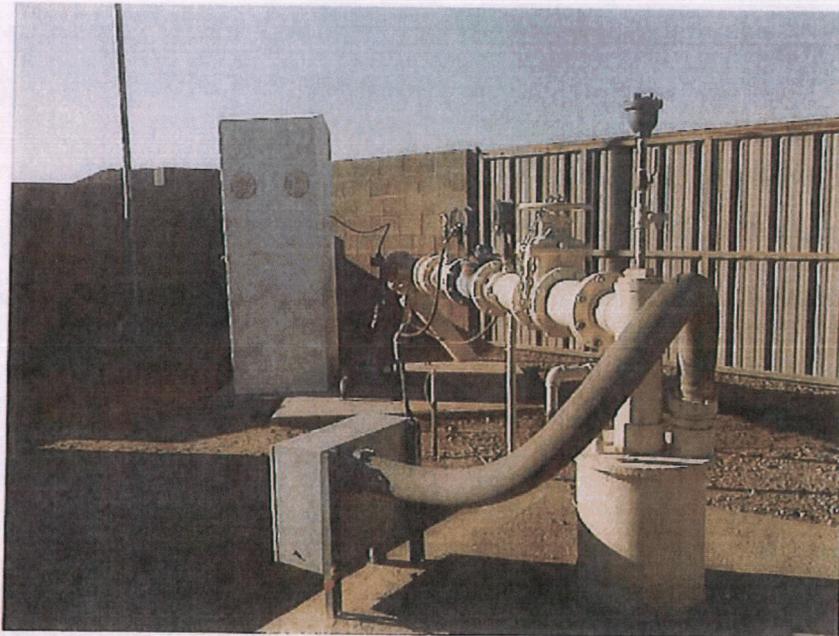
Skyline Well- 55-621462

The Skyline Well (55-621462) is located on Hunt Highway, adjacent to the Morning Sun Farms subdivision. Inspection of the well found it well maintained and operated. The well is located within a locked, secured fence. Gas chlorination is used for disinfection, and is injected in the well outlet. The Skyline Well is discharges directly to the distribution system.

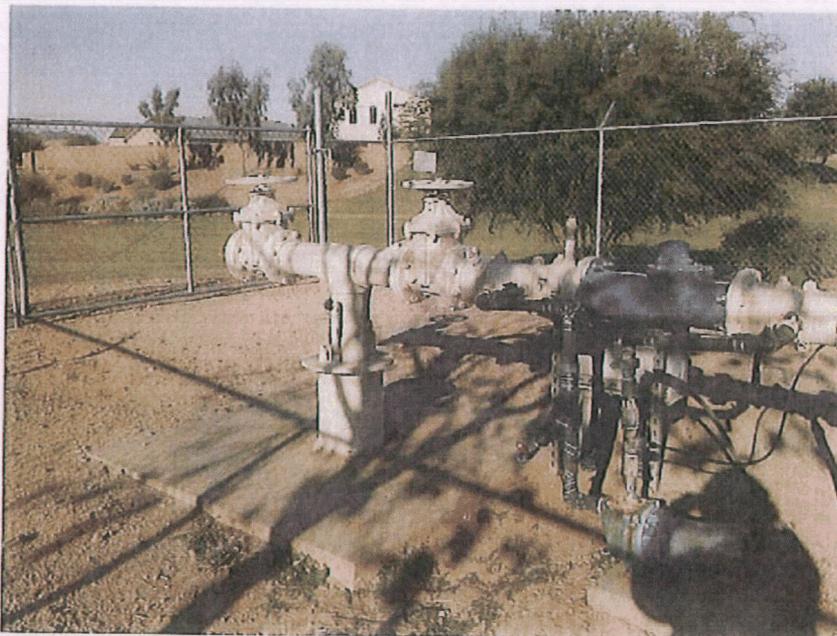
San Tan Well 55-598836

The San Tan Well is located adjacent to Hunt Highway across the road from the Skyline Well. The water from the well (55-598836) is disinfected with gas chlorination, and discharges directly into the distribution system. The well is located within a locked, secured fence.

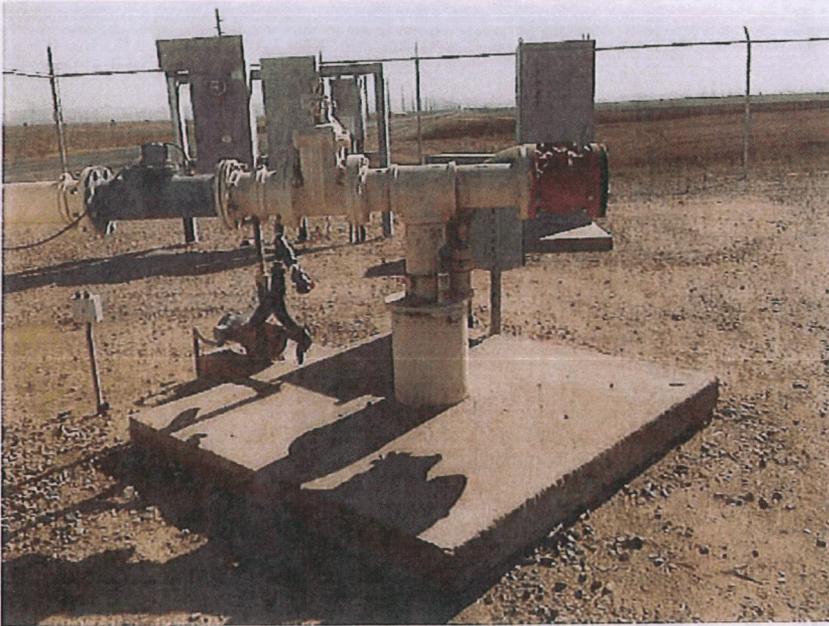
Hardison Well 55-209384

The Hardison Well (55-209384) is located within a locked, fenced enclosure on Bella Vista Road. Inspection of the well found no deficiencies. The water produced from the well is disinfected by gas chlorination, which is injected into the well outlet pipe. The well discharges directly into the distribution system.

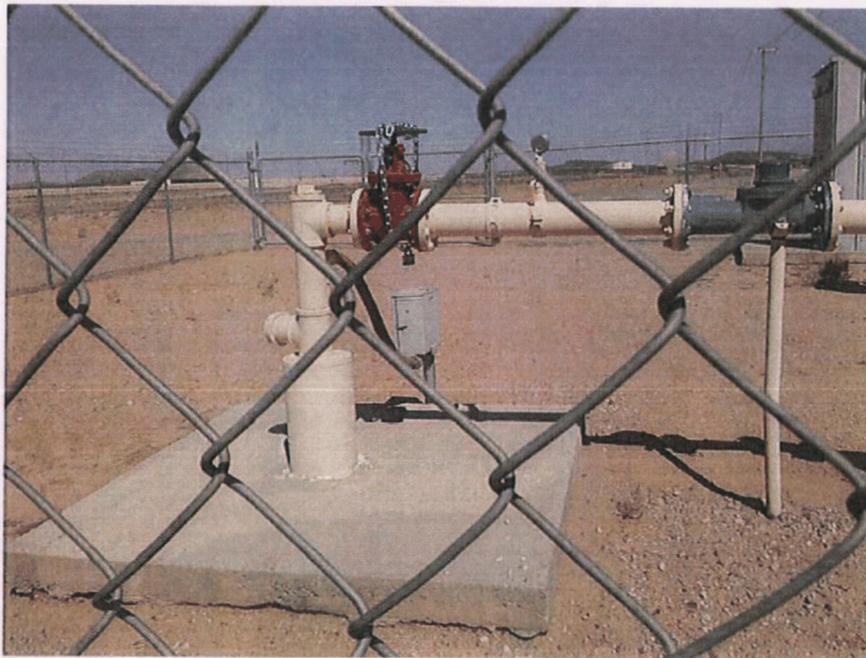
Well 55-212514

EPDS002 is located adjacent to the golf course in the Anthem community. Wells 55-211602 (onsite) and 55-212514 (offsite) provide water for the plant. The water plant and offsite well 55-212514 are located within secure locked fence enclosures. Inspection of the wells, storage tank, hydropneumatic pressure tank, booster pumps, and chlorinator found no deficiencies. The system is disinfected with chlorine gas injected into the outlet prior to entry into the distribution system.

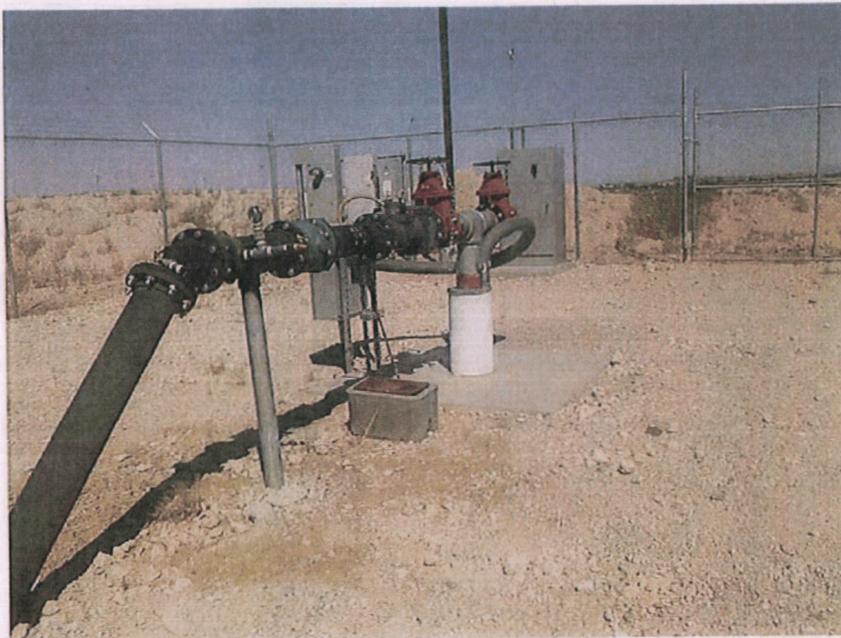
Rancho Sendaro Well 1 55-569177

Inspection of the components found no deficiencies. Chlorine gas is used for disinfection, and is injected prior to entry into the distribution system. Rancho Sendaro Well #1 (55-569177) is located within a locked fenced enclosure approximately a quarter mile south. Inspection of the well found no deficiencies. The water produced from the well is piped to the Plant 1 storage tank.

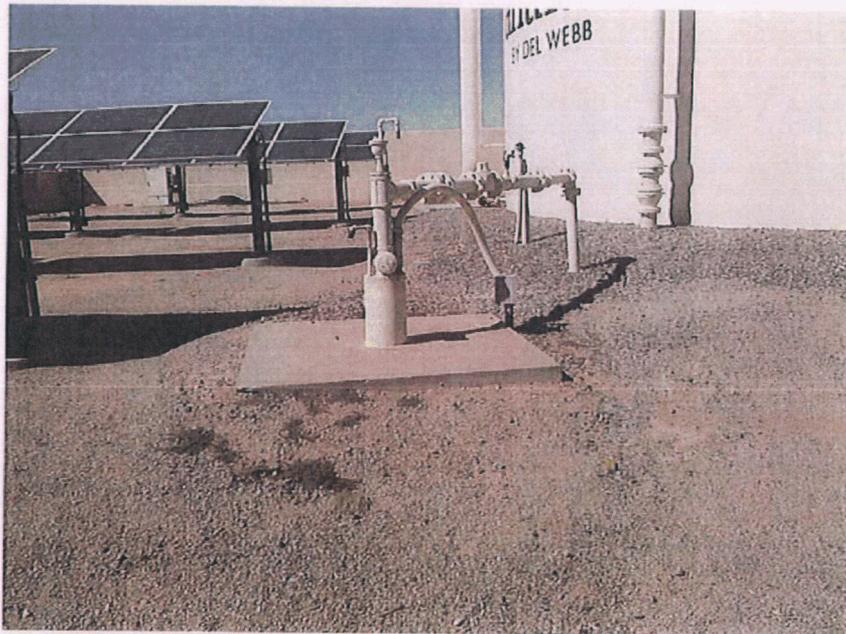
Rancho Sendaro Water Plant. Well 55-583151 in foreground.
