**RESPONSE TO INSUFFICIENCY  
LETTER**

FACILITIES ASSESSMENT REPORT

LIVCO SEWER COMPANY  
CONCHO, ARIZONA

March 2013

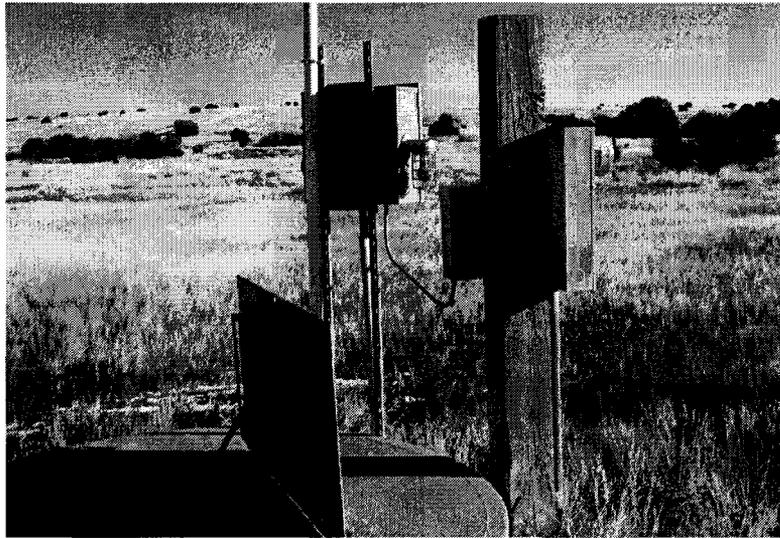
**Figure 2. Exterior of Lift Station 9A**

The lift station was generally in satisfactory condition. The wet well appeared to be holding together and is not breaking down. The lid was also not rusting. As can be seen in Figure 3, there is some rusting inside the wet well on the rails and the piping, however they seem to be functioning fine. It was assumed that the rails are not too rusted to pull the pumps as it was indicated that the pumps have not been pulled in a long period of time. It appeared that the wet well has a PVC vent that runs from the wet well, over to the control panel, and up into the air above the control panel. This vent appears to be functioning properly as the wet well is in good condition.

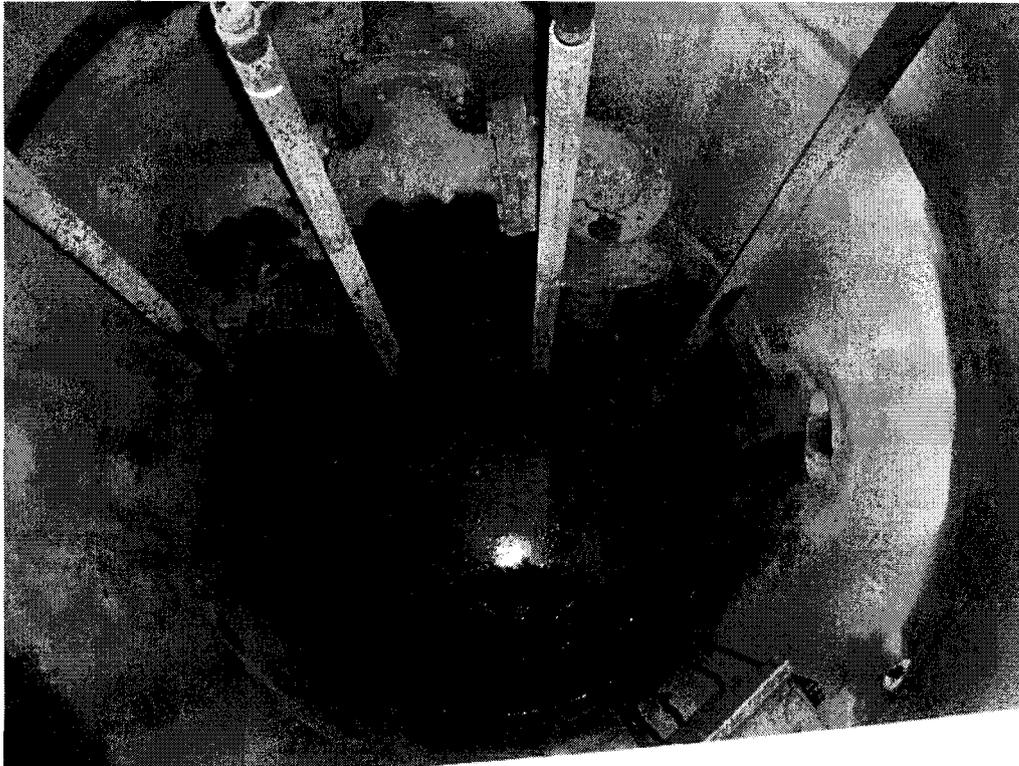
**Figure 3. Interior of Lift Station 9A**

Although there are duplex pumps in the wet well, it was indicated by Matt that there are no replacement pumps for this lift station on hand. An extra pump should be kept on hand for use when one or both of the pumps in the wet well need repaired or replaced. Also, as can be seen in Figure 3, there is an electrical junction box inside the wet well. This box should be relocated outside the wet well to prevent the box from being submerged in sewer as well as to keep the box away from the harmful and corrosive sewer gases (hydrogen sulfide) that exist in the wet well. When the lift station begins to receive more flows, this could become a problem.

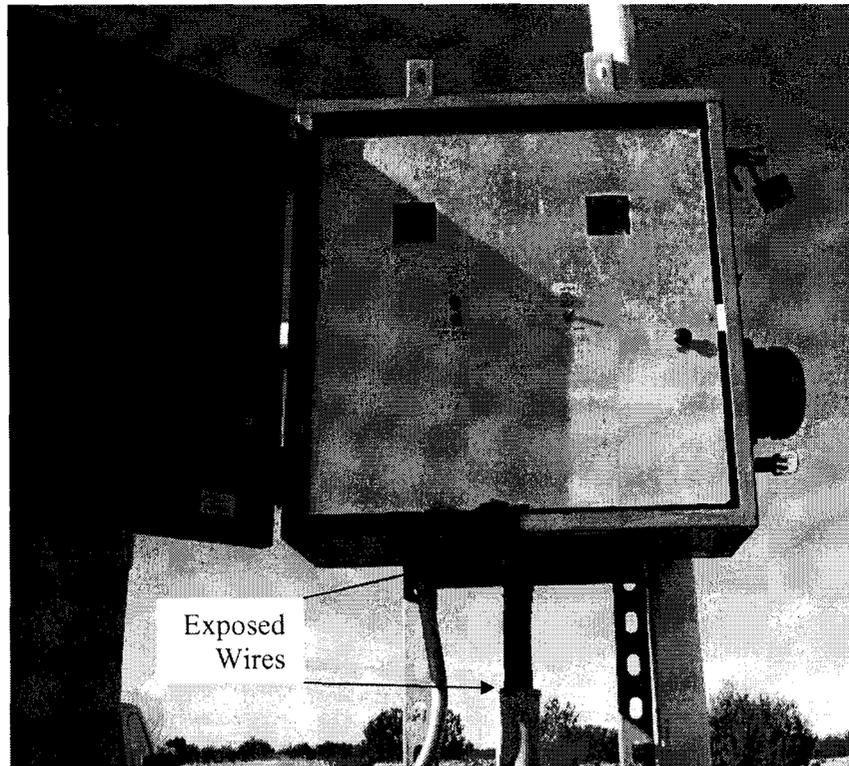
**Figure 4. Lift Station 9A Control Panel**

Figure 4 shows that there are exposed wires between the electrical conduit and the control panel. It appears the control box was raised after the construction was completed. The control panel should be lowered so that there are no exposed wires. This will help protect the wires and will also prevent the wires from rubbing on the sharp edge of the control box when the wires move, which movement can be caused from the pumps turning on and off as well as running. After the control panel is lowered to the conduit, the hole in the control panel should be sealed. This will prevent moisture from entering the control box.

A fence should be added to the lift station site to prevent people from tampering with the lift station. A sign should also be attached in a conspicuous location indicating the phone number to call in case the emergency alarm is sounding or warning light is activated.

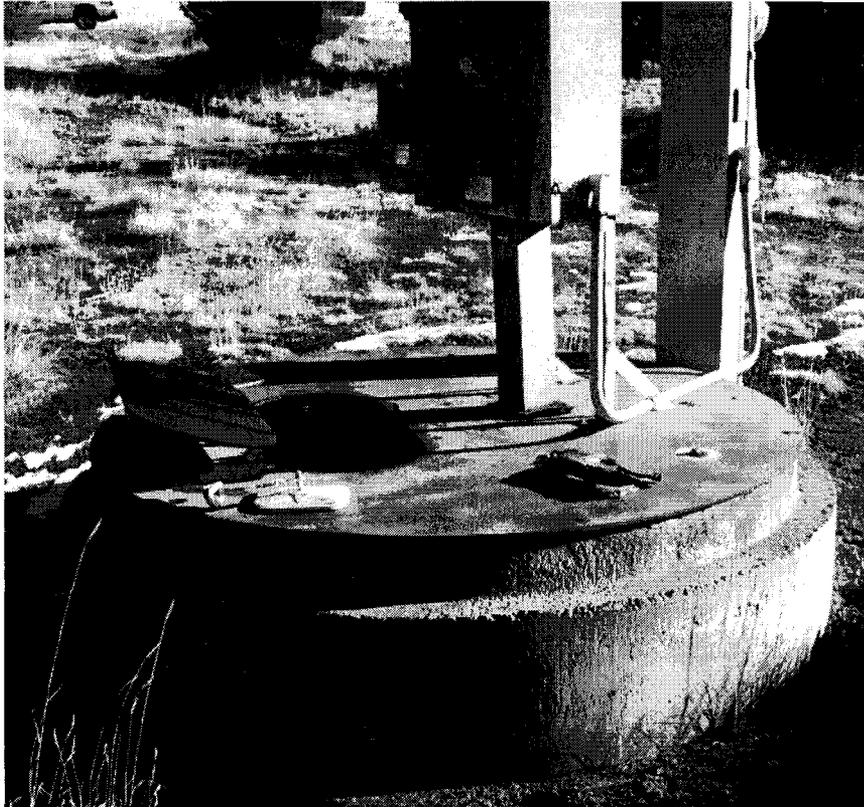
**Figure 5. Exterior of Lift Station 5B-1**

As was mentioned, the access lid to the lift station is too small and should be made larger. The existing lid is also showing a great deal of corrosion. There is not a vent on the wet well to allow the hydrogen sulfide gas to exit the wet well, and a vent should be added to the wet well.

It is also recommended that the control panel be moved from off of the wet well lid and placed near the lift station. Conduit should be ran from the side of the wet well to the control panel and all wiring should be protected and should be contained in the conduit. The entrance to the conduit at the wet well should also be sealed to prevent the sewer gasses from traveling through the conduit to the control panel.

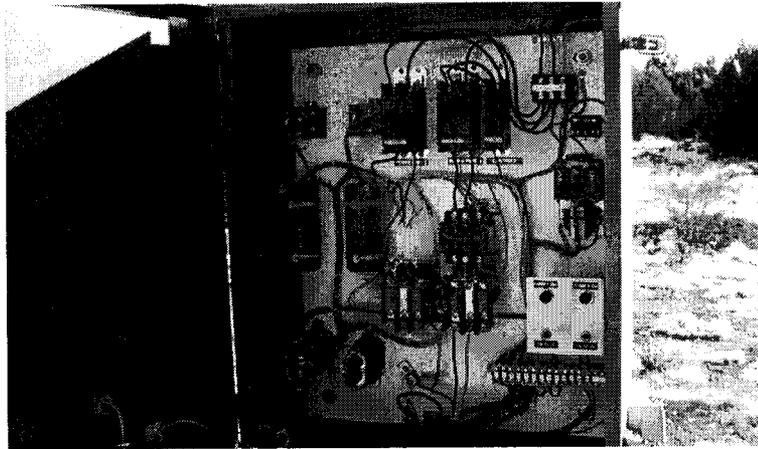
**Figure 6. Lift Station 5B-1 Control Panel**

As can be seen in Figure 6, the wiring in the control panel is in disrepair. It is recommended that an electrician be hired to check the wiring as there are many wires that are not connected. The emergency alarm on this lift station also does not operate and should be addressed.

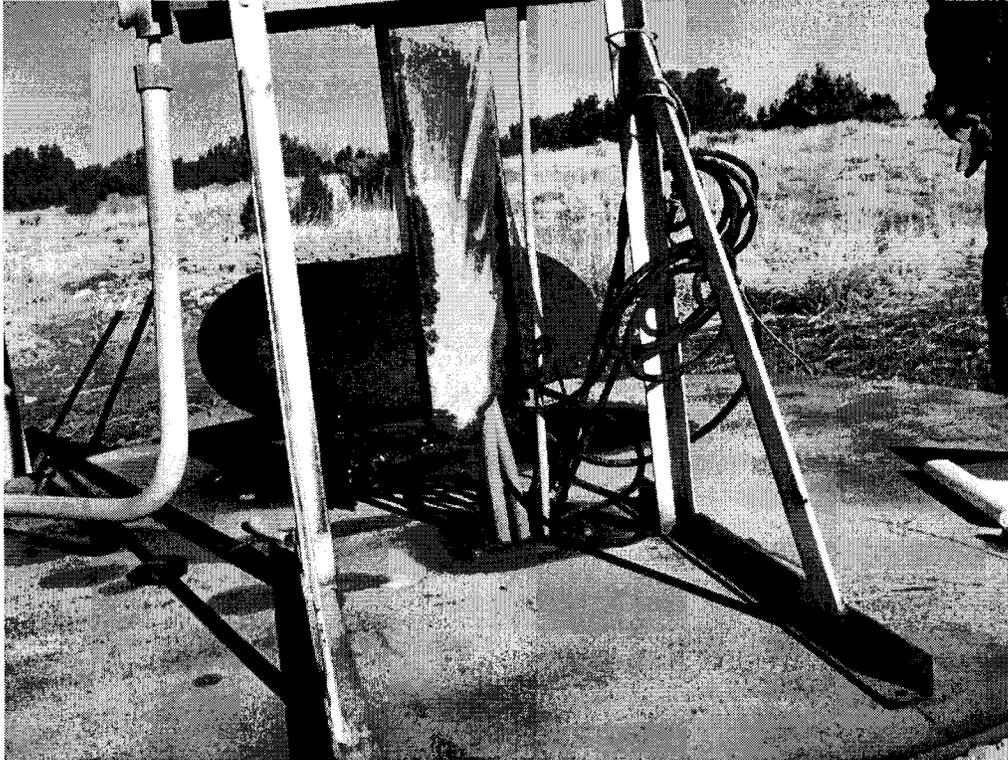
**Figure 8. Exterior of Lift Station 5B-2**

Lift station 5B-2 is located on the south side of Concho Valley Unit 5B, in the southwest corner of Lot 400. This lift station was in poor condition. The lift station also only has a single functioning pump. The force main from the wet well is a four inch (4") diameter line that runs to the same gravity manhole that Lift Station 9A flows to which is located on Lot 402 of Concho Valley Unit 5B. The wet well is five feet (5') in diameter and has a metal top and lid, similar to the lid on Lift Station 5B-1. Lift Station 5B-2 also has some of the same problems as Lift Station 5B-1.

The control panel was also mounted directly onto the metal top and has the same corrosion problems, although more severe than Lift Station 5B-1. Figure 5 shows a photo of the exterior of the lift station.

This lift station lid is also too small and should be made larger. The existing lid is also showing a great deal of corrosion, and therefore a vent should also be added to the wet well lid. It is also recommended that the control panel be moved from off of the wet well lid and placed near the lift station. Conduit should be ran from the side of the wet well to the control panel and all wiring should be protected and should be contained in the conduit. The entrance to the conduit at the wet well should also be sealed to prevent the sewer gasses from traveling through the conduit to the control panel. It appears some wiring for the float controls has been pulled through the hole in the lift station lid that allows the

wiring to enter the control panel. These float control wires should be in the wet well or in conduit for protection. They should not be opened to the elements.

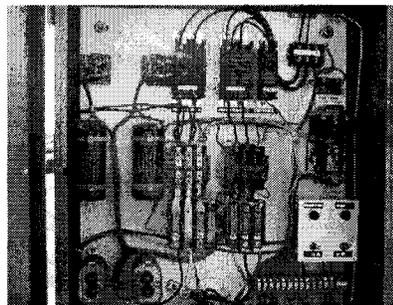
**Figure 9. Lift Station 5B-2 Control Panel**

As can be seen in Figure 9, the wiring in the control panel is in fair condition, however it was reported that the warning alarm does not work at this lift station. It is recommended that an electrician be hired to address this problem. A sign should also be attached in a conspicuous location indicating the phone number to call in case the emergency alarm is sounding. A fence should also be installed to prohibit tampering and damage of the lift station.

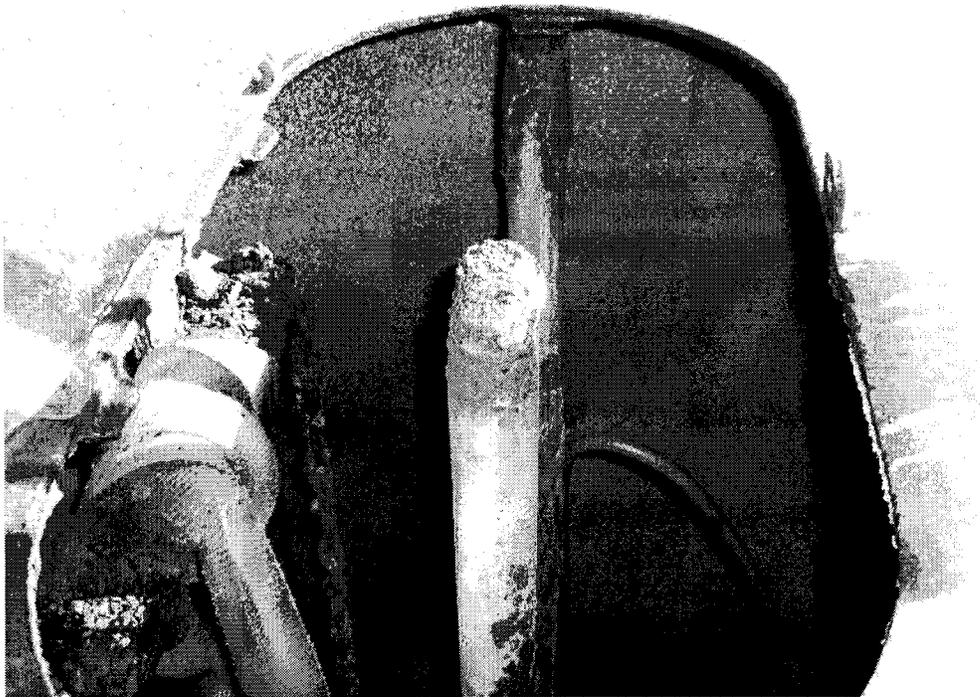
**Figure 10. Interior of Lift Station 5B-2**

In Figure 10 it can be seen that the metal inside the wet well has a great amount of corrosion and there is also a nylon strap to pull the pump. All of the metal in the wet well should be replaced with stainless steel metal, including a pull chain for the pumps.

The wet well should have two (2) working pumps installed that have been sized for the flows entering the lift station, the required head and the size of the force main to achieve sufficient velocity to scour the force main. There should also be a backup pump in storage in case the lift station pumps require maintenance or replacement. It would be beneficial if several of the lift stations use the same pump. Therefore a single pump could be kept on hand for backup of several lift stations instead of having a backup pump for each lift station.

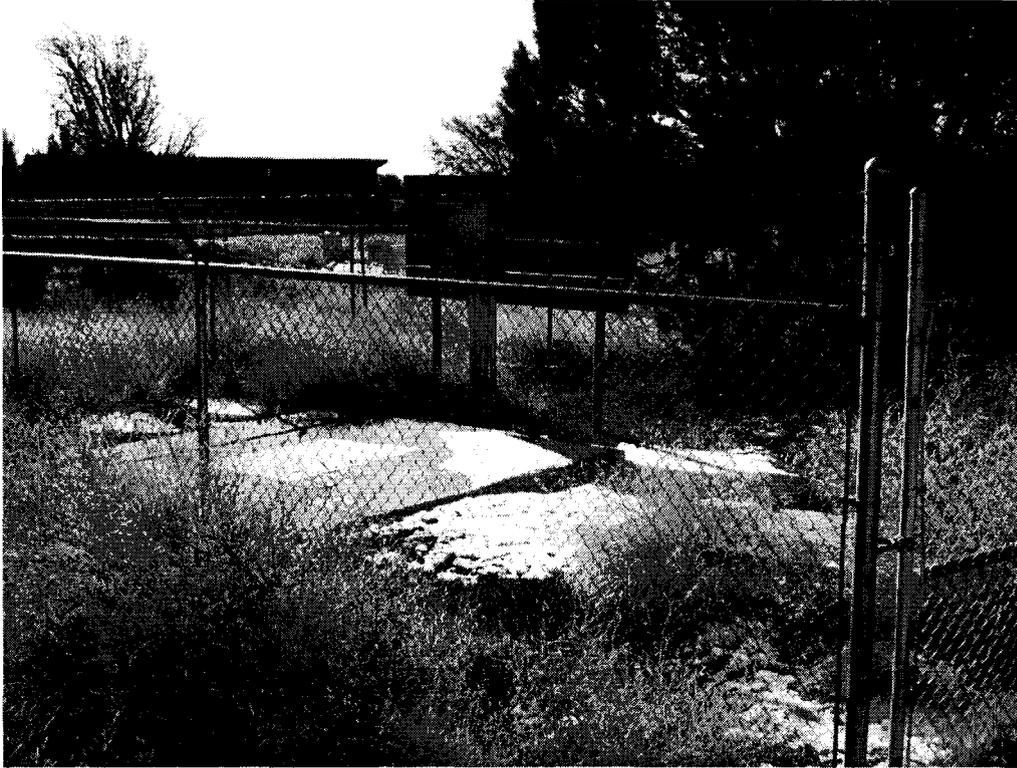
**Figure 11. Exterior of Golf Course Lift Station**

The wet well is in good condition. The metal in the wet well also appears to be in good condition. The control panel is located off of the wet well and it mounted on an adjacent panel. However, the openings in the control panel are quite a bit larger than the conduit. These openings should be closed to seal the control panel (see Figure 12).

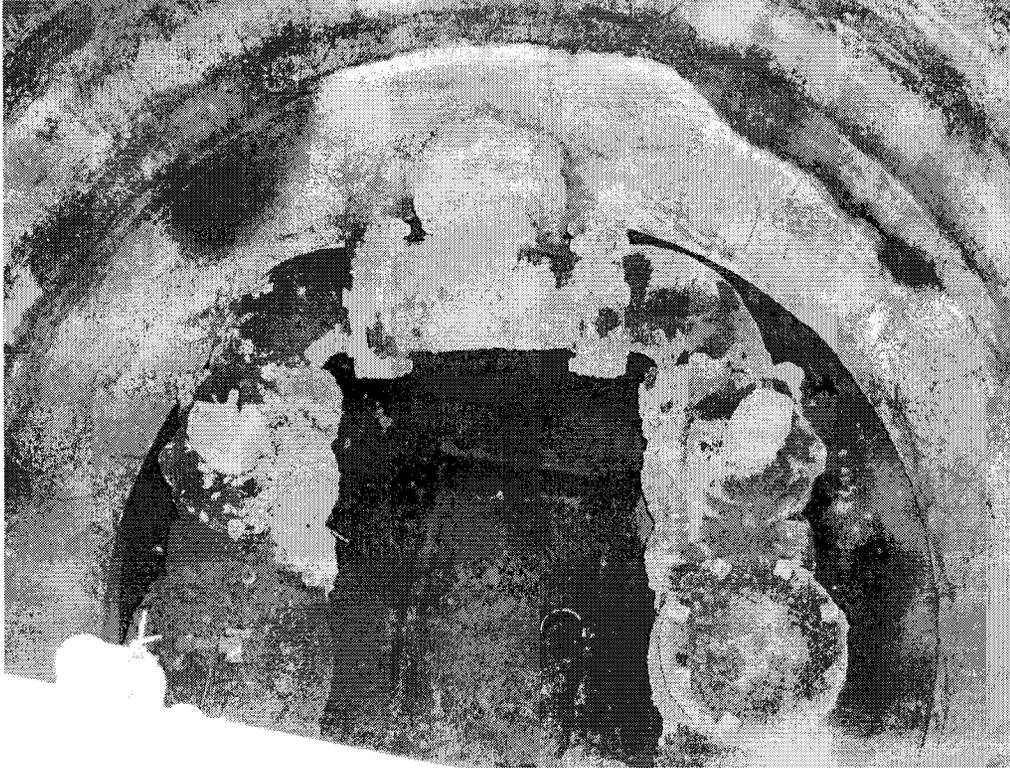
**Figure 14. Golf Course Lift Station Valve Vault**

As was mentioned, this lift station has a separate valve vault for the force main as it exits the wet well. The piping in the valve vault has a large amount of corrosion. In Figure 15 it can be seen that water has entered the valve vault and the check valve on the line that allows the valve vault to drain to the wet well has not opened or the line itself is plug. Based on the high water marks in the vault it appears the water sat in the vault for a long period of time. This should be corrected by either repairing or replacing the check valve, or

clearing the line (which ever work is required to correct the problem) to allow the vault to drain.

Also, in the same valve vault, the concrete on the vault itself has deteriorated around the force main that extends out of the vault. This concrete should be patched to keep the vault from deteriorating completely and allowing infiltration.

The wet well should have two (2) working pumps installed that have been sized for the flows entering the lift station, the required head and the size of the force main to achieve sufficient velocity to scour the force main. There should also be a backup pump in storage in case the lift station pumps require maintenance or replacement.

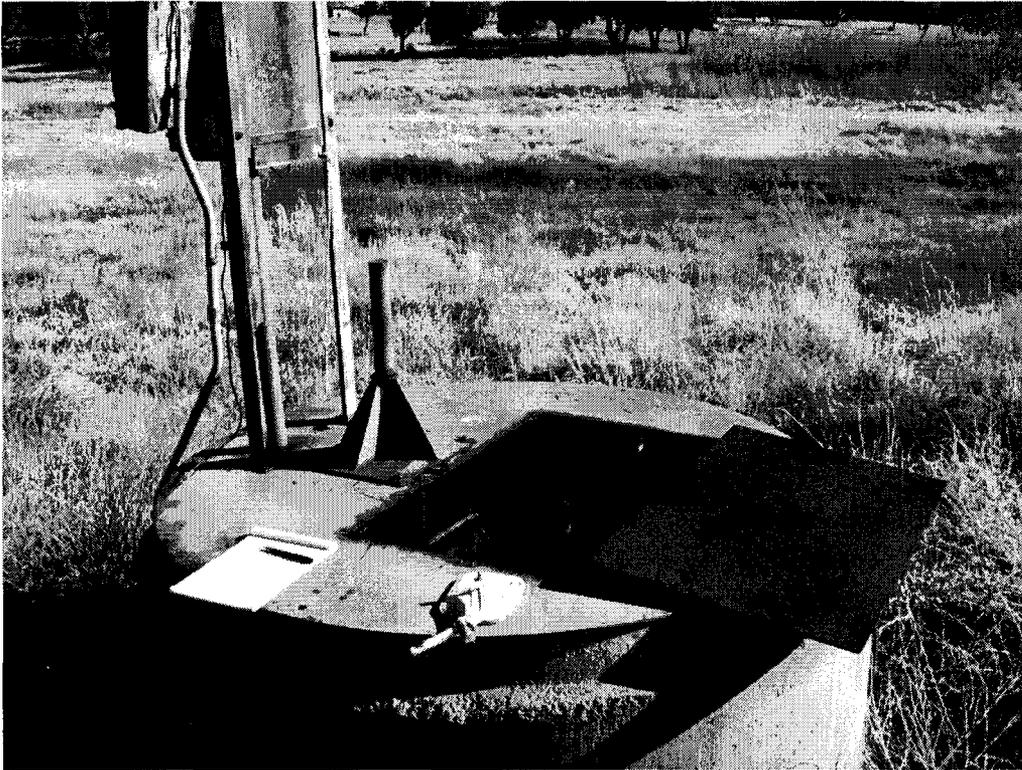
**Figure 15. Exterior of Motel Lift Station**

The existing lid is also showing a great deal of corrosion. There is also not a vent on this wet well to allow the hydrogen sulfide gasses to exit, but should be added to the wet well.

It is also recommended that the control panel be moved from off of the wet well lid and be placed near the lift station. Conduit should be ran from the side of the wet well to the control panel. Special care should be made to install all wiring in conduit to provide protection. As can be seen in Figure 15, there are wires that are exposed. The entrance to the conduit at the wet well should also be sealed to prevent the sewer gasses from traveling through the conduit to the control panel.

It was also reported that the emergency alarm on this lift station does not work. This problem should also be corrected. Also, there is no fence installed to prohibit tampering of the lift station. It is recommended that a fence be installed to prevent damage to the lift station. A sign should also be attached in a conspicuous location indicating the phone number to call in case the emergency alarm is sounding.

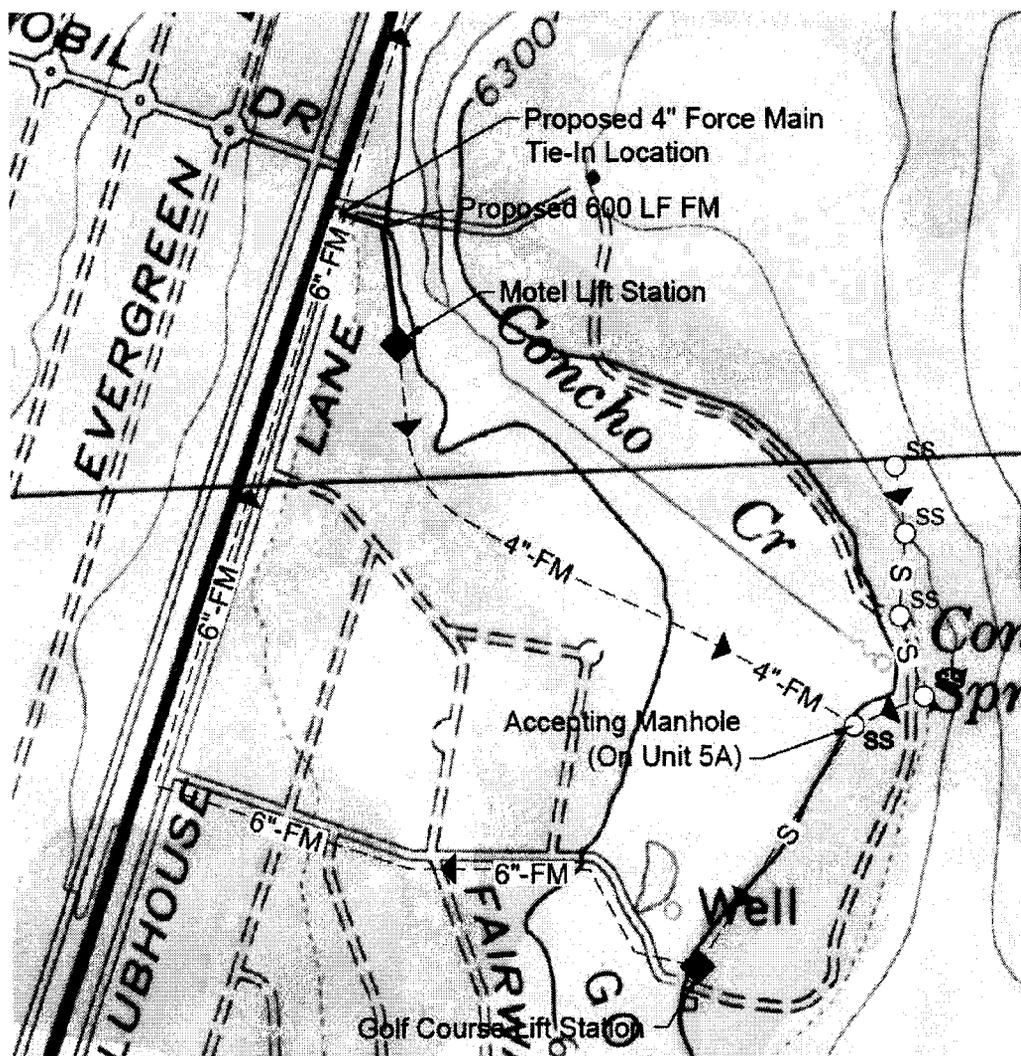
Figure 16. Possible Force Main Location

As previously mentioned, the Motel Lift Station pumps sewer through a four-inch (4") force main to an existing manhole located in Concho Valley Unit 5A. This sewer in this manhole then gravity flows to the south to the Golf Course Lift Station. The Golf Course Lift Station then pumps the sewer to the west to the right-of-way of Highway 61. The sewer continues north, parallel to Highway 61, and past the Concho Hotel and eventually to the Main Lift Station in Concho. To reduce pumping costs, a new four-inch (4") force main should be installed from the Motel Lift Station, northward to County Road 5100 and then west over to connect to the existing force main located in the right-of-way of Highway 61. This would decrease Golf Course Lift Station operating costs. This would require approximately 600 linear feet of four-inch (4") force main be installed. The approximate location of the proposed force main is shown in Figure 16. This line would need to be designed and constructed to prevent backflow into the Motel Lift Station.

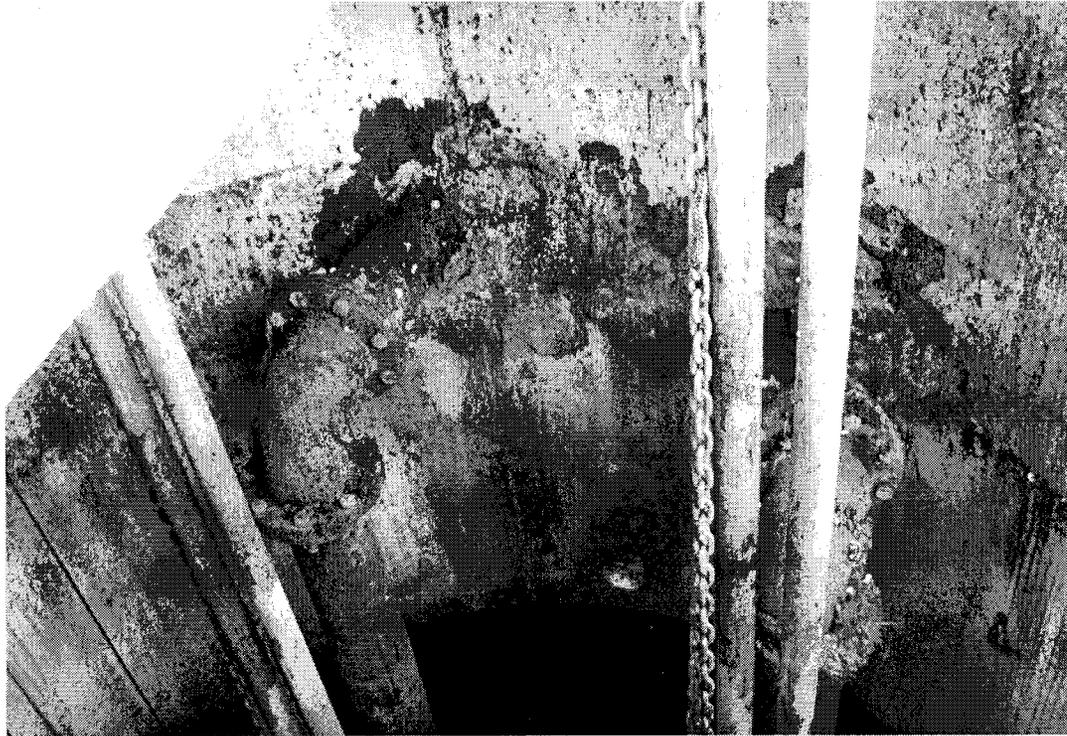
**Figure 18. Main Lift Station Wet Well**

As can be seen in Figure 18, the wet well needs some concrete patching around the pipes that penetrate the wet well wall. The metal in the wet well also appears to be in fair condition. The control panel is located off of the wet well and it mounted on good supports. However, the openings in the control panel are quite a bit larger than the conduit. These openings should be closed to seal the control panel (see Figure 19).

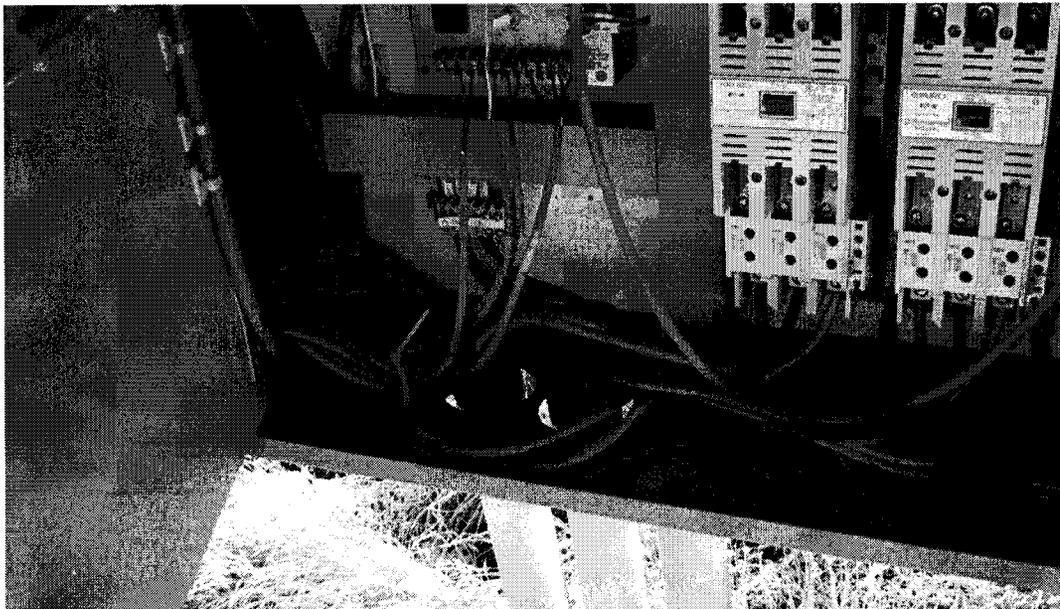
**Figure 19. Main Lift Station Control Panel**

The control panel appears to be in good shape. It was reported that the alarms on the lift station do not always work. It is recommended that the alarms be fixed to give a warning if the lift station does not operate correctly. A sign should also be added to the site indicating a phone number to call when the alarm is warning.

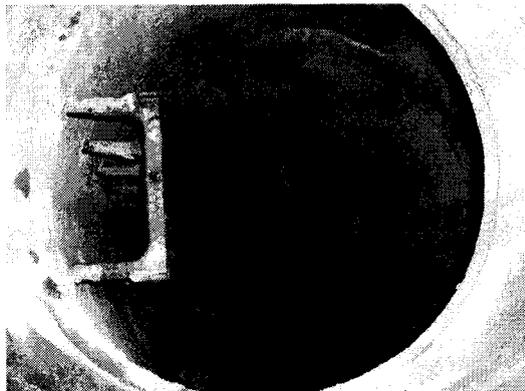
**Figure 20. Manhole on Lot 138, Unit 9**

The six (6) manholes in Unit 9 were all in very good condition. None of the manholes had any flow in them. It didn't appear that any work is required for these manholes. Figure 20 is a photograph of the manhole located at Lot 138 in Unit 9. This shows the condition of the inside of the manhole.

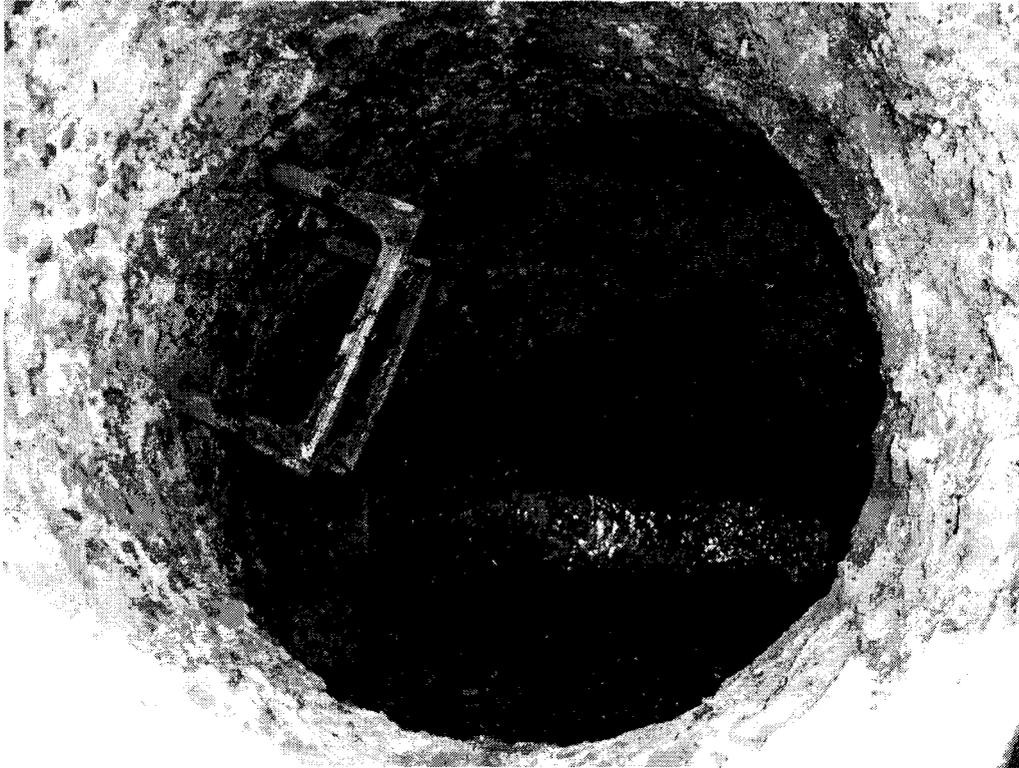
**Figure 21. Interceptor Manhole**

As was mentioned, the interceptor manhole is the manhole that the Golf Course Lift Station empties in to and is the first manhole on the interceptor line. This manhole is located at station 126+00 in the ADOT right-of-way of Highway 61. The manhole is a four-foot (4') diameter manhole, with a depth of approximately six-feet (6'). The manhole was in poor condition as can be seen in Figure 21.

As can be seen in Figure 21, the concrete of the manhole has deteriorated. This is most likely because of the hydrogen sulfide introduced from the force main. Because there is a relatively small amount of flow into the system, it is likely that the sewer in the force goes septic before the sewer enters the manhole. With the septic sewage also comes the hydrogen sulfide which can cause Microbial Induced Corrosion (MIC) and will severely corrode the concrete in the manhole. This manhole should be replaced and then the manhole should be coated with an epoxy liner. The liner will bond to the concrete of the manhole to prevent the corrosion of the concrete. Although the next downstream manhole is approximately five-hundred feet (500') downstream of this manhole, it should be examined to determine if the hydrogen sulfide gasses have caused corrosion problems in it as well. It may need replaced and/or coated as well.

Other manholes in the system that receive flows from force mains should also be inspected to determine if they are in similar condition as the manhole that was inspected. It is likely that these manholes will be corroded and need replaced and/or coated as well.

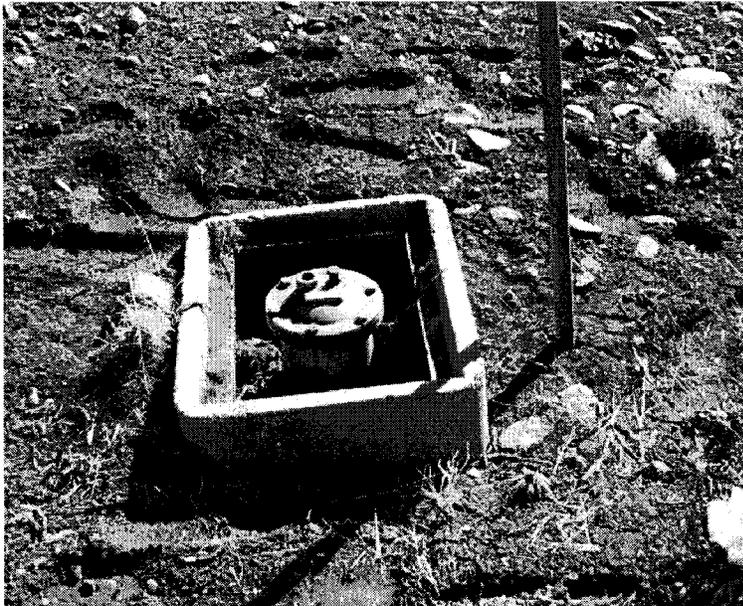
**Figure 22. Air Relief Valve**

Based on the construction plans, there appear to be many air relief valves (ARV) in the system. One ARV was observed. The valve was located in a concrete box, and the top of the valve was above the box. There was also a metal pole, indicating the location of the valve. A photo of the valve is shown in Figure 22.

It is suggested that the valve be protected. A higher box is required that can be installed above the valve so that the lid can be placed over the valve. It was not known if the valve was working. The valve should also be checked to make sure that it is allowing air out of the force main. All of the valves in the system should be examined to determine if the same corrective measures are necessary for them as well.

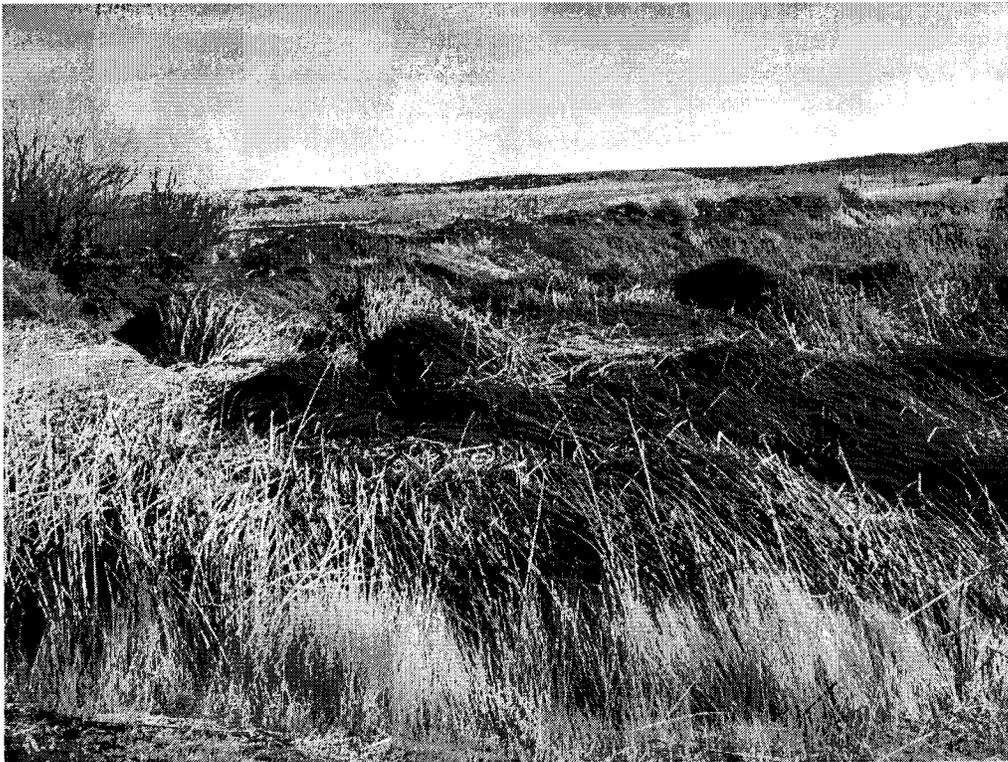
**Figure 23. Settling Pond - Lagoon**

Based on the Design Report which was completed by Shreeve & Associates, Inc. in 1991, the treatment site was designed with three (3) components. They consist of a settling pond or lagoon, wetland, and reuse area. The treatment plant was designed for the influent to be receive primary treatment by entering the settling pond and allowing the solids to settle to the bottom of the pond. Then the effluent will enter wetland cells for further treatment. There have been two (2) cells constructed for treatment of up to 20,000 gpd. From the wetlands, the effluent will enter the chlorine contact chamber for further treatment, and then be sent to the reuse area for disposal. It is apparent that the treatment site has not recently received enough flows to allow the settling pond to fill and flow over into the wetlands areas. Because of the small flows, the influent has entered into the settling pond and has been treated there instead of the wetlands. As can be seen in Figure 23, a great deal of vegetation has grown in the settling pond.

The settling pond (lagoon) was designed to allow a detention time between five (5) to ten (10) days to provide time for the solids to settle out of the influent. Based on the Aquifer Protection Permit (APP) number P-102422, the settling pond was designed to have an 18" clay liner. The substantial vegetation root system could penetrate the liner and allow the effluent to flow below the liner and enter the groundwater, which could at some point, show up in the groundwater. Also, based on Part II.A.3 in the APP on page 2 of 27, the accumulated sludge in the pond shall be removed to obtain the required operating depth in

the pond, but at least every five (5) years. Because the flows to the pond are so small compared to the design flow, there most likely has not been a large amount of sludge build up in the pond, however ADEQ may have an issue with this in the future.

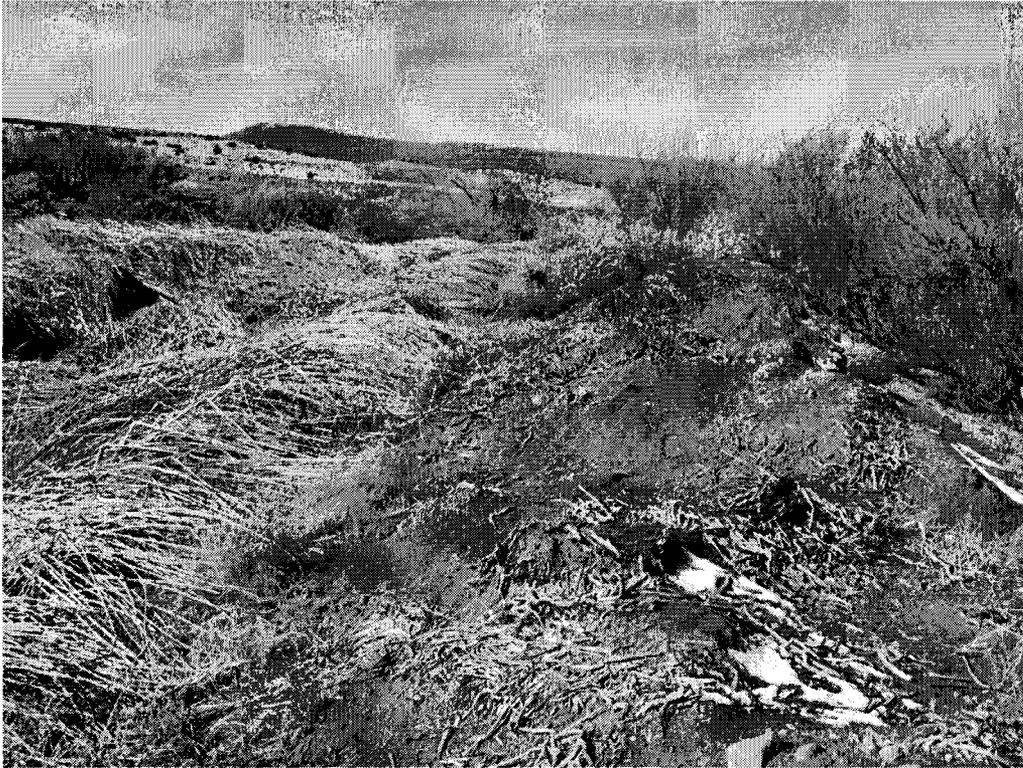
**Figure 24. Settling Pond Berm**

It appears the berms of the pond are slowly sloughing off in to the pond. Over time, the berm will break down and require maintenance. Based on the APP, the berm should have a free board height of three feet (3'). Although the flows are small now and therefore the required depth of the pond to achieve the free board is not much more than three feet, this could be a problem in the future. It is suggested that the berm be lined with riprap to prevent erosion of the berm.
