DOCKET NO. E-01750A-09-0149

NOTICE OF FILING  
INSPECTION REPORT

### Arizona Corporation Commission (“Commission”) Utilities Division Staff (“Staff”) Inspection of Mohave Electric Distribution Line between Mile Markers 66 and 80 on US Route 66 Northeast of Kingman, Arizona

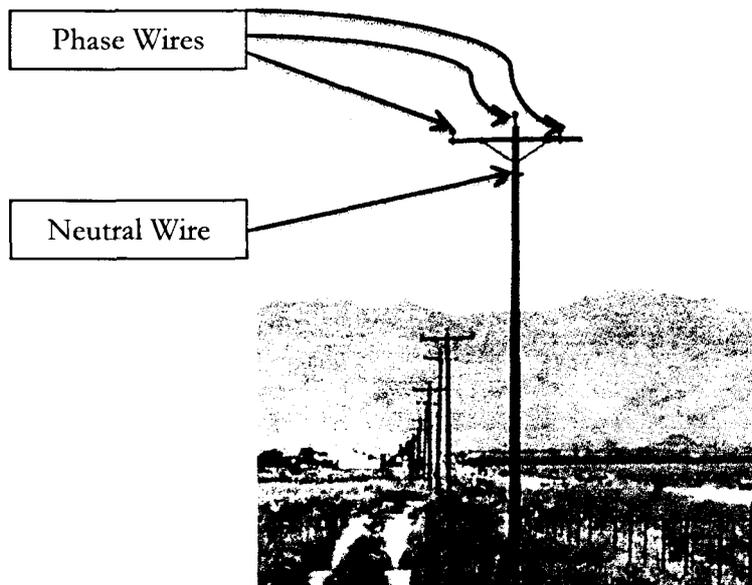
Figure 1 – Mile Marker 69 Looking Northeast

The subject three-phase line serves MEC customers along its entire length, including Valle Vista subdivision and several railroad signal facilities along the railroad that parallels US Route 66. Per MEC the line was originally constructed in 1949. The configuration and design of the line, therefore, was built and is subject to the standards that were in effect at that time. The line is typical wood pole horizontal construction with the neutral attached to the pole and located beneath the phase wires as shown in Figure 1 below.

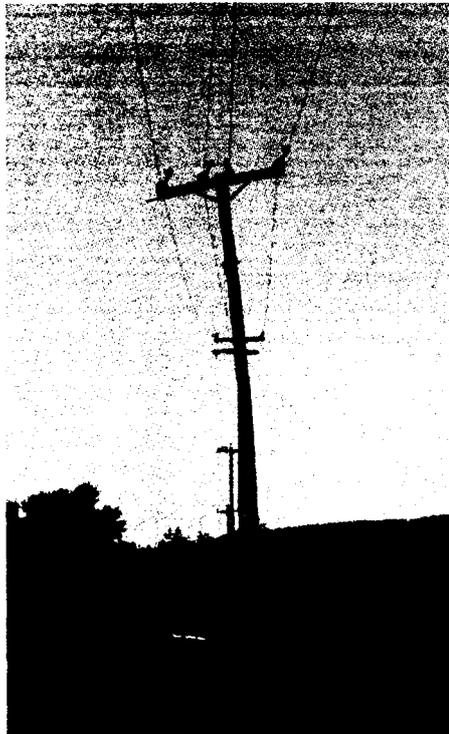
**Figure 2 – 2<sup>nd</sup> Pole West of Mile 74.5**

The leaning pole that was inspected west of mile 74.5 (No. 9 in Attachment B) is shown below in Figure 2. While the pole does not appear to be an immediate risk to safety or reliability, MEC was asked about it. MEC indicated that this pole will be replaced as part of a rebuild and upgrading of this line discussed previously.

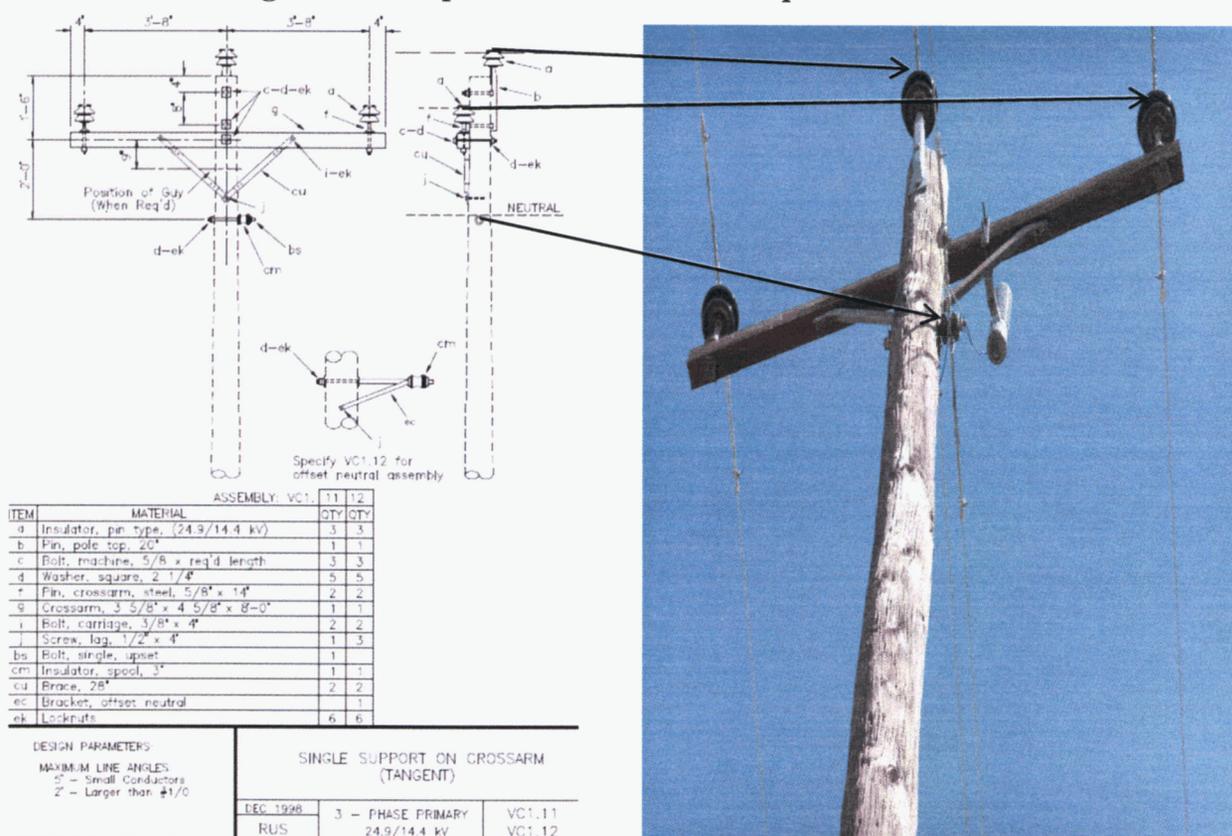
**Figure 3 – Comparison of Current RUS Specification to MEC Line**

As indicated above, the line was built in 1949, and was built to standards in existence at that time. Unless a utility is rebuilding a line, there is generally no obligation for that utility to specifically modify existing facilities for the sole purpose of reflecting new standards. That said, Staff found that the existing line is consistent with current Rural Utility Services (“RUS”) specifications<sup>2</sup> (which MEC uses) for 14.4kV/24.9kV three phase horizontal construction. RUS specifications are developed consistent with the National Electrical Safety Code (“NESC”). Figure 3 shows a comparison of the actual configuration of the MEC line with the current RUS specification. In addition, based upon approximate measurements of conductor spacing taken on the existing MEC line, the spacing of the existing line is the same as the current design configuration, which is compliant with the NESC.

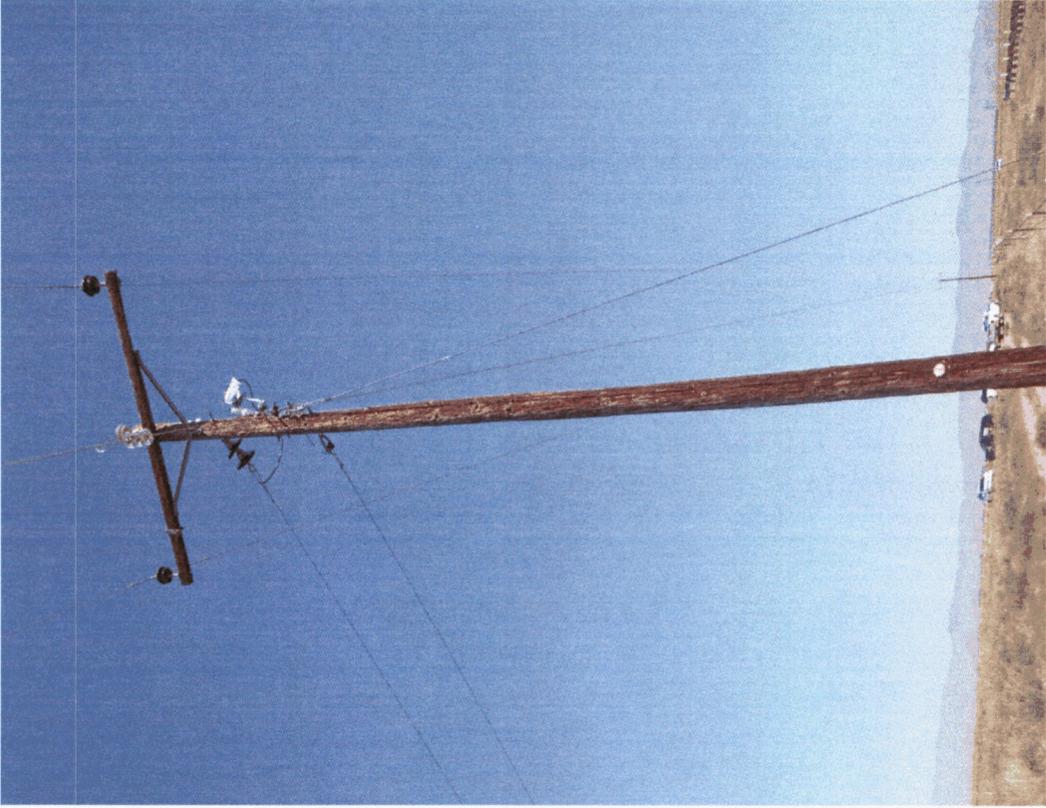
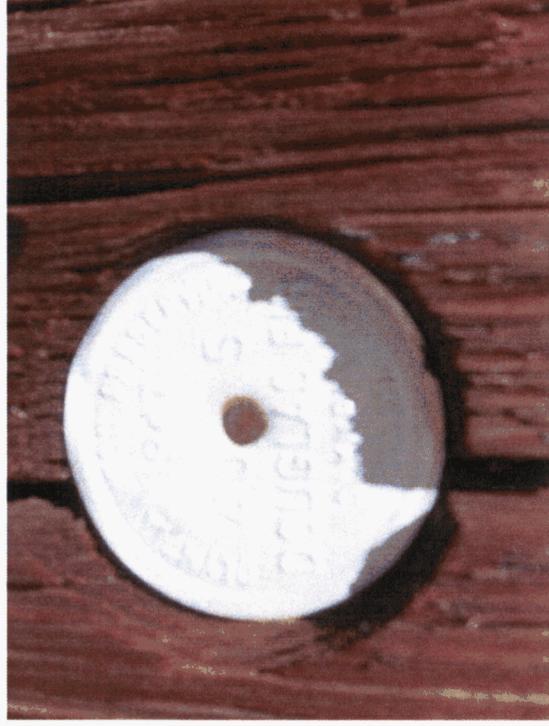
1 - Mile Marker 69 1<sup>st</sup> Pole West of - 1947 Vintage Pole

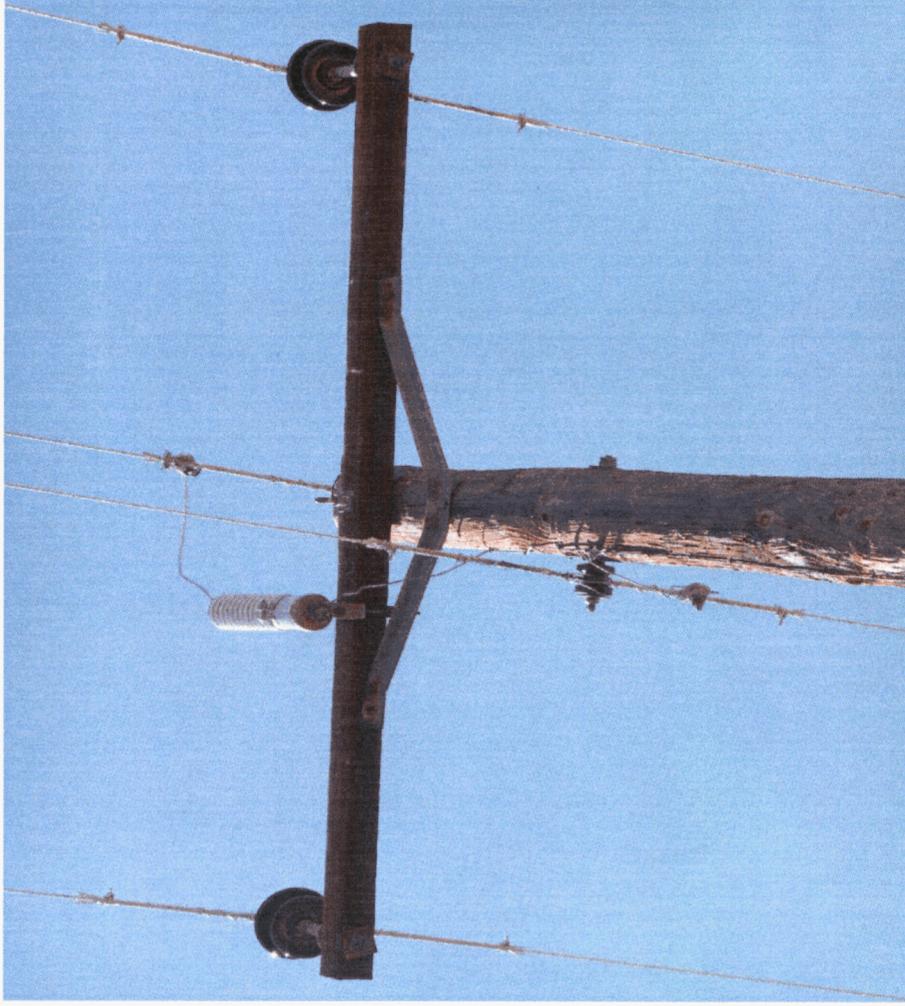
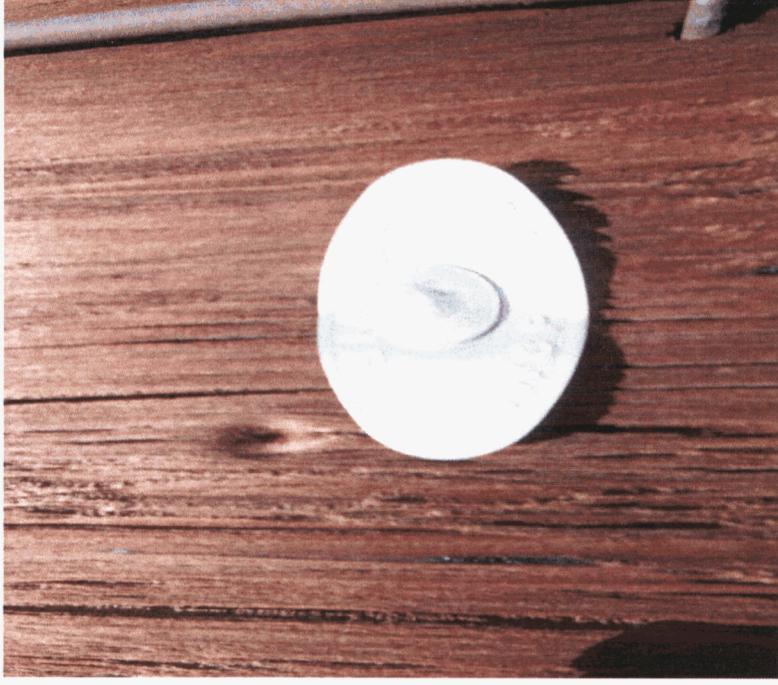
2 - Mile Marker 69 2<sup>nd</sup> Pole West of - 1947 Vintage Pole, OSMOS Inspection Tag 1998

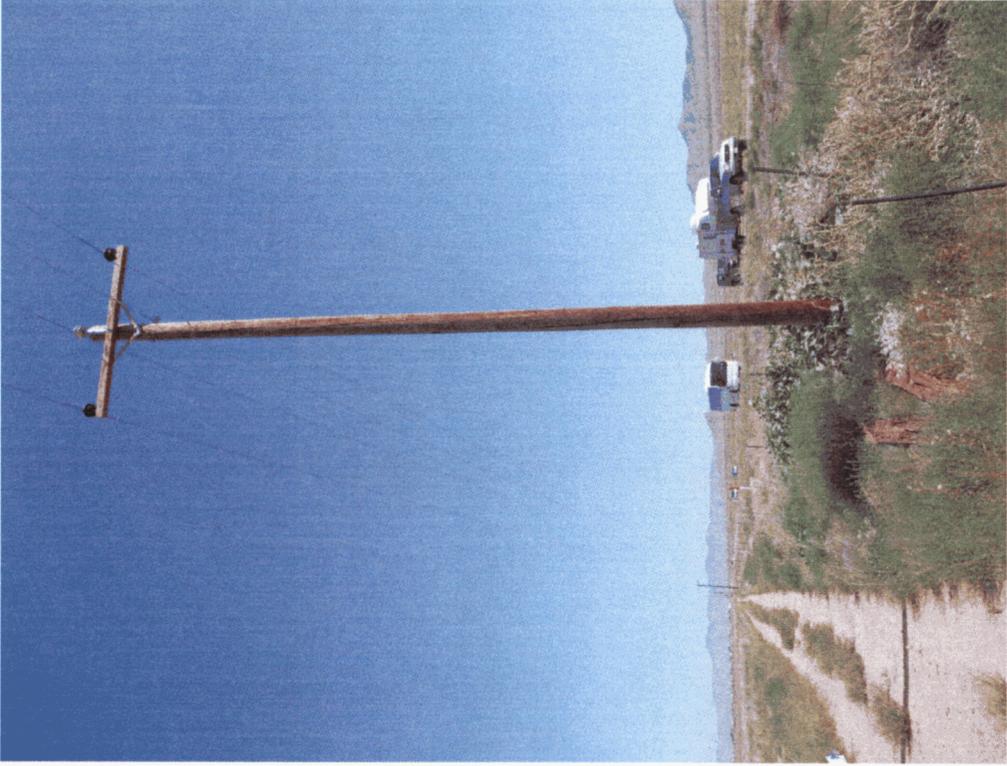
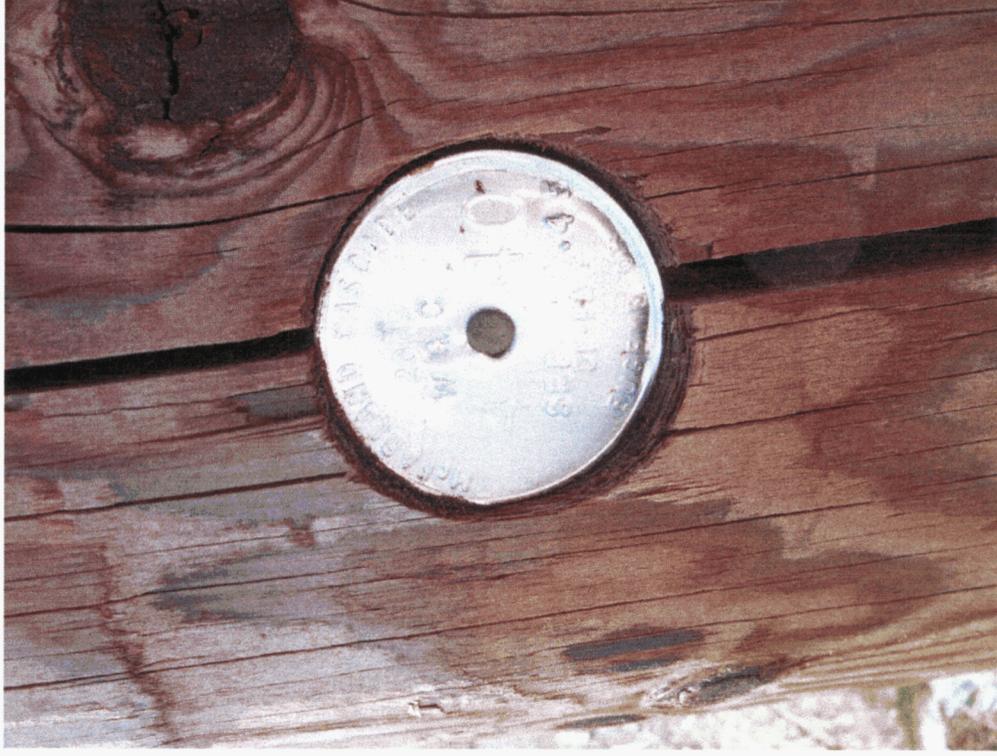
3 - Mile Marker 69 1<sup>st</sup> Pole East of - New Pole 2005 Vintage

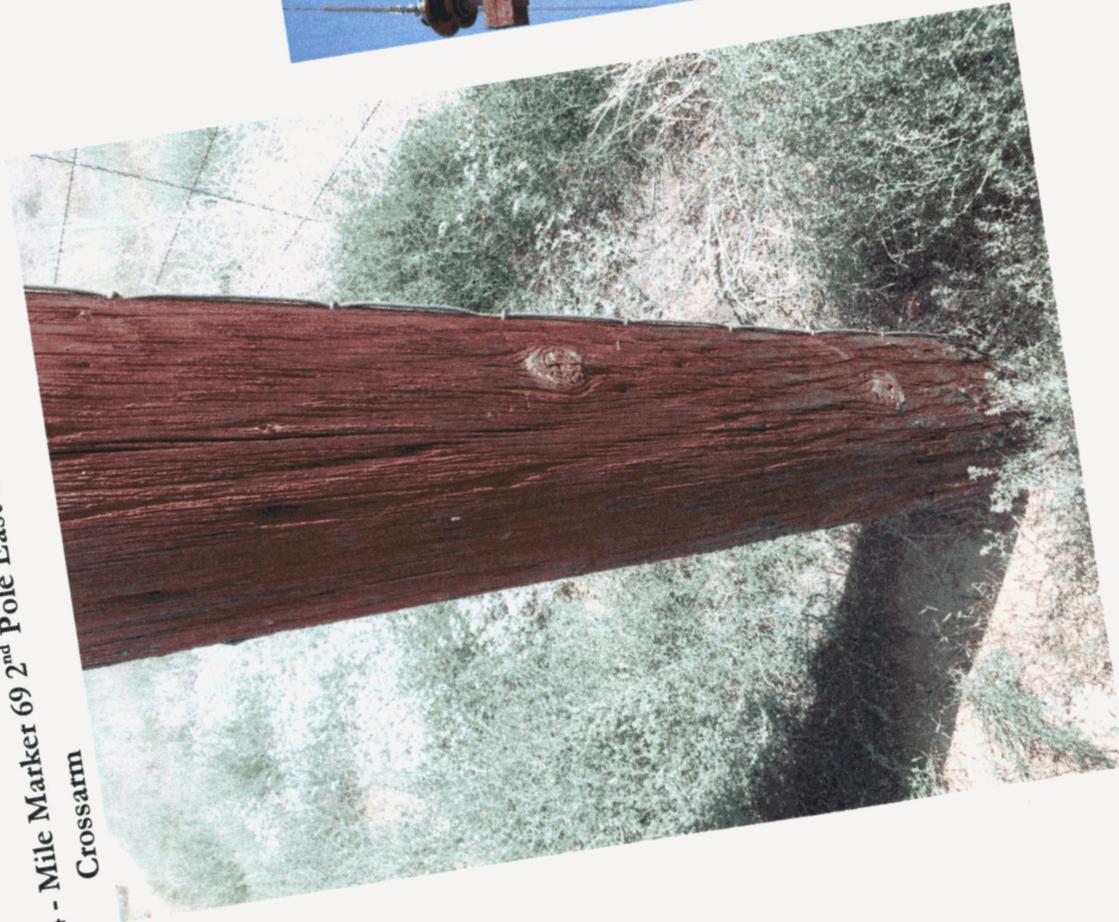
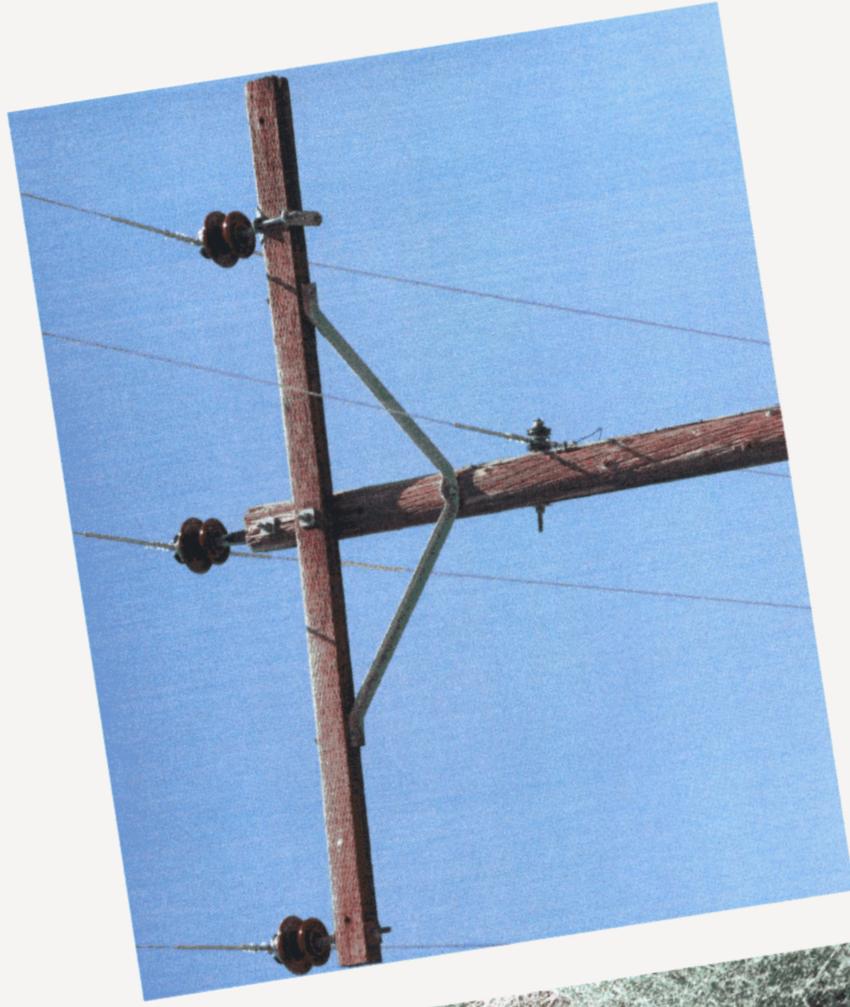
4 - Mile Marker 69 2<sup>nd</sup> Pole East of - Likely 1947 Vintage - Note Insulator Bracket on Right Side of Crossarm Used to Repair Split

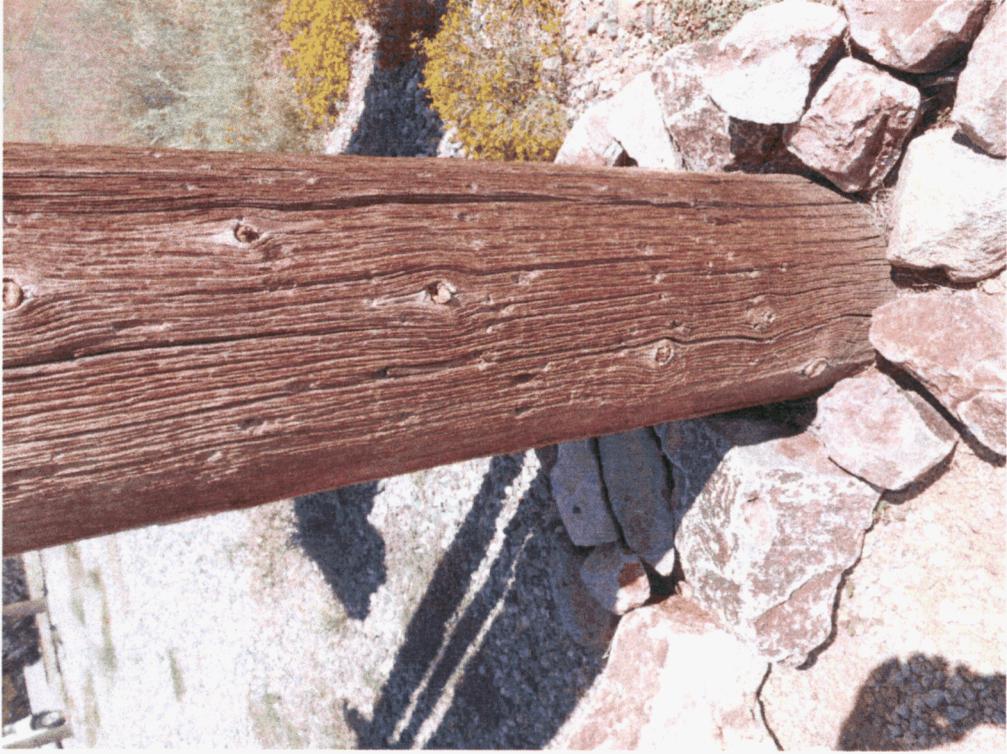
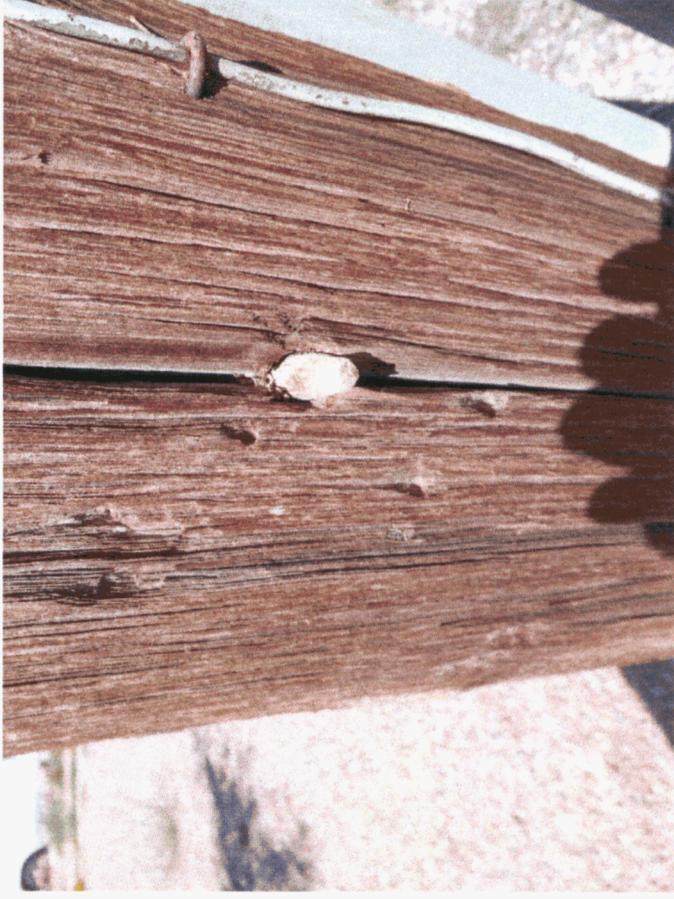
5 - Mile Marker 71 2<sup>nd</sup> Pole East of - Likely 1947 Vintage - Note Wood Plug in Picture on Right Either from a Boring when Originally Produced or from a Prior Bore Inspection

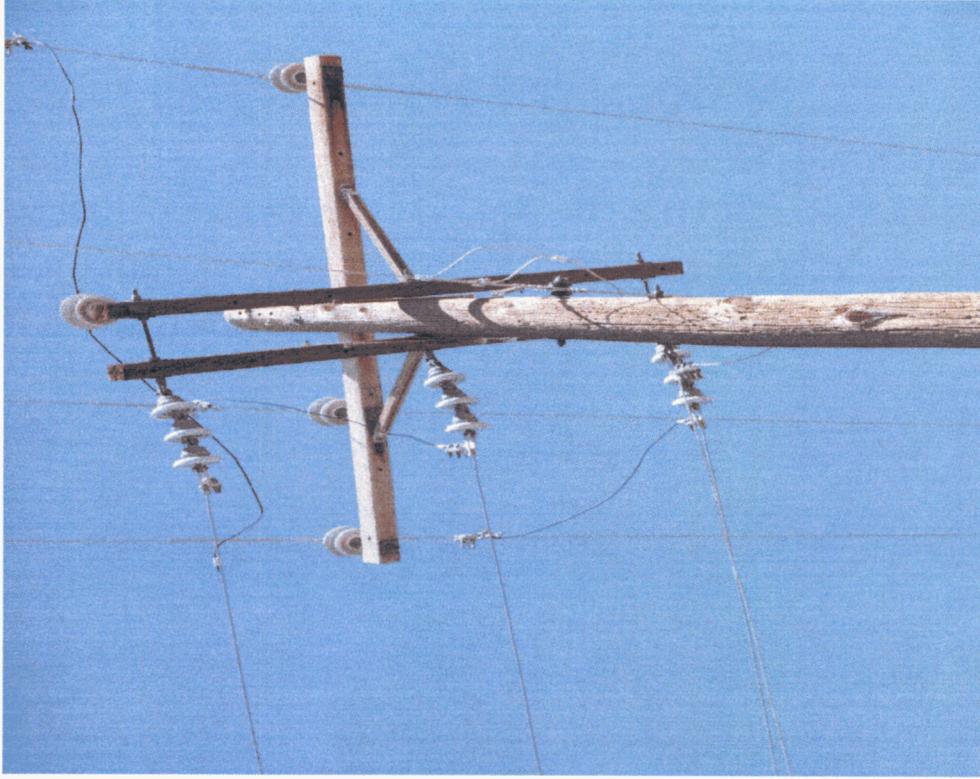
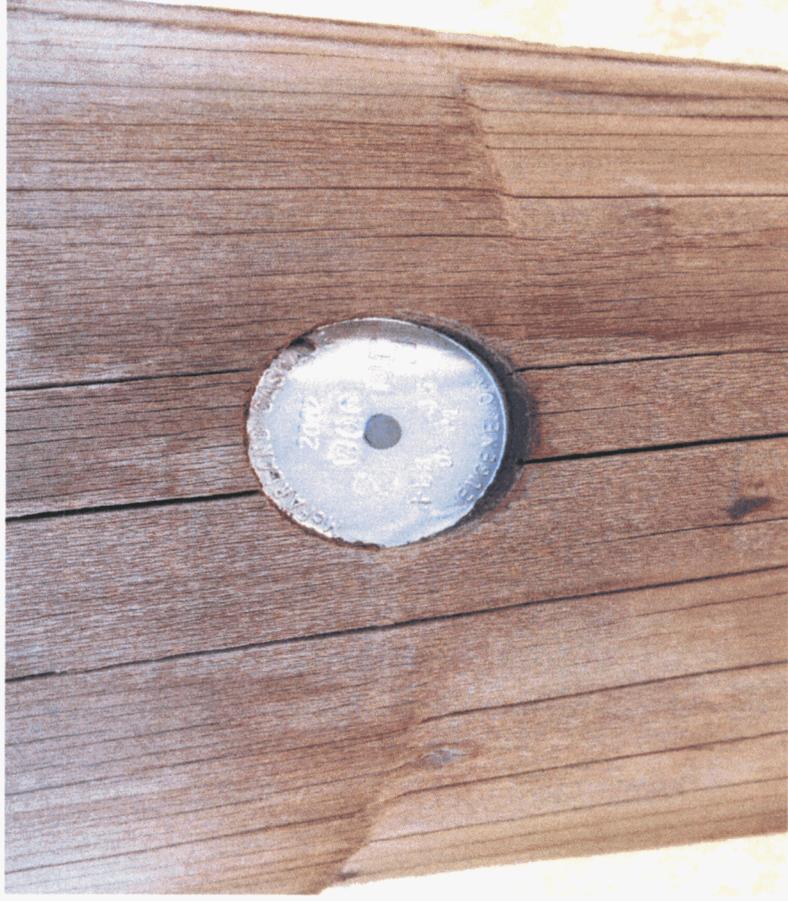
6 - Mile Marker 71 3<sup>rd</sup> Pole East of – New Pole 202 Vintage

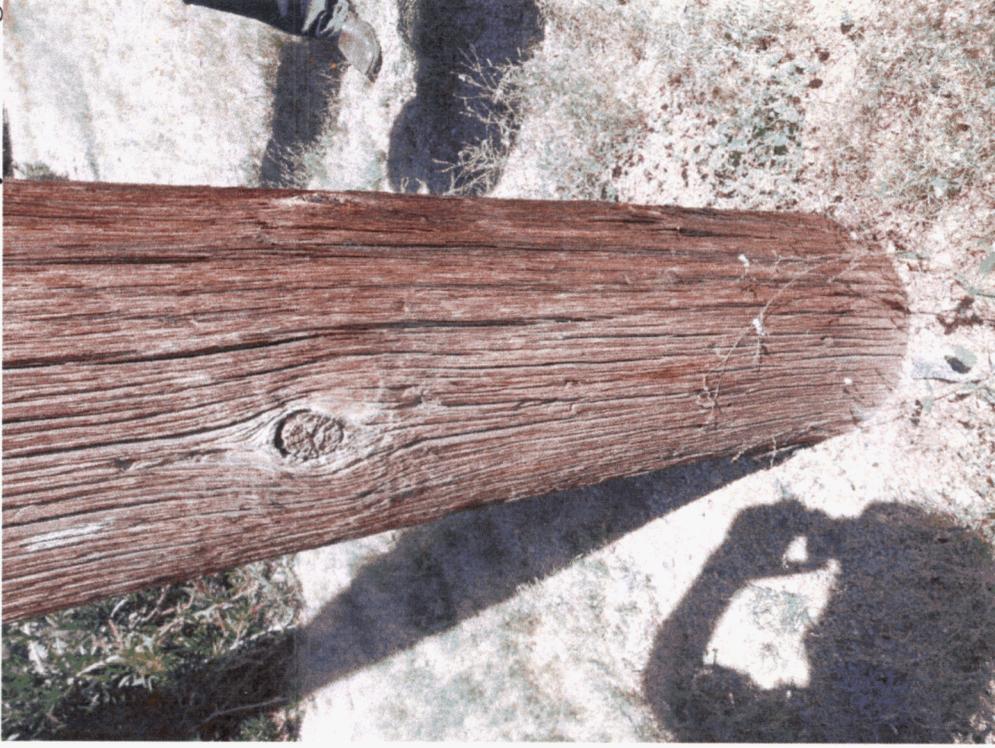
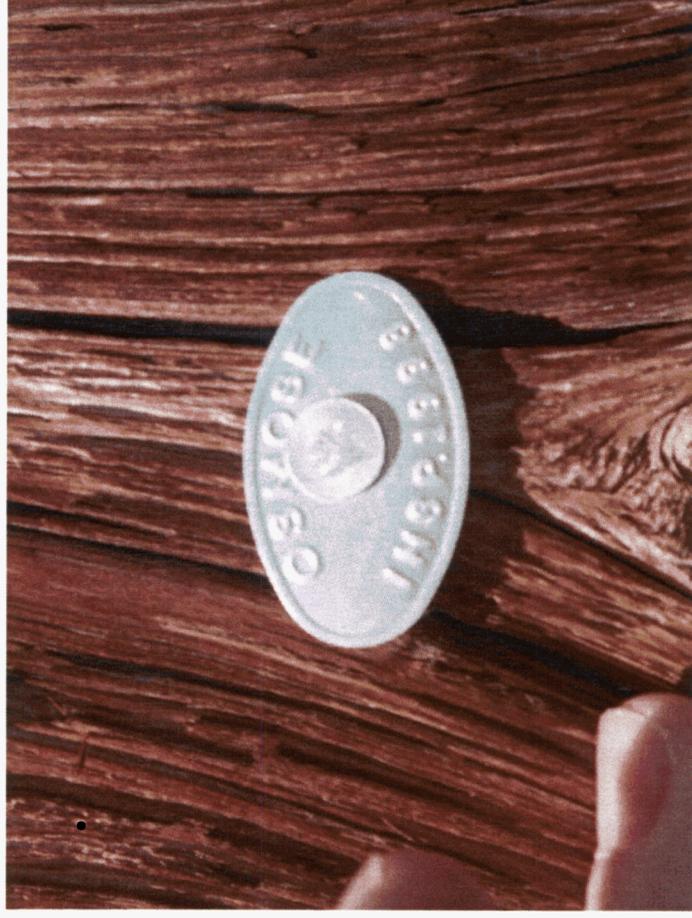
7 - Mile Marker 71 4<sup>th</sup> Pole East of - Likely 1947 Vintage, 1998 OSMOS Inspection Tag

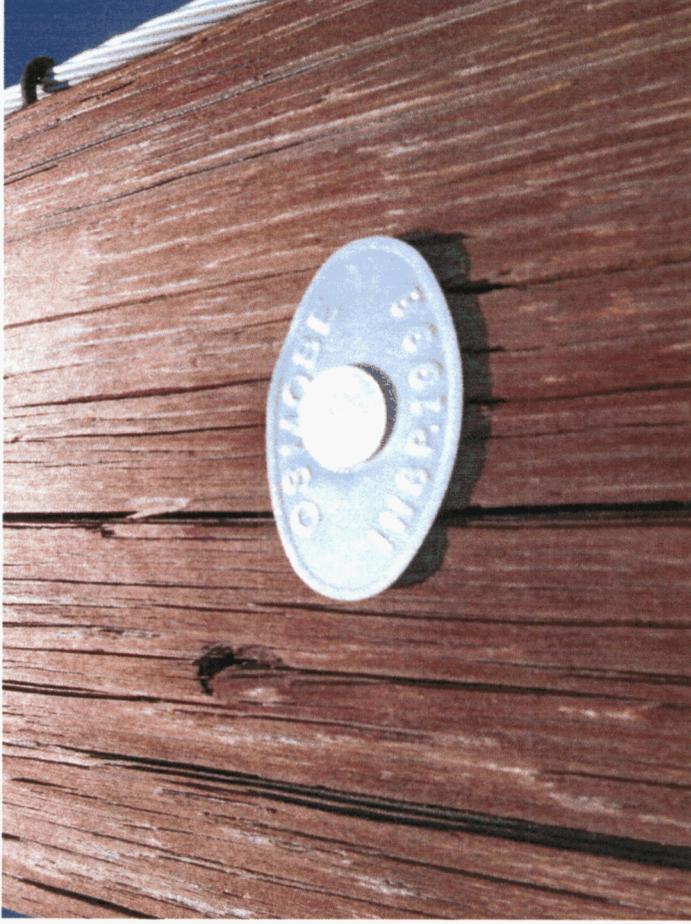
8 - Mile Marker 74.5 1<sup>st</sup> Pole West of - Likely Vintage 1947, 1998 OSMOS Inspection Tag

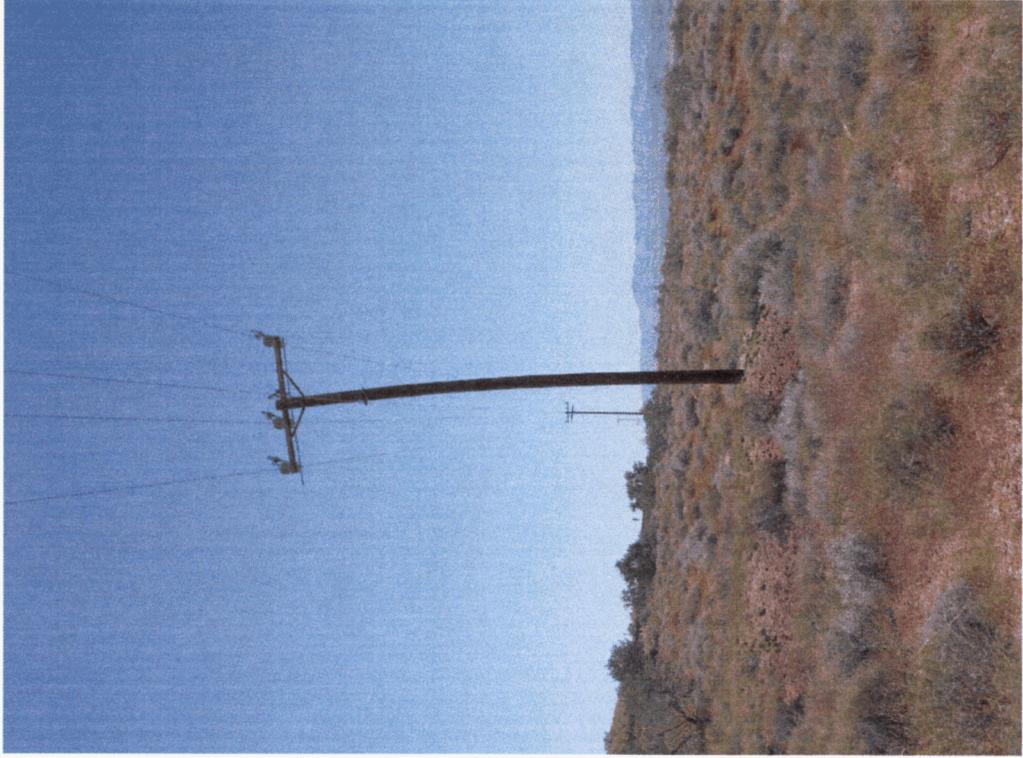
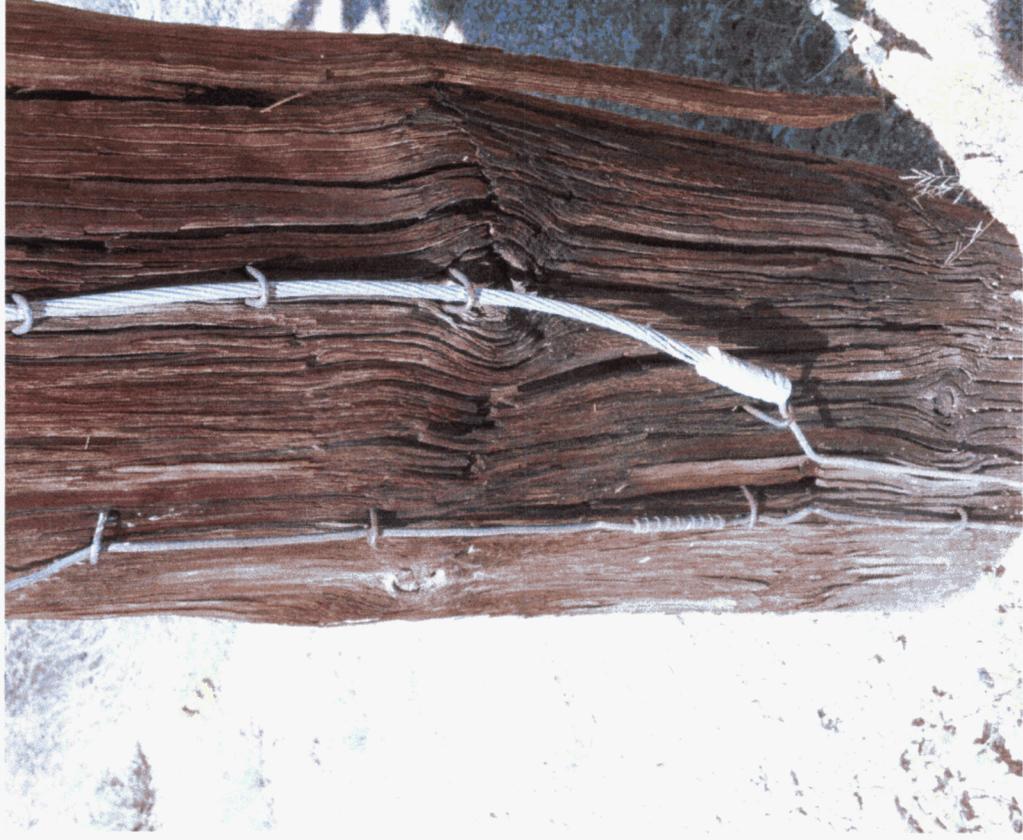
9 - Mile Marker 74.5 2<sup>nd</sup> Pole West of - Likely Vintage 1947, Sectionalizing Line Switch Pole, Pole is Leaning

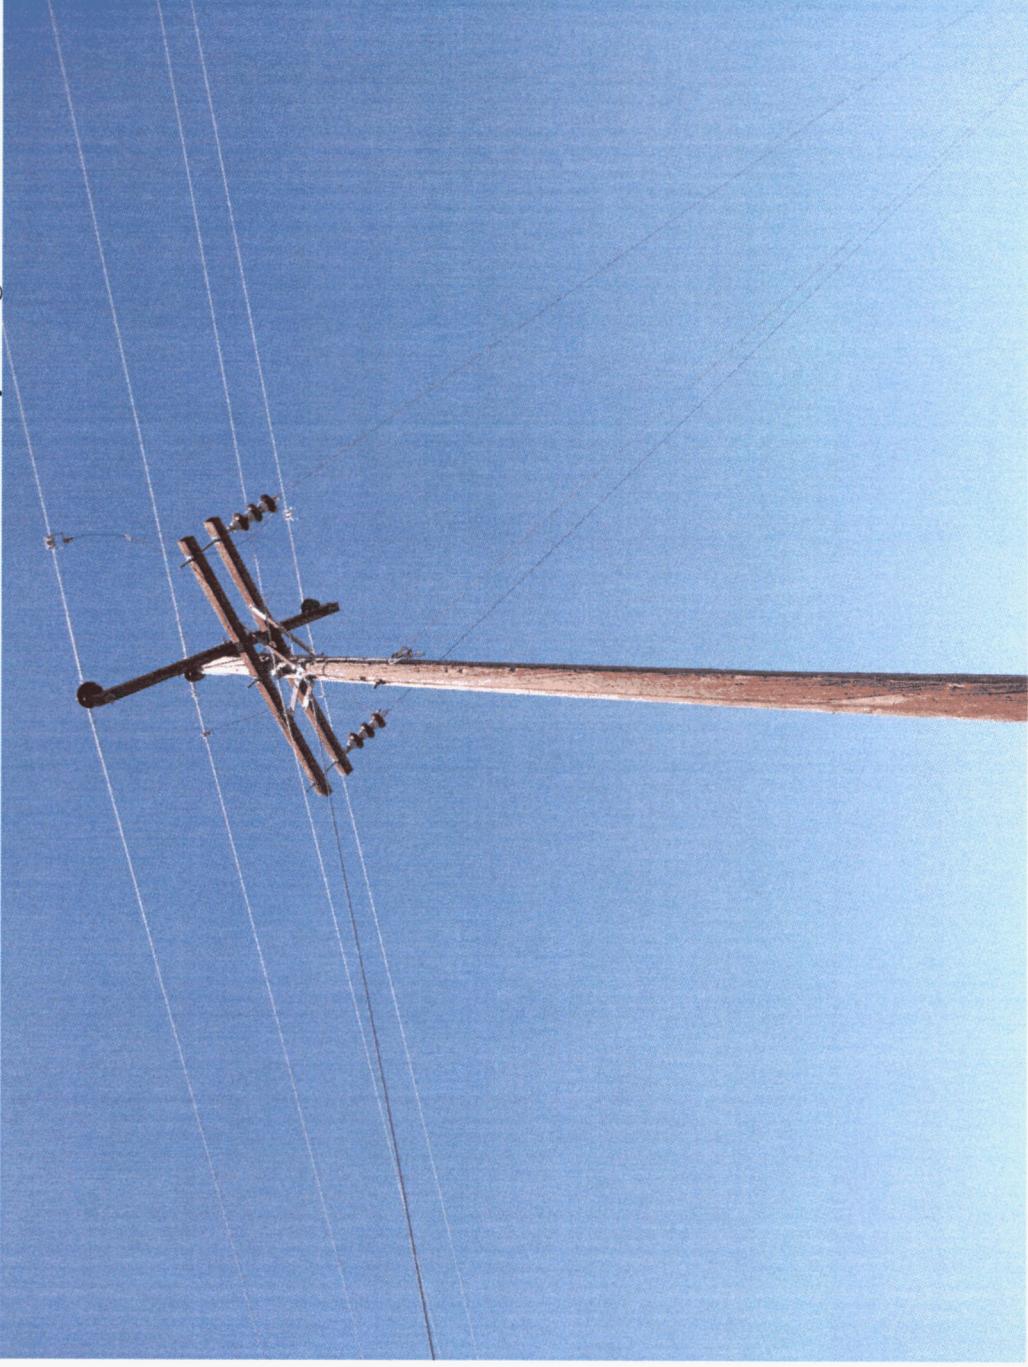
10 - Mile Marker 74.5 Pole at Intersection of US 66 & Boulder Rd- Likely Vintage 1947

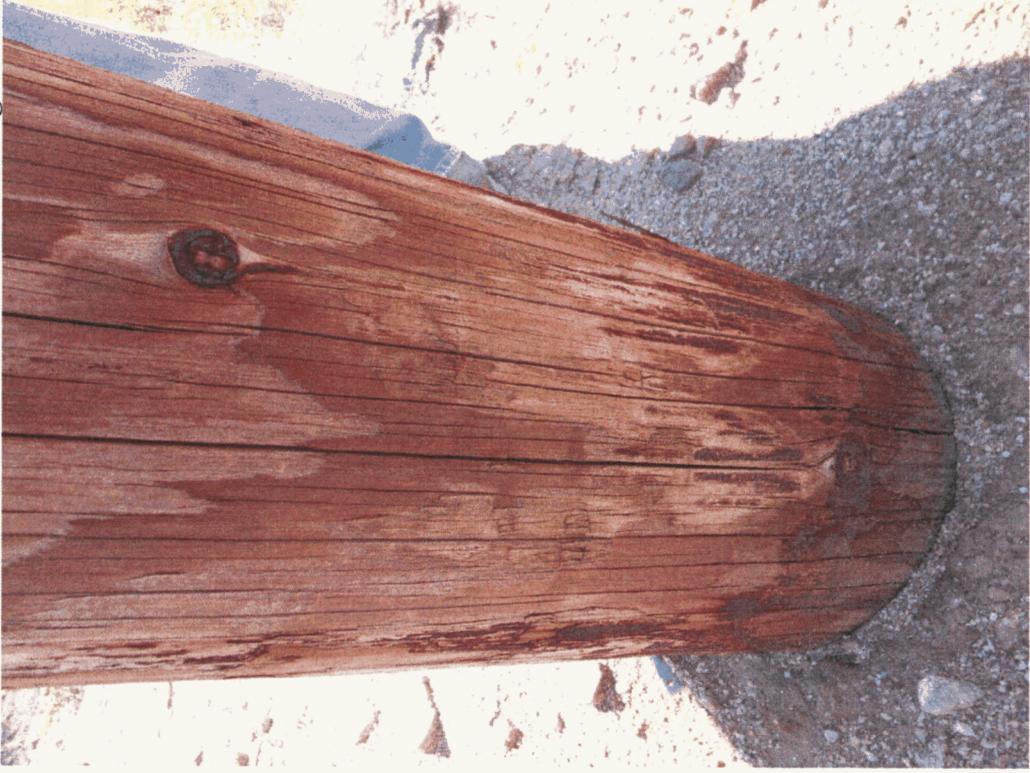
11- Mile Marker 74.5 1<sup>st</sup> Pole East of – 1993 Vintage

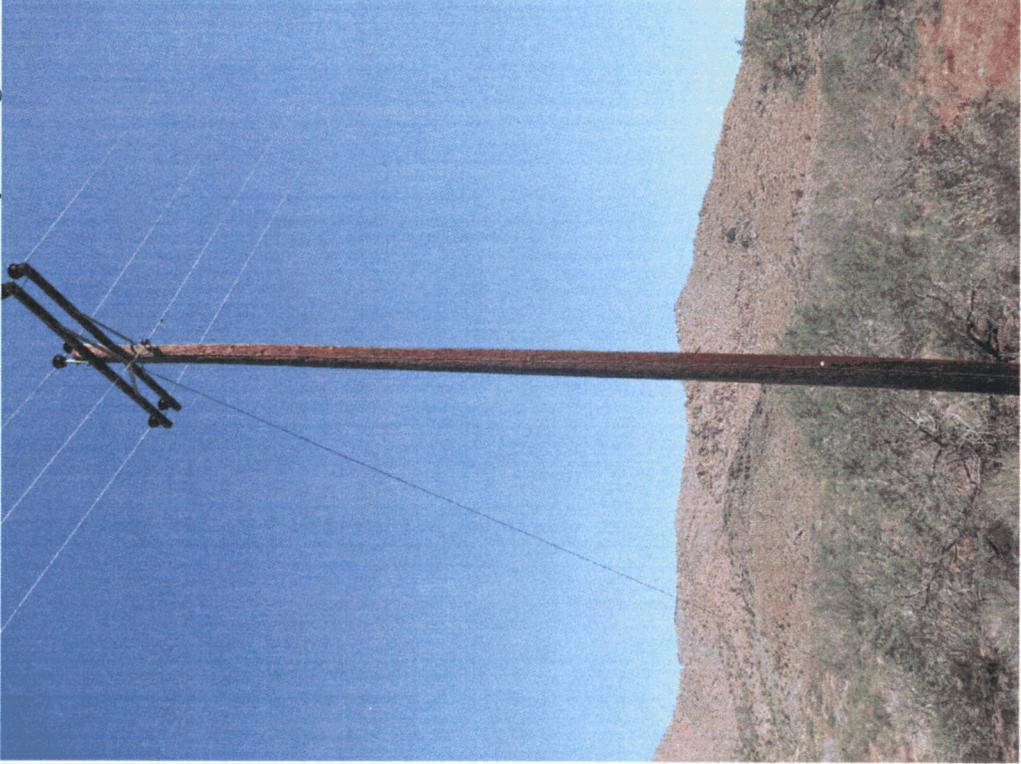
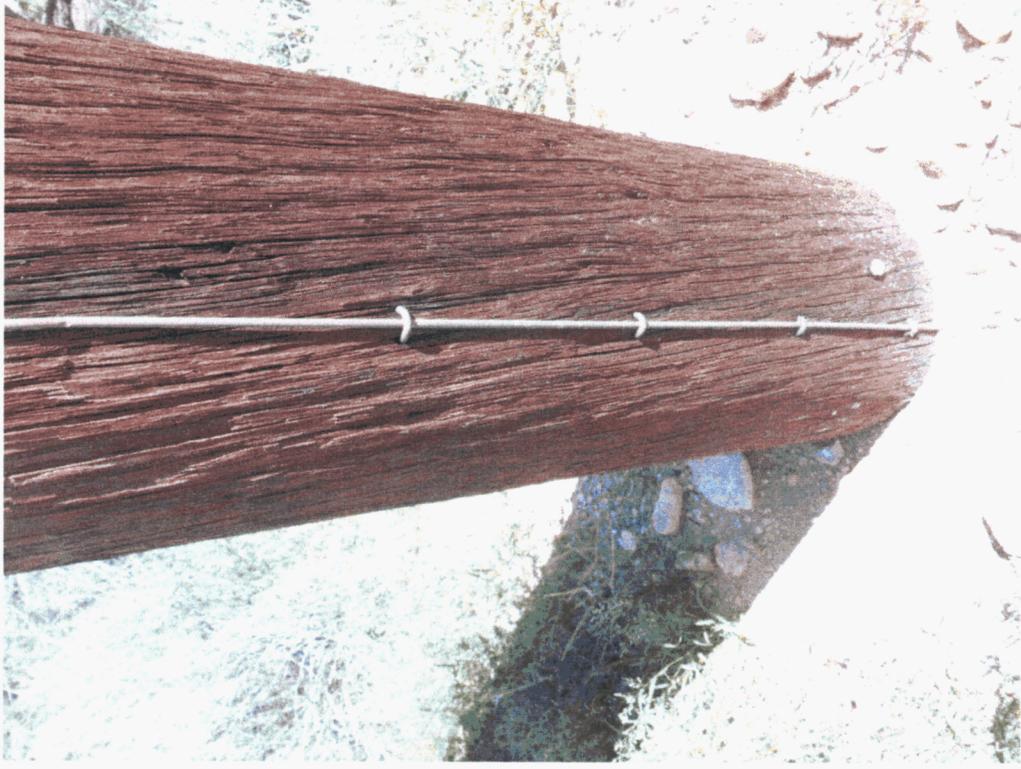
12 - Mile Marker 80 1<sup>st</sup> Pole East of - Likely Vintage 1947

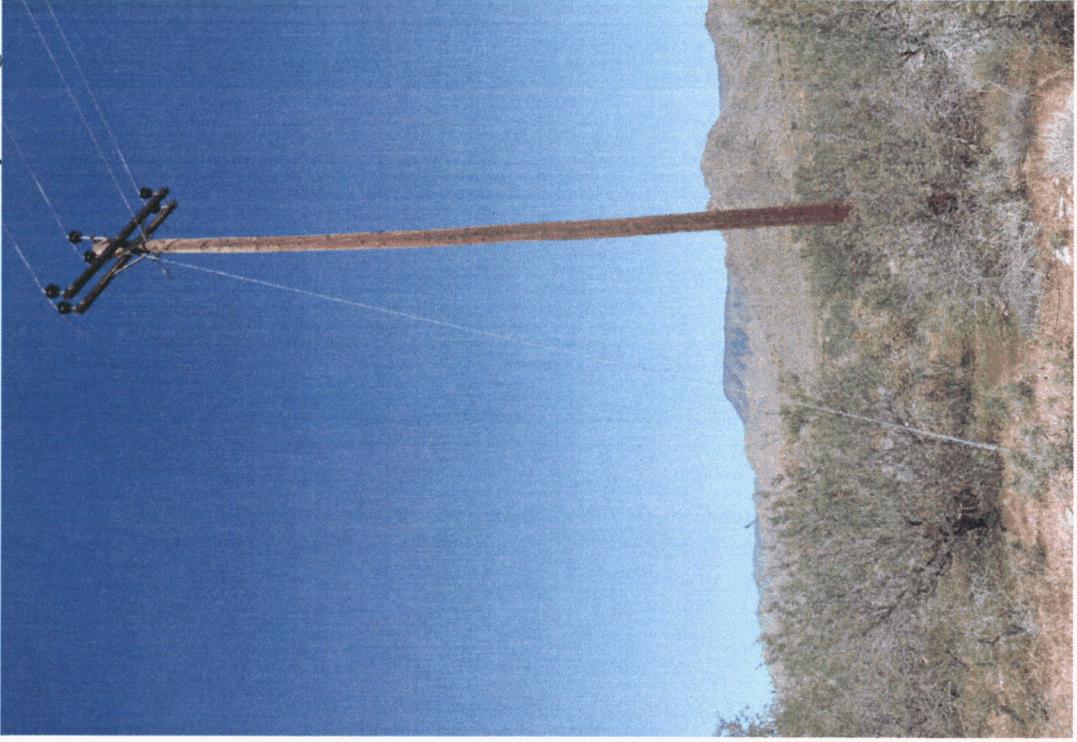
13 - Mile Marker 80 2<sup>nd</sup> Pole East of - Likely Vintage 1947, Guyed Angle Pole
