Docket #(s): Sw-02563A-14-0058

**NEW APPLICATION**

Docket Nos. SW-02563A-14-0058

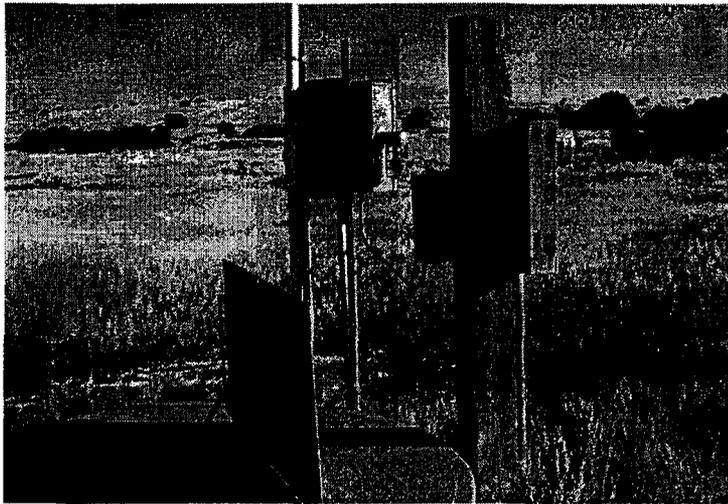
**Figure 2. Exterior of Lift Station 9A**

The lift station was generally in satisfactory condition. The wet well appeared to be holding together and is not breaking down. The lid was also not rusting. As can be seen in Figure 3, there is some rusting inside the wet well on the rails and the piping, however they seem to be functioning fine. It was assumed that the rails are not too rusted to pull the pumps as it was indicated that the pumps have not been pulled in a long period of time. It appeared that the wet well has a PVC vent that runs from the wet well, over to the control panel, and up into the air above the control panel. This vent appears to be functioning properly as the wet well is in good condition.

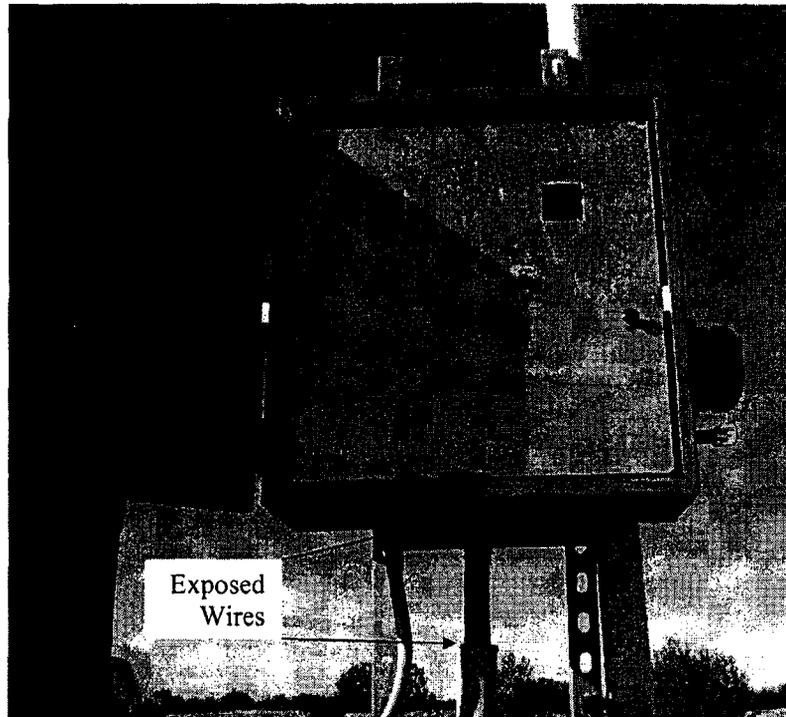
**Figure 4. Lift Station 9A Control Panel**

Figure 4 shows that there are exposed wires between the electrical conduit and the control panel. It appears the control box was raised after the construction was completed. The control panel should be lowered so that there are no exposed wires. This will help protect the wires and will also prevent the wires from rubbing on the sharp edge of the control box when the wires move, which movement can be caused from the pumps turning on and off as well as running. After the control panel is lowered to the conduit, the hole in the control panel should be sealed. This will prevent moisture from entering the control box.

A fence should be added to the lift station site to prevent people from tampering with the lift station. A sign should also be attached in a conspicuous location indicating the phone number to call in case the emergency alarm is sounding or warning light is activated.

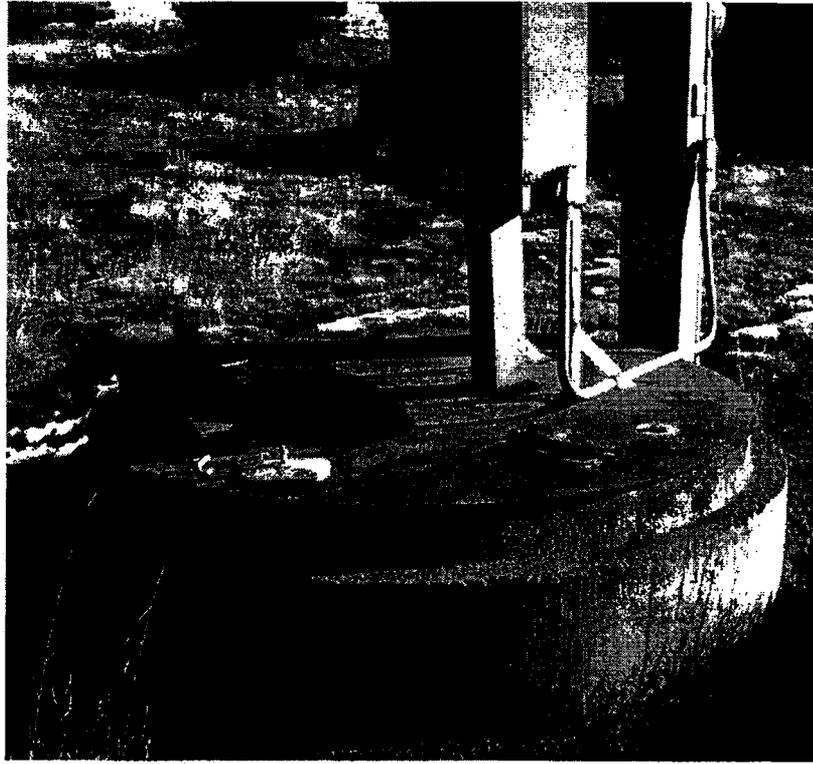
**Figure 5. Exterior of Lift Station 5B-1**

Lift station 5B-1 is located on the south side of Concho Valley Unit 5B, in between Lots 380 and 381. This lift station is constructed to have redundant pumps, however only a single pump is functioning. The force main from the wet well is a four inch (4") diameter line that runs to a gravity manhole located on Lot 388 of Concho Valley Unit 5B. The wet well is five feet (5') in diameter and has a metal top and lid. The control panel is mounted directly onto the metal top. It appears the control panel started to corrode and break away from the lid so additional bracing was added to hold the control panel up. The corrosion of the control panel post was most likely from the hydrogen sulfide gas entering the post from the wet well. The lid has a small opening for access to the wet well and the pumps. Figure 5 shows a photo of the exterior of the lift station.

As was mentioned, the access lid to the lift station is too small and should be made larger. The existing lid is also showing a great deal of corrosion. There is not a vent on the wet well to allow the hydrogen sulfide gas to exit the wet well, and a vent should be added to the wet well.

It is also recommended that the control panel be moved from off of the wet well lid and placed near the lift station. Conduit should be ran from the side of the wet well to the control panel and all wiring should be protected and should be contained in the conduit. The entrance to the conduit at the wet well should also be sealed to prevent the sewer gasses from traveling through the conduit to the control panel.

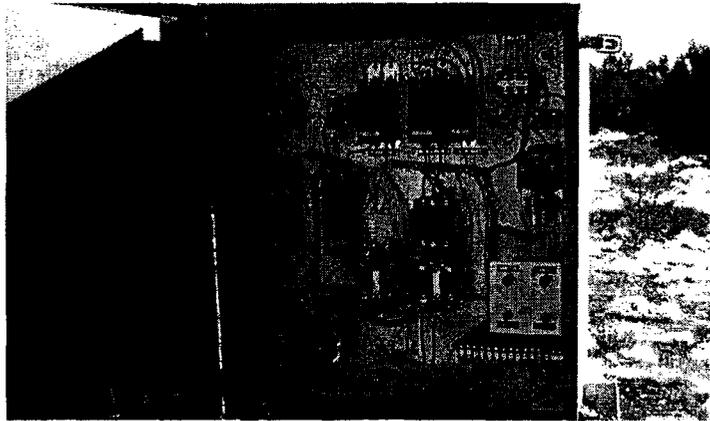
**Figure 6. Lift Station 5B-1 Control Panel**

As can be seen in Figure 6, the wiring in the control panel is in disrepair. It is recommended that an electrician be hired to check the wiring as there are many wires that are not connected. The emergency alarm on this lift station also does not operate and should be addressed.

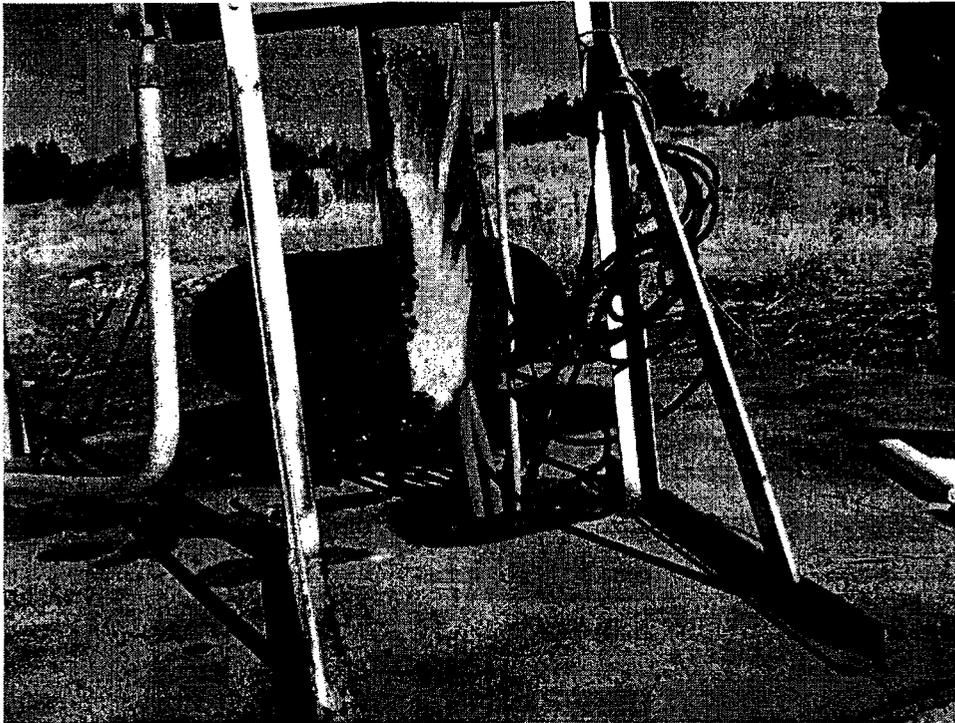
**Figure 8. Exterior of Lift Station 5B-2**

Lift station 5B-2 is located on the south side of Concho Valley Unit 5B, in the southwest corner of Lot 400. This lift station was in poor condition. The lift station also only has a single functioning pump. The force main from the wet well is a four inch (4") diameter line that runs to the same gravity manhole that Lift Station 9A flows to which is located on Lot 402 of Concho Valley Unit 5B. The wet well is five feet (5') in diameter and has a metal top and lid, similar to the lid on Lift Station 5B-1. Lift Station 5B-2 also has some of the same problems as Lift Station 5B-1.

The control panel was also mounted directly onto the metal top and has the same corrosion problems, although more severe than Lift Station 5B-1. Figure 5 shows a photo of the exterior of the lift station.

This lift station lid is also too small and should be made larger. The existing lid is also showing a great deal of corrosion, and therefore a vent should also be added to the wet well lid. It is also recommended that the control panel be moved from off of the wet well lid and placed near the lift station. Conduit should be ran from the side of the wet well to the control panel and all wiring should be protected and should be contained in the conduit. The entrance to the conduit at the wet well should also be sealed to prevent the sewer gasses from traveling through the conduit to the control panel. It appears some wiring for the float controls has been pulled through the hole in the lift station lid that allows the

wiring to enter the control panel. These float control wires should be in the wet well or in conduit for protection. They should not be opened to the elements.

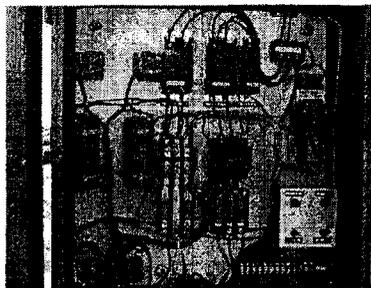
**Figure 9. Lift Station 5B-2 Control Panel**

As can be seen in Figure 9, the wiring in the control panel is in fair condition, however it was reported that the warning alarm does not work at this lift station. It is recommended that an electrician be hired to address this problem. A sign should also be attached in a conspicuous location indicating the phone number to call in case the emergency alarm is sounding. A fence should also be installed to prohibit tampering and damage of the lift station.

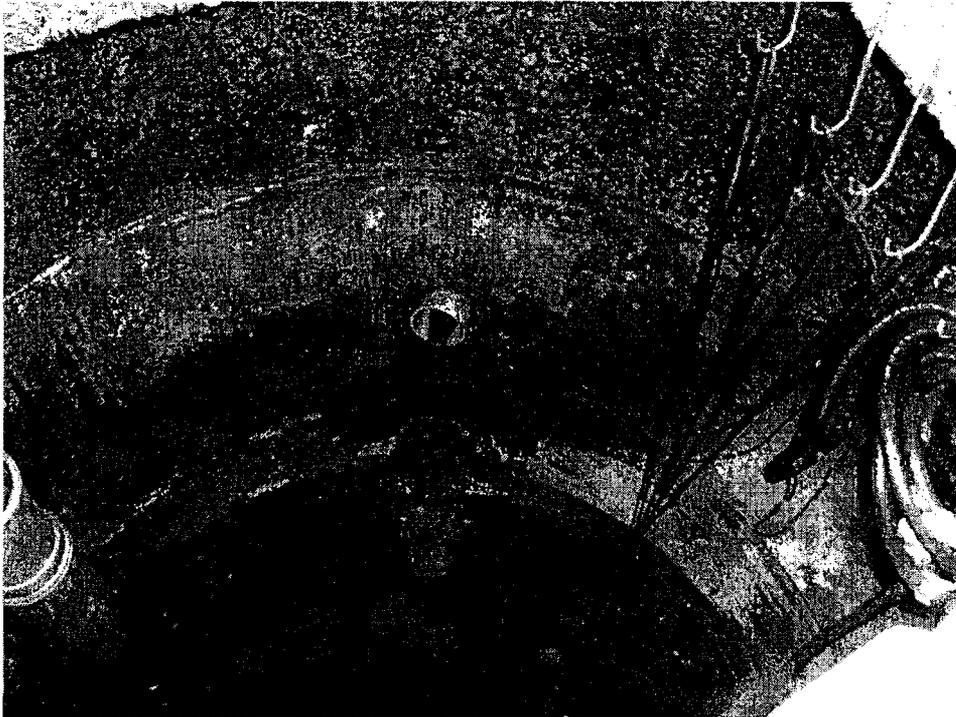
**Figure 13. Interior of Golf Course Lift Station**

The control panel appears to be in good shape. It was reported that the alarms on the lift station do not work. It is recommended that the alarms be fixed to give a warning if the lift station does not operate correctly. A sign should also be added to the site indicating a phone number to call when the alarm is warning.

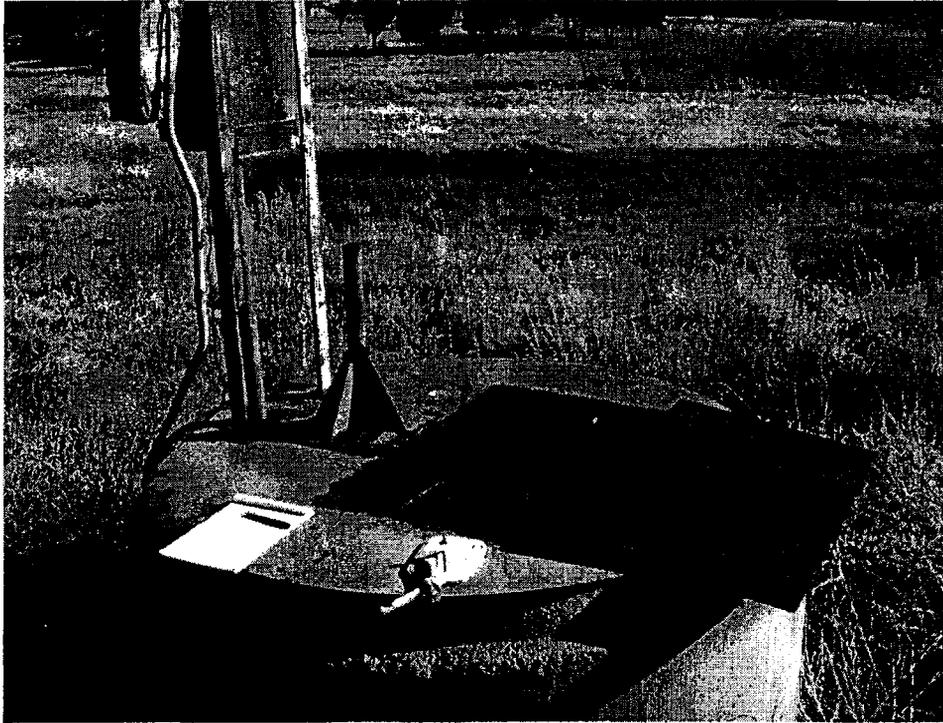
**Figure 15. Exterior of Motel Lift Station**

The Motel Lift Station is located southeast of the Concho Motel. The lift station handles sewer flows from Concho Valley Unit 1B and the Club House. The wet well is five feet (5') in diameter and was reported to only have a single functioning 2 HP pump. The force main from the wet well is a four inch (4") diameter line that runs to a gravity manhole located on the west side of Concho Valley Unit 5A. The wet well has a metal top and lid. The control panel is mounted directly onto the metal top; however it doesn't appear that

the mounting pole of the panel has corroded much. This lift station also has a hoist base that can be utilized to lift the pumps from the wet well. Figure 15 shows a photo of the exterior of the lift station.

The existing lid is also showing a great deal of corrosion. There is also not a vent on this wet well to allow the hydrogen sulfide gasses to exit, but should be added to the wet well.

It is also recommended that the control panel be moved from off of the wet well lid and be placed near the lift station. Conduit should be ran from the side of the wet well to the control panel. Special care should be made to install all wiring in conduit to provide protection. As can be seen in Figure 15, there are wires that are exposed. The entrance to the conduit at the wet well should also be sealed to prevent the sewer gasses from traveling through the conduit to the control panel.

It was also reported that the emergency alarm on this lift station does not work. This problem should also be corrected. Also, there is no fence installed to prohibit tampering of the lift station. It is recommended that a fence be installed to prevent damage to the lift station. A sign should also be attached in a conspicuous location indicating the phone number to call in case the emergency alarm is sounding.

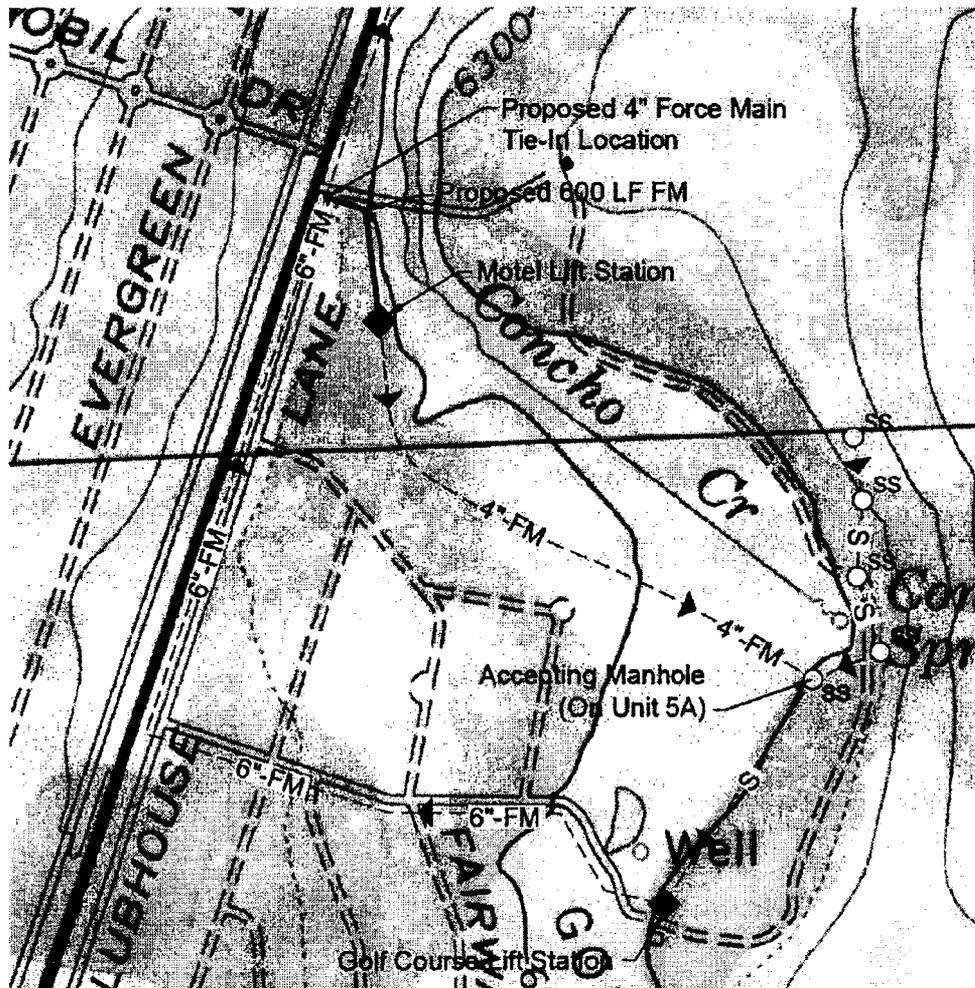
Figure 16. Possible Force Main Location

As previously mentioned, the Motel Lift Station pumps sewer through a four-inch (4") force main to an existing manhole located in Concho Valley Unit 5A. This sewer in this manhole then gravity flows to the south to the Golf Course Lift Station. The Golf Course Lift Station then pumps the sewer to the west to the right-of-way of Highway 61. The sewer continues north, parallel to Highway 61, and past the Concho Hotel and eventually to the Main Lift Station in Concho. To reduce pumping costs, a new four-inch (4") force main should be installed from the Motel Lift Station, northward to County Road 5100 and then west over to connect to the existing force main located in the right-of-way of Highway 61. This would decrease Golf Course Lift Station operating costs. This would require approximately 600 linear feet of four-inch (4") force main be installed. The approximate location of the proposed force main is shown in Figure 16. This line would need to be designed and constructed to prevent backflow into the Motel Lift Station.

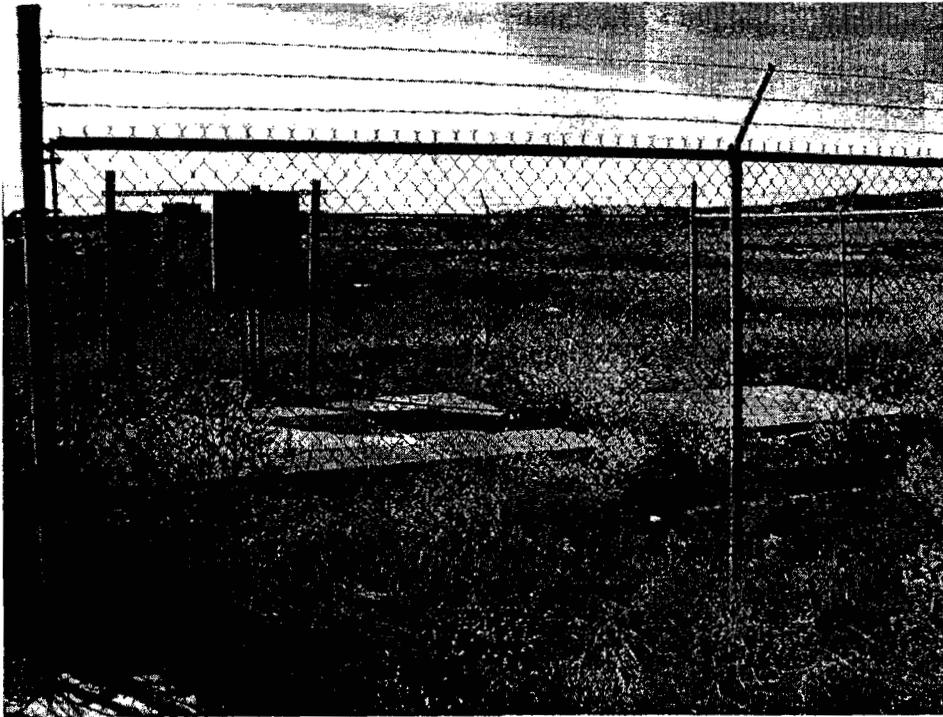
**Figure 17. Exterior of Main Lift Station**

The Main Lift Station is located west of Concho itself and on the south side of County Road 5020 (Snowflake Highway). This lift station accepts flows from the Golf Course Lift Station, which is approximately 359 feet higher in elevation than the Main Lift Station. The sewer is delivered to the Main Lift Station via force main and gravity line. The Main Lift Station has an eight foot (8') diameter wet well with two (2) 20 HP pumps. The Main Lift Station has an eight-inch (8") diameter force main and sends flows to the treatment facility site. Generally, the lift station is in fair condition. The lift station is configured with a wet well chamber as well as a separate valve vault for the force main. Figure 17 shows a photo of the exterior of the lift station.

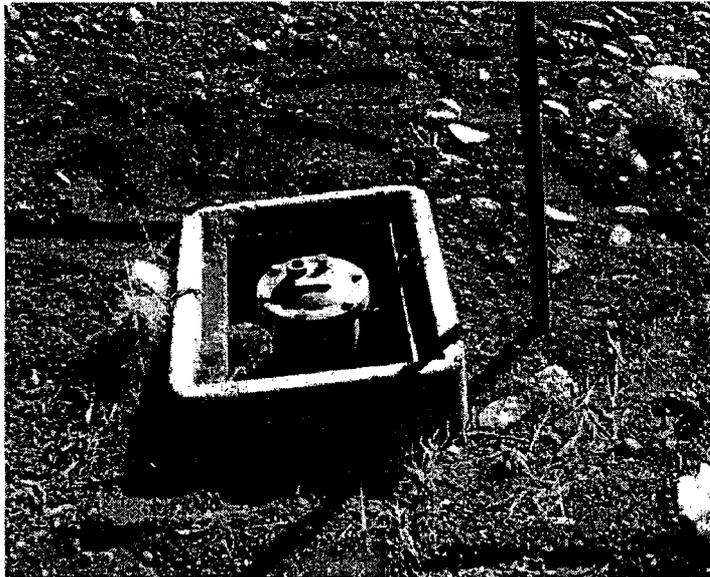
**Figure 22. Air Relief Valve**

Based on the construction plans, there appear to be many air relief valves (ARV) in the system. One ARV was observed. The valve was located in a concrete box, and the top of the valve was above the box. There was also a metal pole, indicating the location of the valve. A photo of the valve is shown in Figure 22.

It is suggested that the valve be protected. A higher box is required that can be installed above the valve so that the lid can be placed over the valve. It was not known if the valve was working. The valve should also be checked to make sure that it is allowing air out of the force main. All of the valves in the system should be examined to determine if the same corrective measures are necessary for them as well.

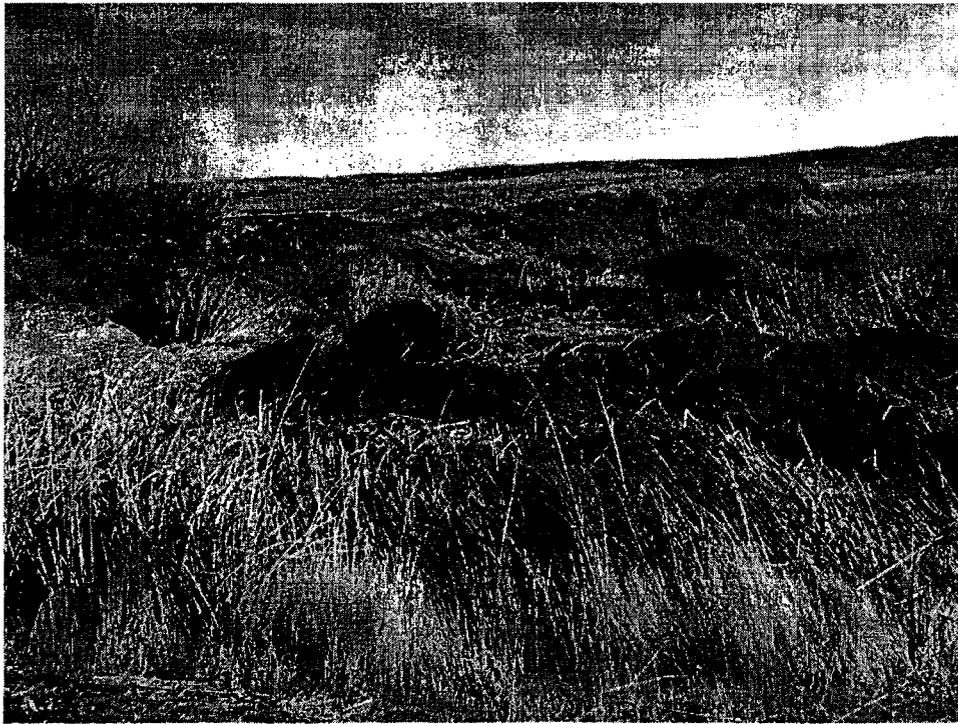
**Figure 23. Settling Pond - Lagoon**

Based on the Design Report which was completed by Shreeve & Associates, Inc. in 1991, the treatment site was designed with three (3) components. They consist of a settling pond or lagoon, wetland, and reuse area. The treatment plant was designed for the influent to be receive primary treatment by entering the settling pond and allowing the solids to settle to the bottom of the pond. Then the effluent will enter wetland cells for further treatment. There have been two (2) cells constructed for treatment of up to 20,000 gpd. From the wetlands, the effluent will enter the chlorine contact chamber for further treatment, and then be sent to the reuse area for disposal. It is apparent that the treatment site has not recently received enough flows to allow the settling pond to fill and flow over into the wetlands areas. Because of the small flows, the influent has entered into the settling pond and has been treated there instead of the wetlands. As can be seen in Figure 23, a great deal of vegetation has grown in the settling pond.

The settling pond (lagoon) was designed to allow a detention time between five (5) to ten (10) days to provide time for the solids to settle out of the influent. Based on the Aquifer Protection Permit (APP) number P-102422, the settling pond was designed to have an 18" clay liner. The substantial vegetation root system could penetrate the liner and allow the effluent to flow below the liner and enter the groundwater, which could at some point, show up in the groundwater. Also, based on Part II.A.3 in the APP on page 2 of 27, the accumulated sludge in the pond shall be removed to obtain the required operating depth in

the pond, but at least every five (5) years. Because the flows to the pond are so small compared to the design flow, there most likely has not been a large amount of sludge build up in the pond, however ADEQ may have an issue with this in the future.
