**Report on 2005 Service Interruptions to
Customers of Circle City Water Co., L.L.C.**

**Report on the 2005 Service Interruptions to
Customers of Circle City Water Co., L.L.C.**

**In the Matter of the Application of Circle City
Water Co., L.L.C. for an Extension of
It's Certificate of Convenience and
Necessity for Water Service**

ACC Docket No. W-03510A-05-0146

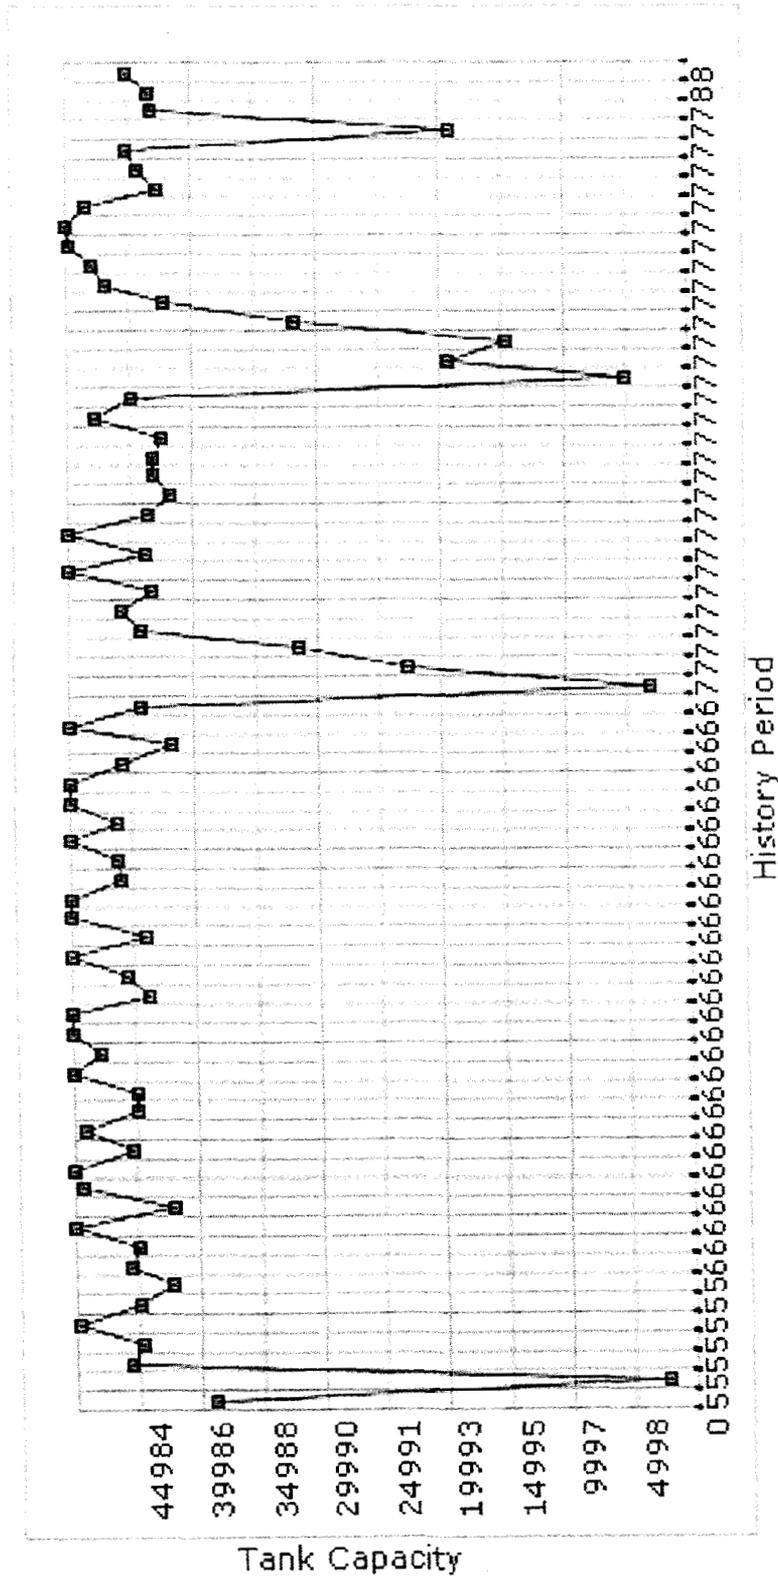
Circle City Water Co. - RMU Device; Daily Reads at ~ 0500 Hours
- May 23 through August 2, 2005

As discussed below and as can be see on attached Exhibit 1 water customers of CCWCoLLC have experienced low water supplies and corresponding reduced pressure on the following dates ("Incident Dates") in 2005:

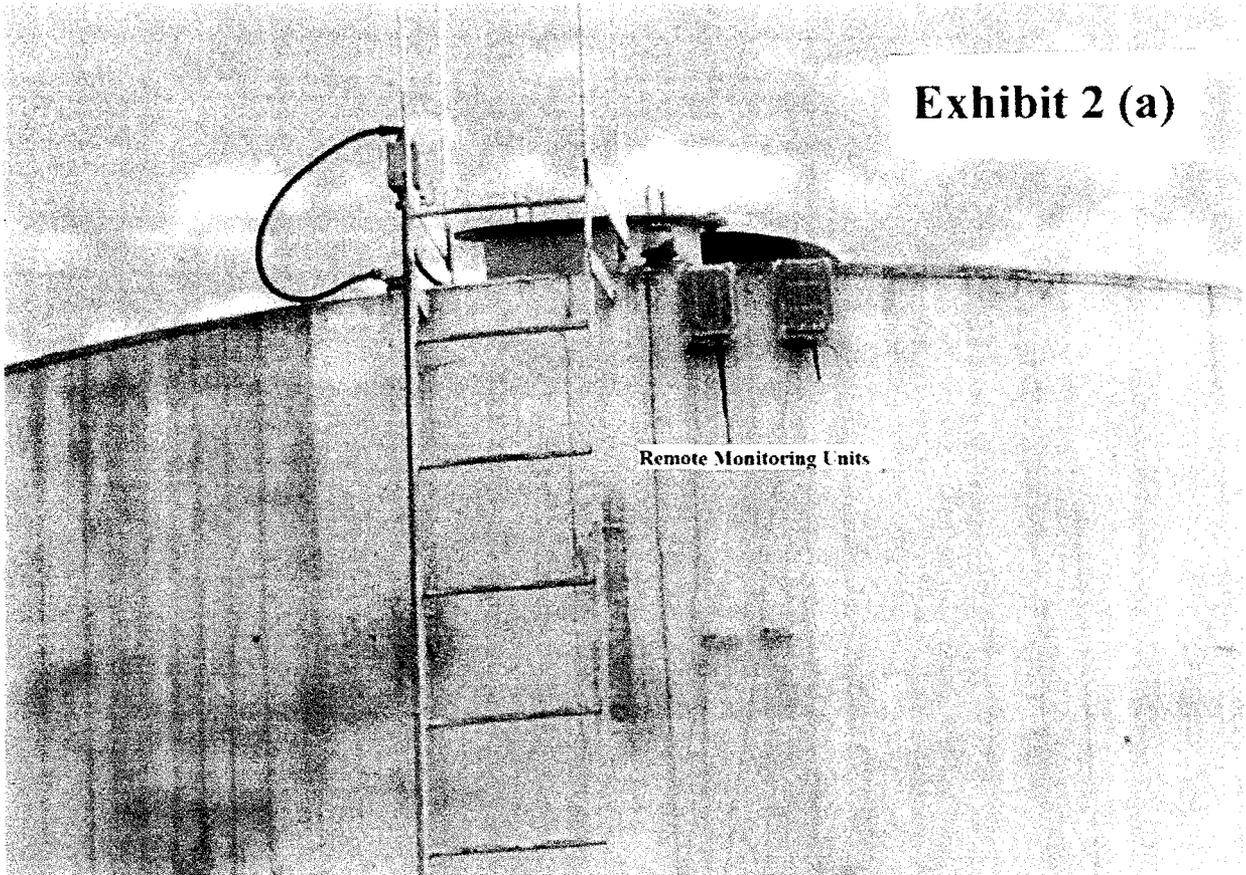
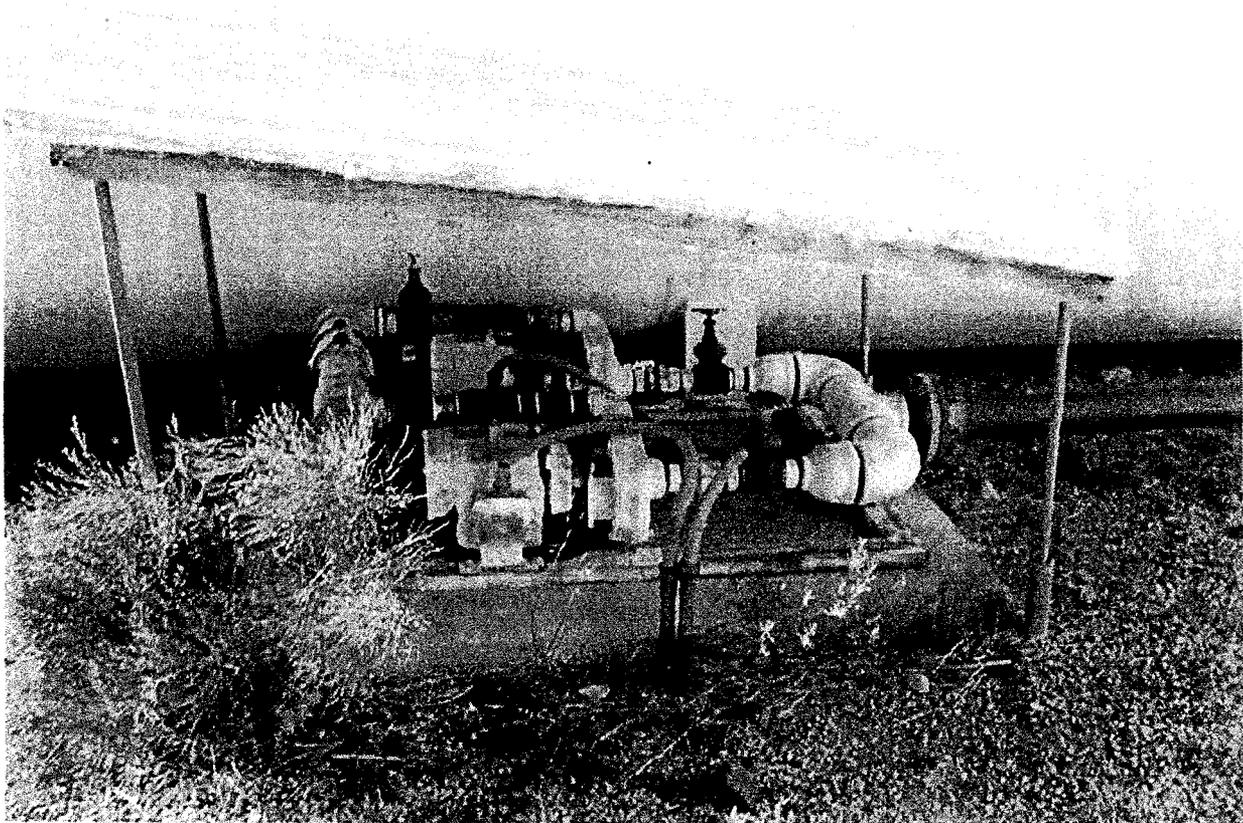
Exhibit 2 (a)

Circle City Booster Station

⁶ RMU's are powered by solar batteries and communicate once daily through CDMA packet cellular networks (see Exhibit 2 for RMU's mounted on CCWCoLLC water storage tanks). BUI accesses a secured Internet site that is password protected for internal operations only.

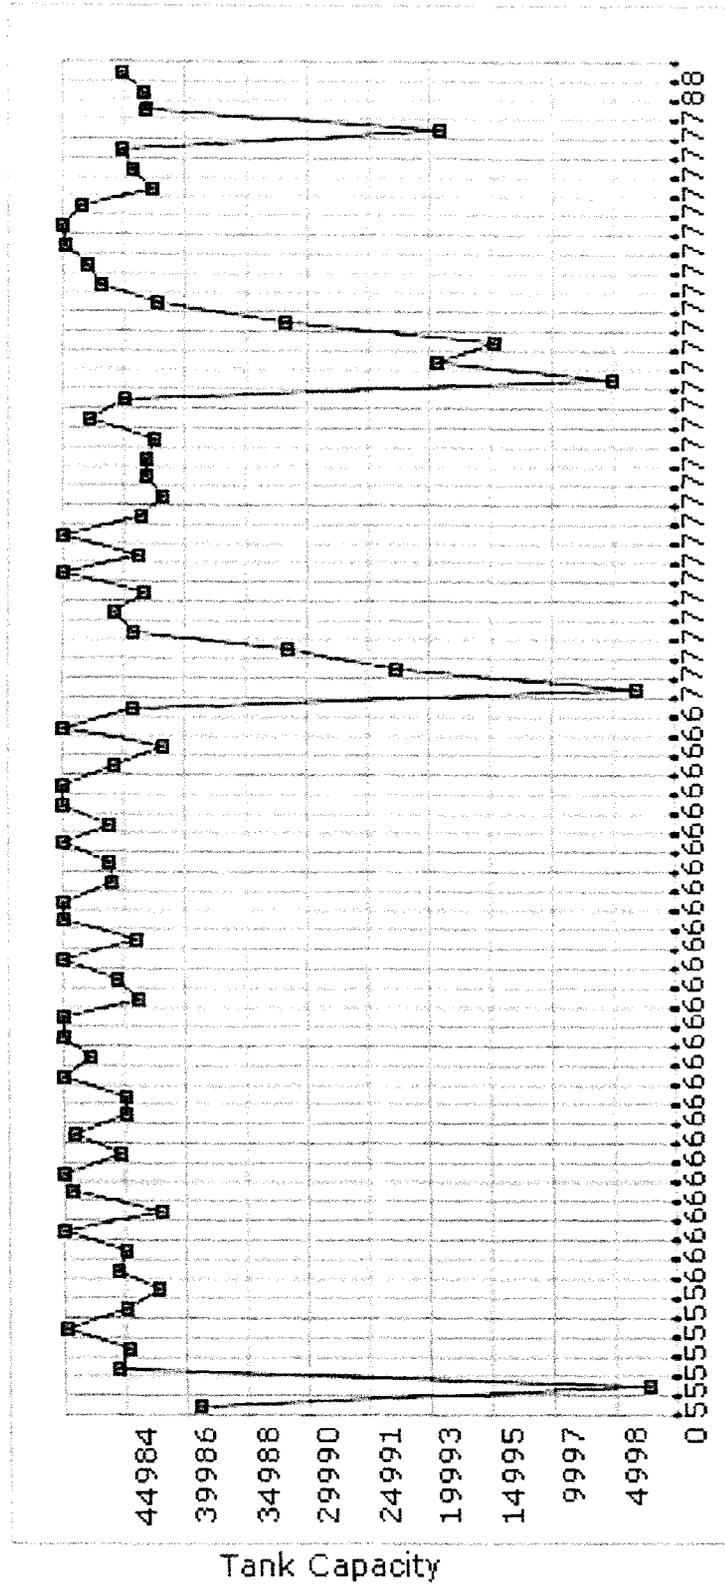
Circle City Water Co. – RMU Device; Daily Reads at ~ 0500 Hours
- May 23 through August 2, 2005

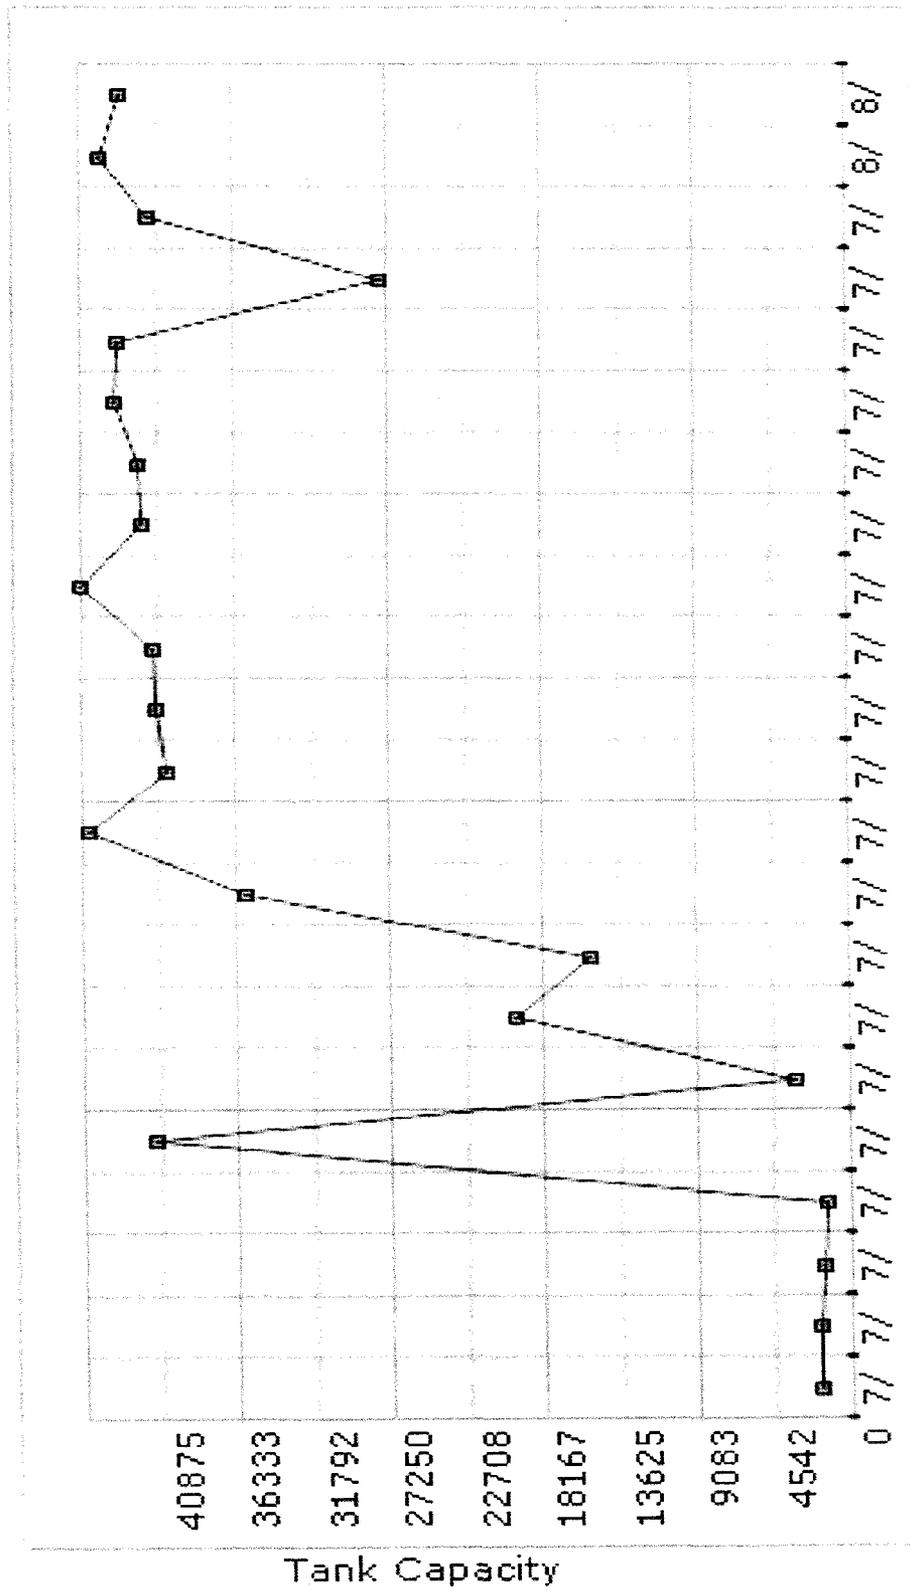
Circle City Water Co. – RMU Device #2; Daily Reads at ~ 1300 Hours
 - July 12 through August 2, 2005

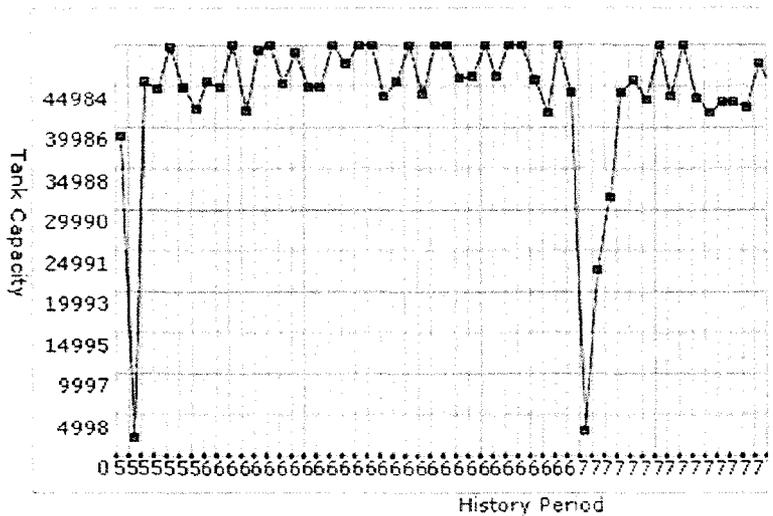
Graphical View

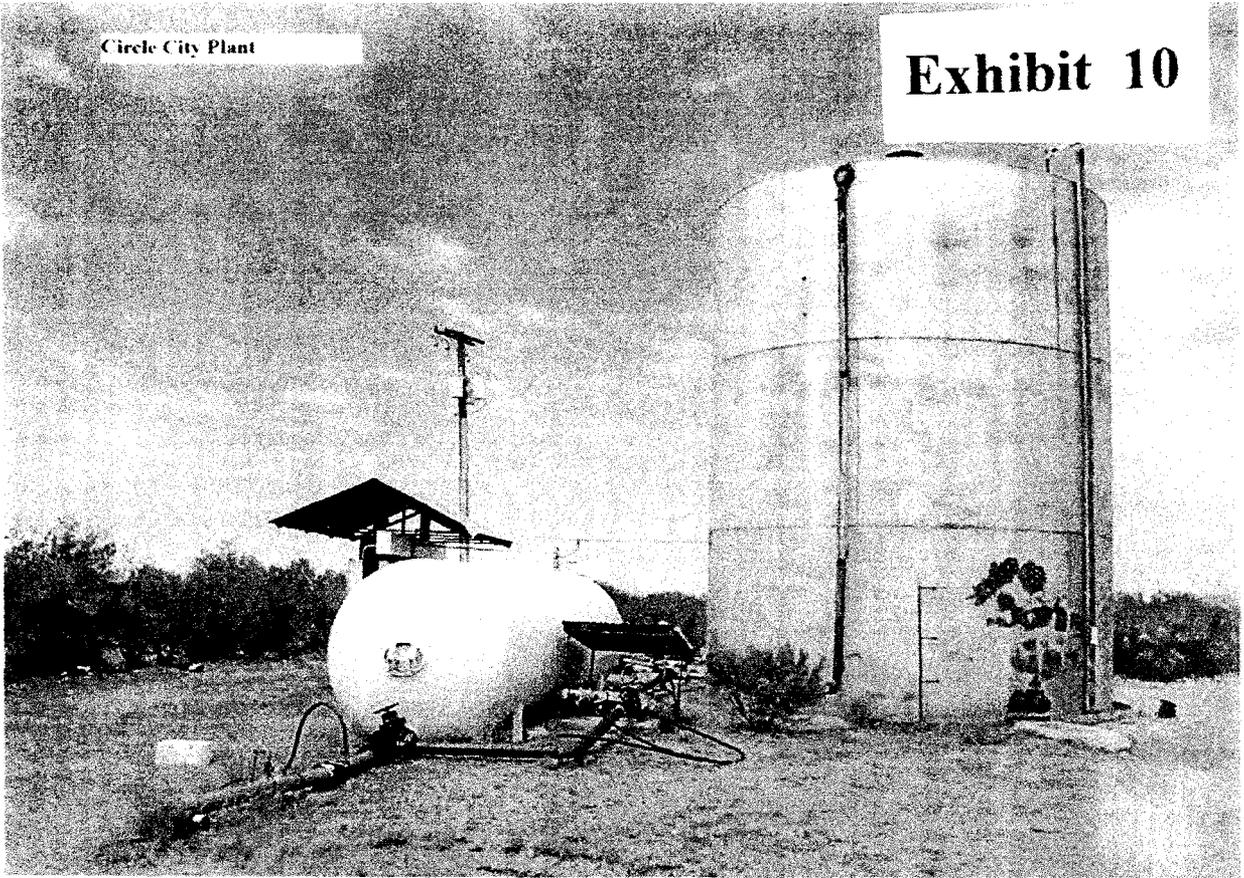
Exhibit 10

Circle City Plant

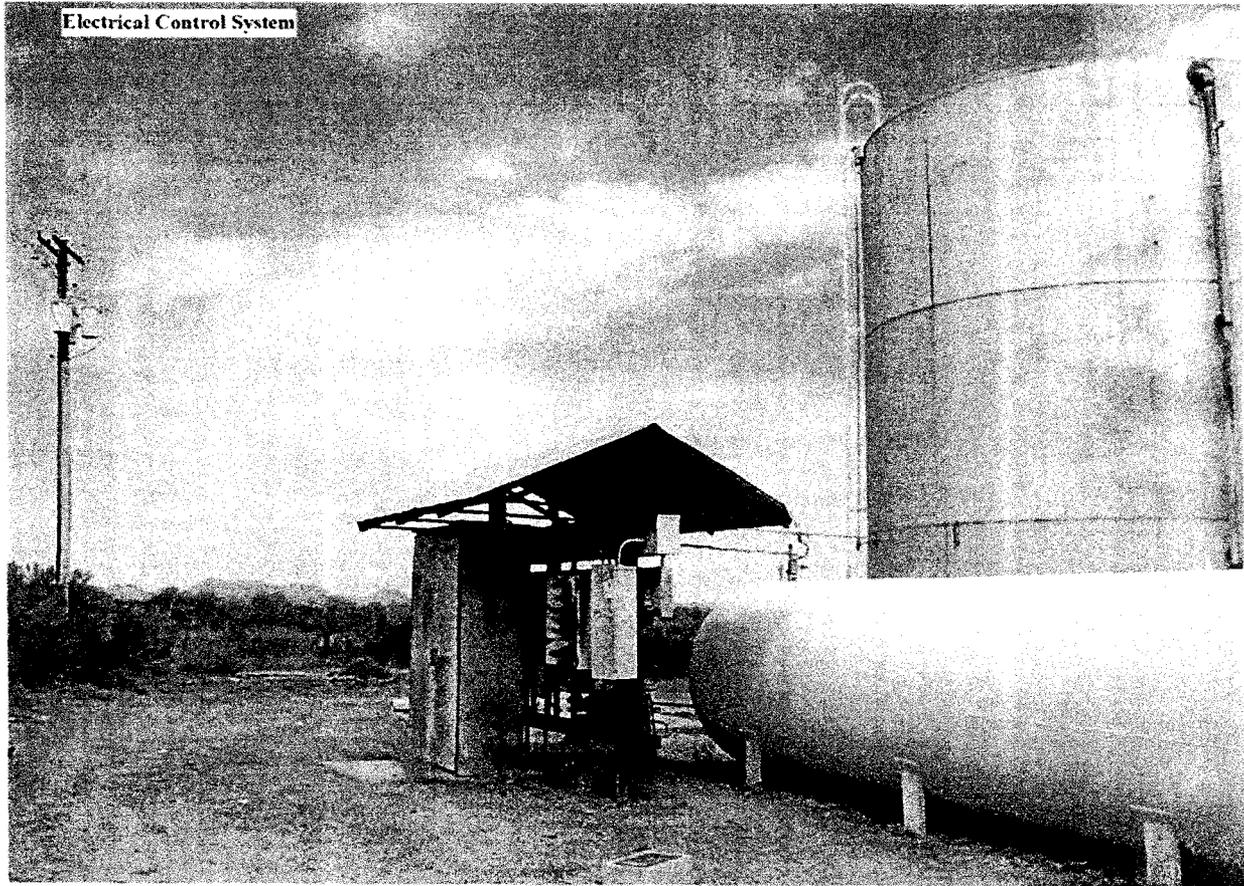
Electrical Control System

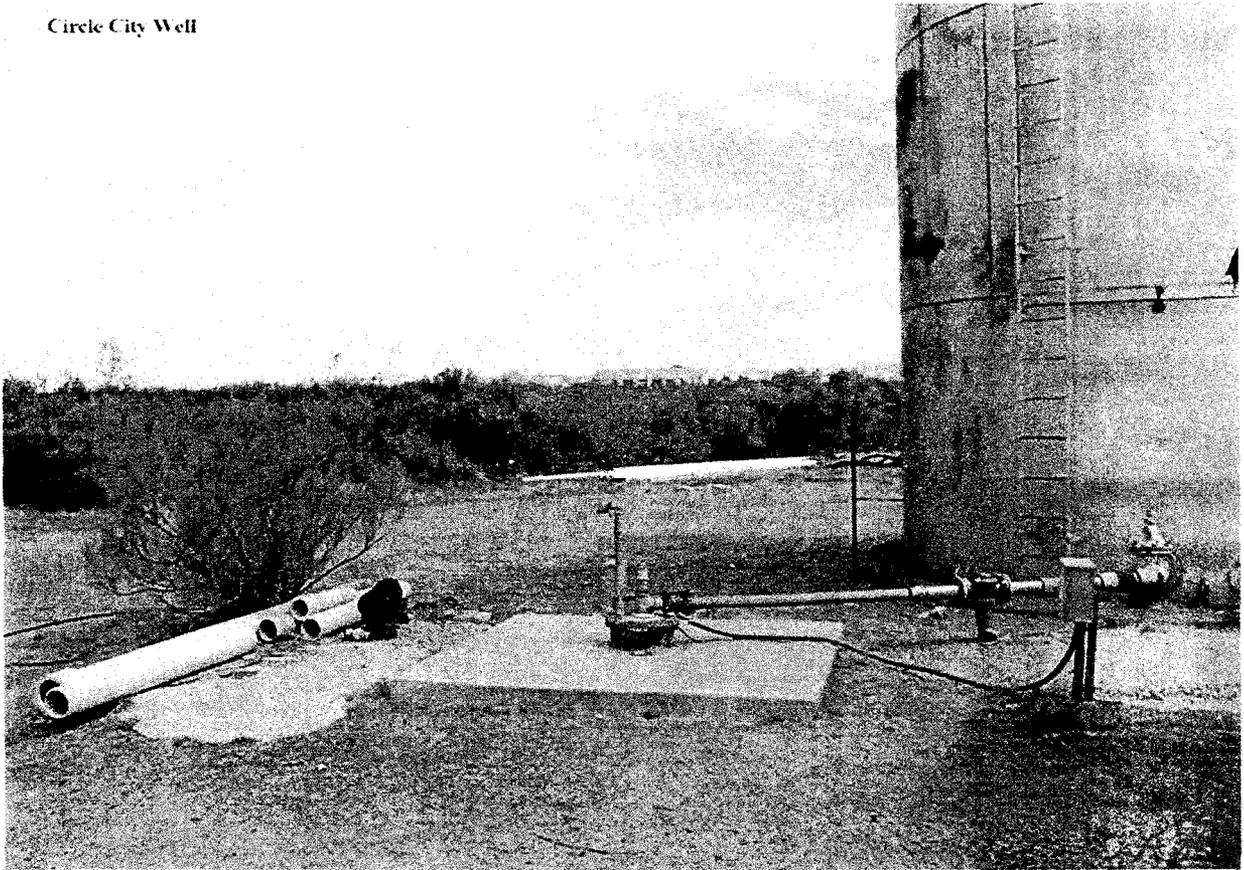
Circle City Well

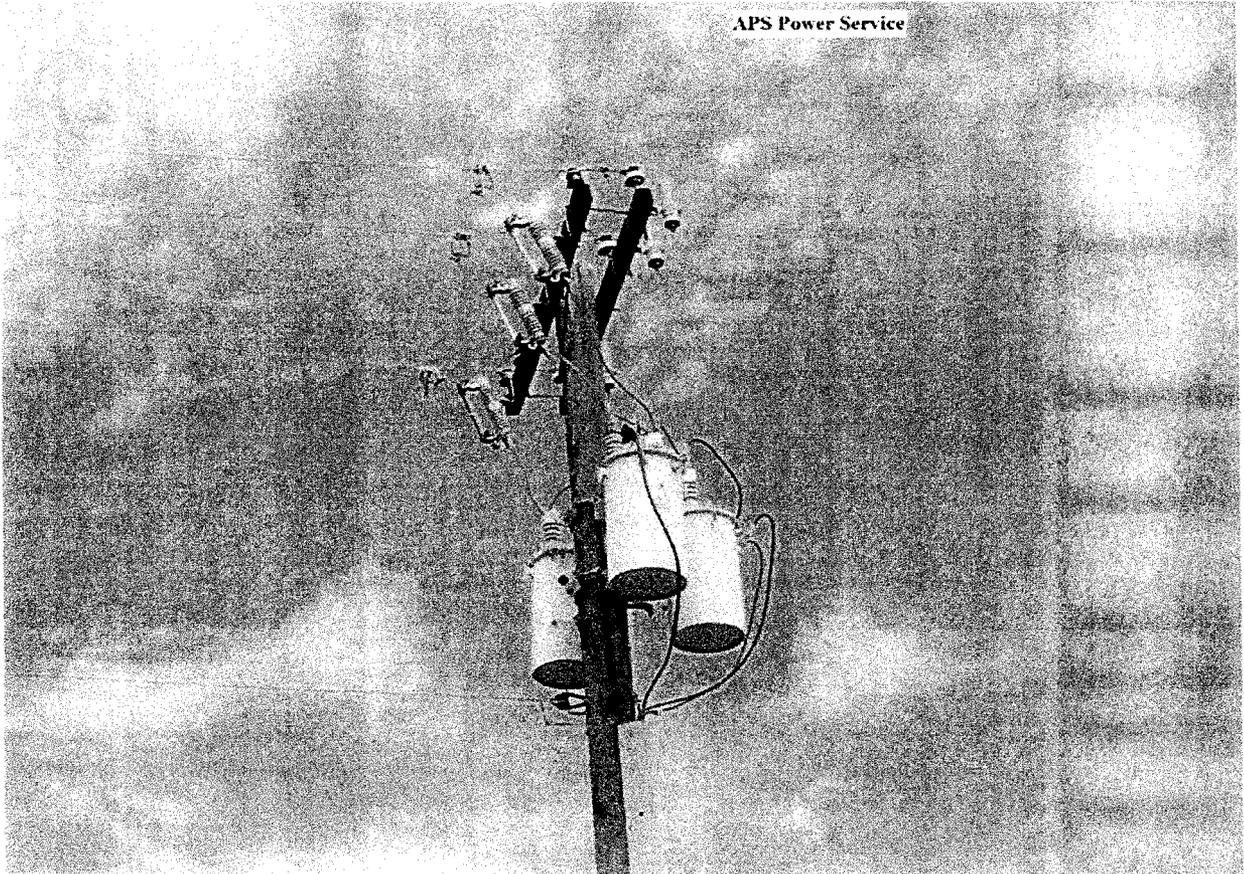
APS Power Service

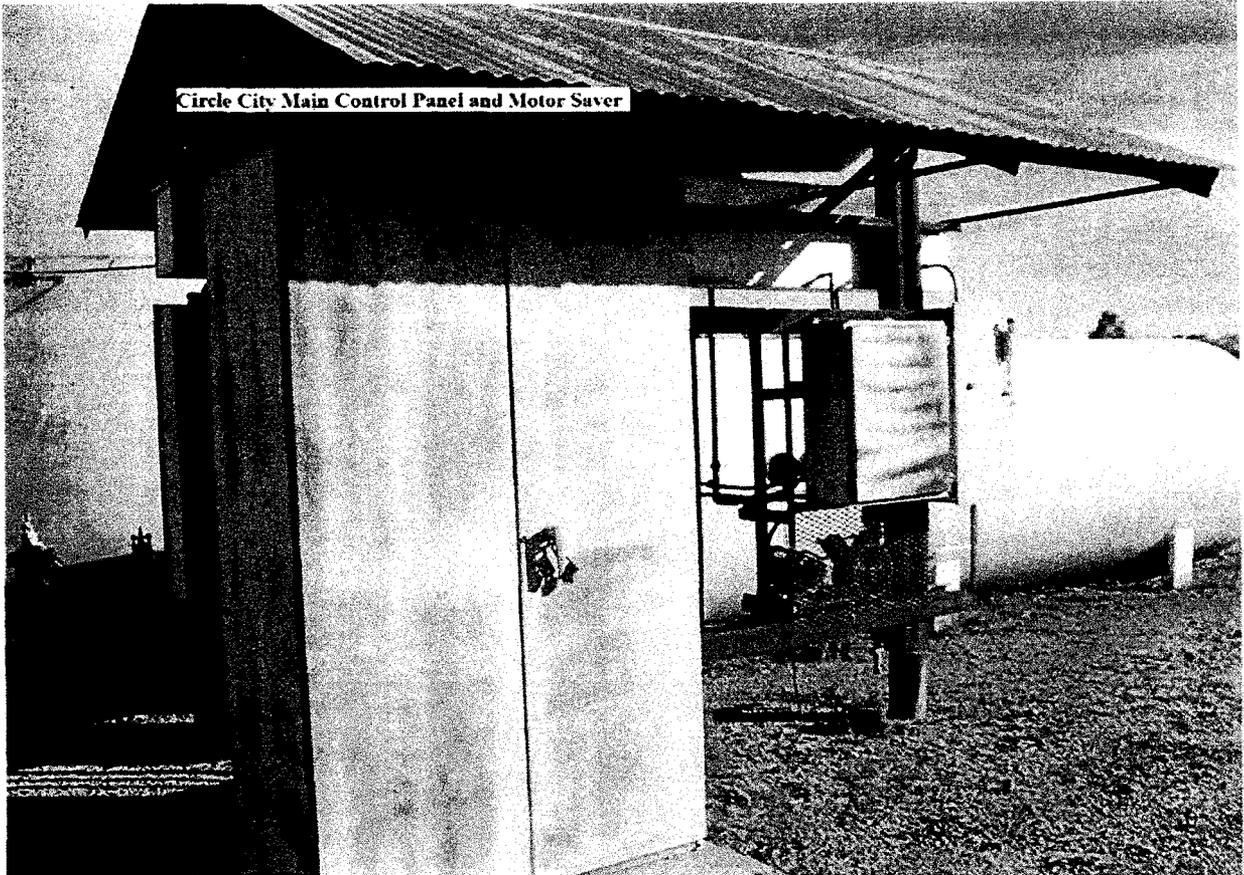
Circle City Main Control Panel and Motor Saver

³ A motor saver is the commercial, high voltage equivalent of a circuit breaker. When electrical utility operating ranges are below or above the normal operating range of the power demand of the system the motor saver "trips" itself into an "off" condition preventing damage to the electrical components connected to the system.

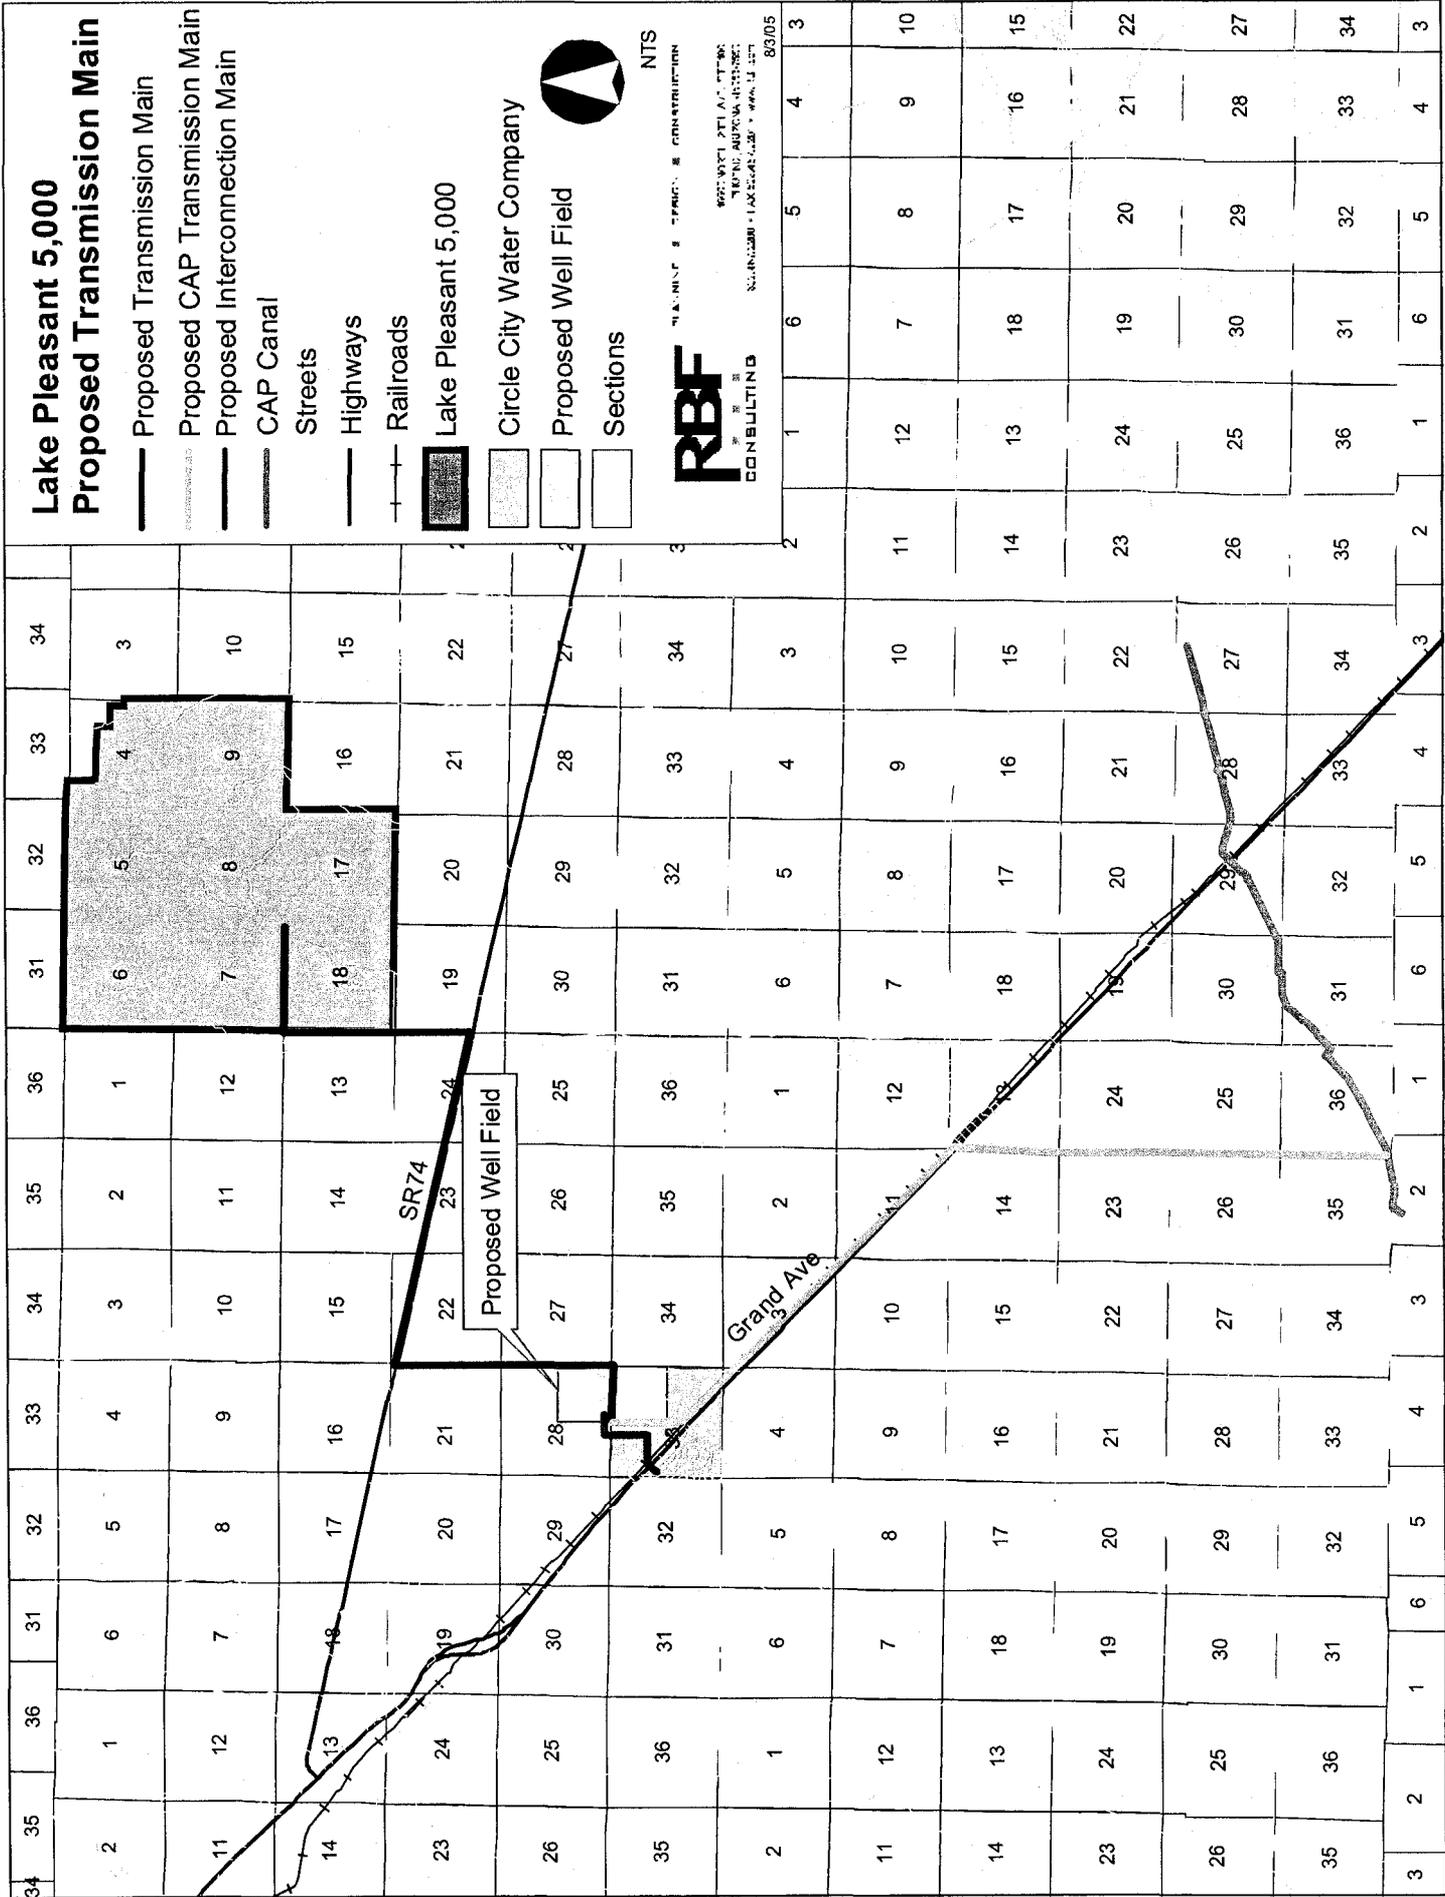
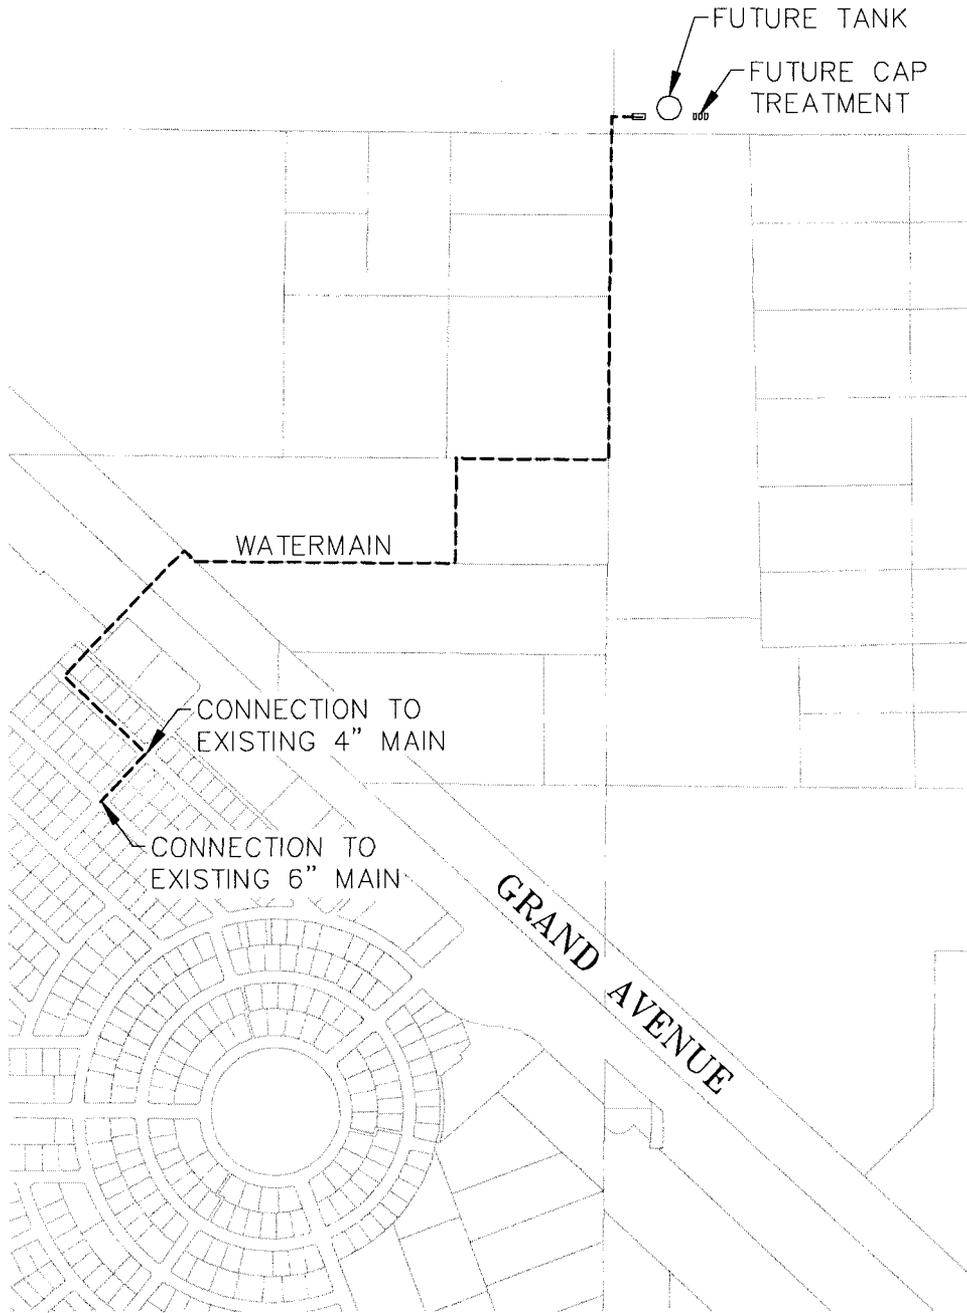
Appendix C Lake Pleasant 5,000/Circle City Interconnection Exhibit

LAKE PLEASANT 5,000/CIRCLE CITY INTERCONNECTION EXHIBIT
