**NOTICE OF FILING LATE FILED
EXHIBIT**

**Report on 2005 Service Interruptions to
Customers of Circle City Water Co., L.L.C.**

**Report on the 2005 Service Interruptions to
Customers of Circle City Water Co., L.L.C.**

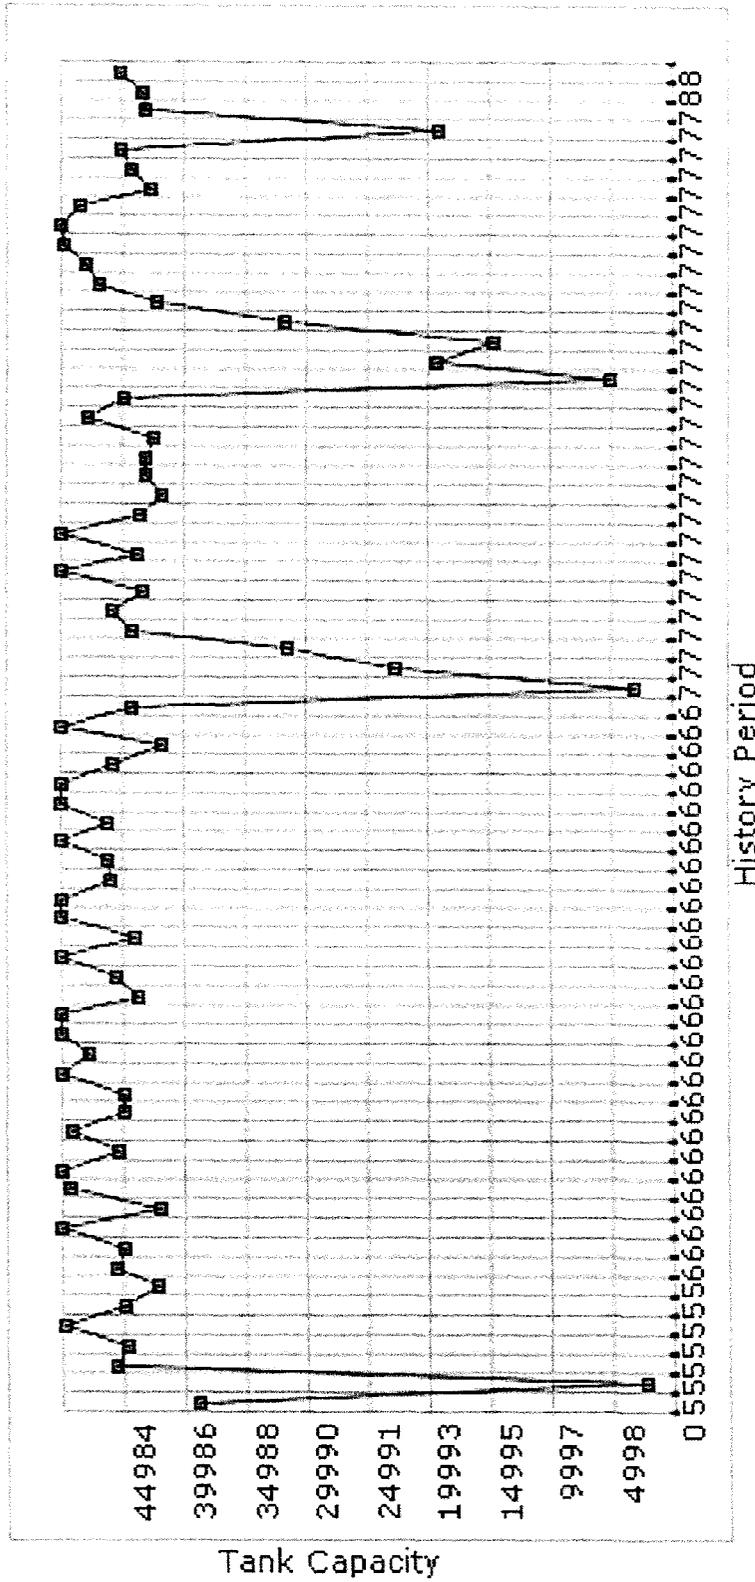
Circle City Water Co. - RMU Device: Daily Reads at ~ 0500 Hours
- May 23 through August 2, 2005

As discussed below and as can be see on attached Exhibit 1 water customers of CCWCoLLC have experienced low water supplies and corresponding reduced pressure on the following dates ("Incident Dates") in 2005:

- May 23
- June 13
- June 15
- July 1
- July 17
- July 31

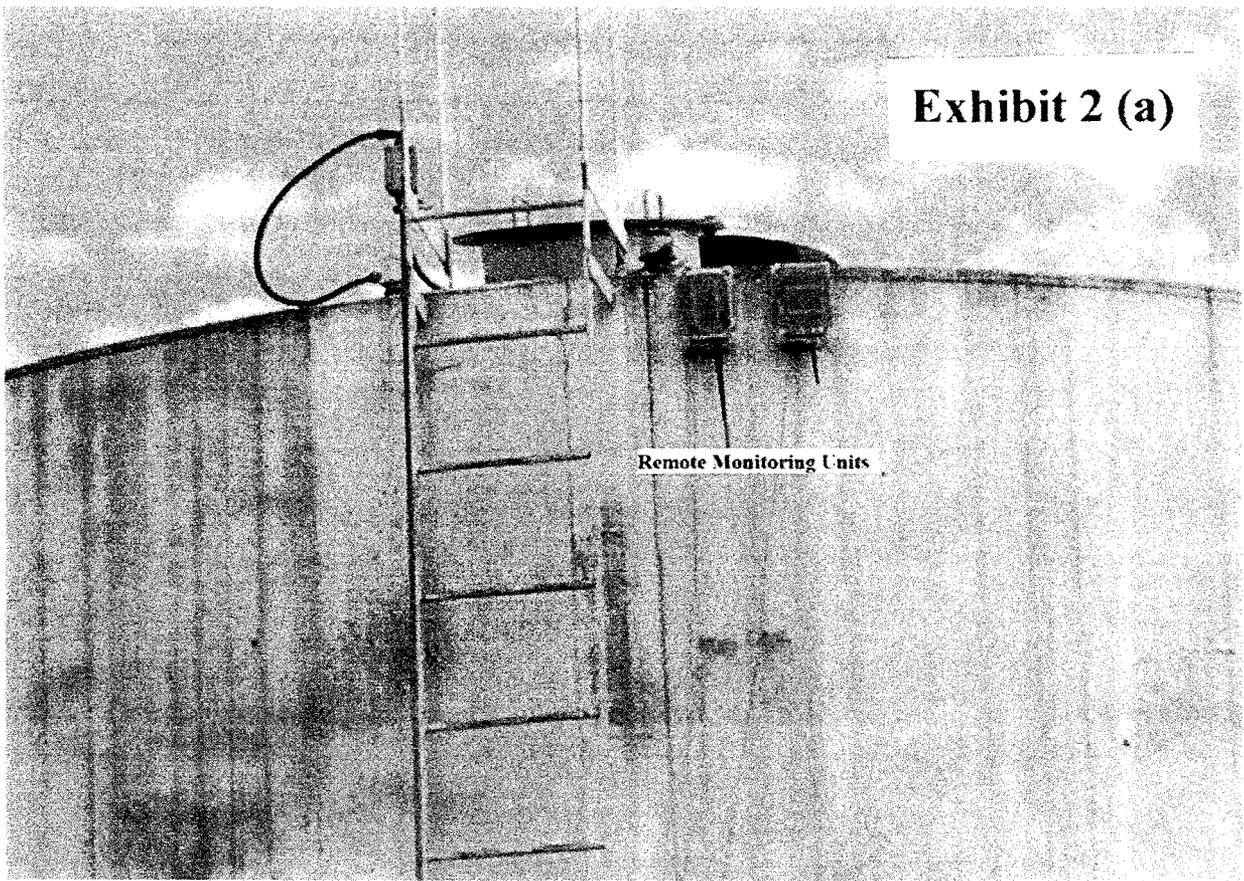
Exhibit 2 (a)

⁶ RMU's are powered by solar batteries and communicate once daily through CDMA packet cellular networks (see Exhibit 2 for RMU's mounted on CCWCoLLC water storage tanks). BUI accesses a secured Internet site that is password protected for internal operations only.

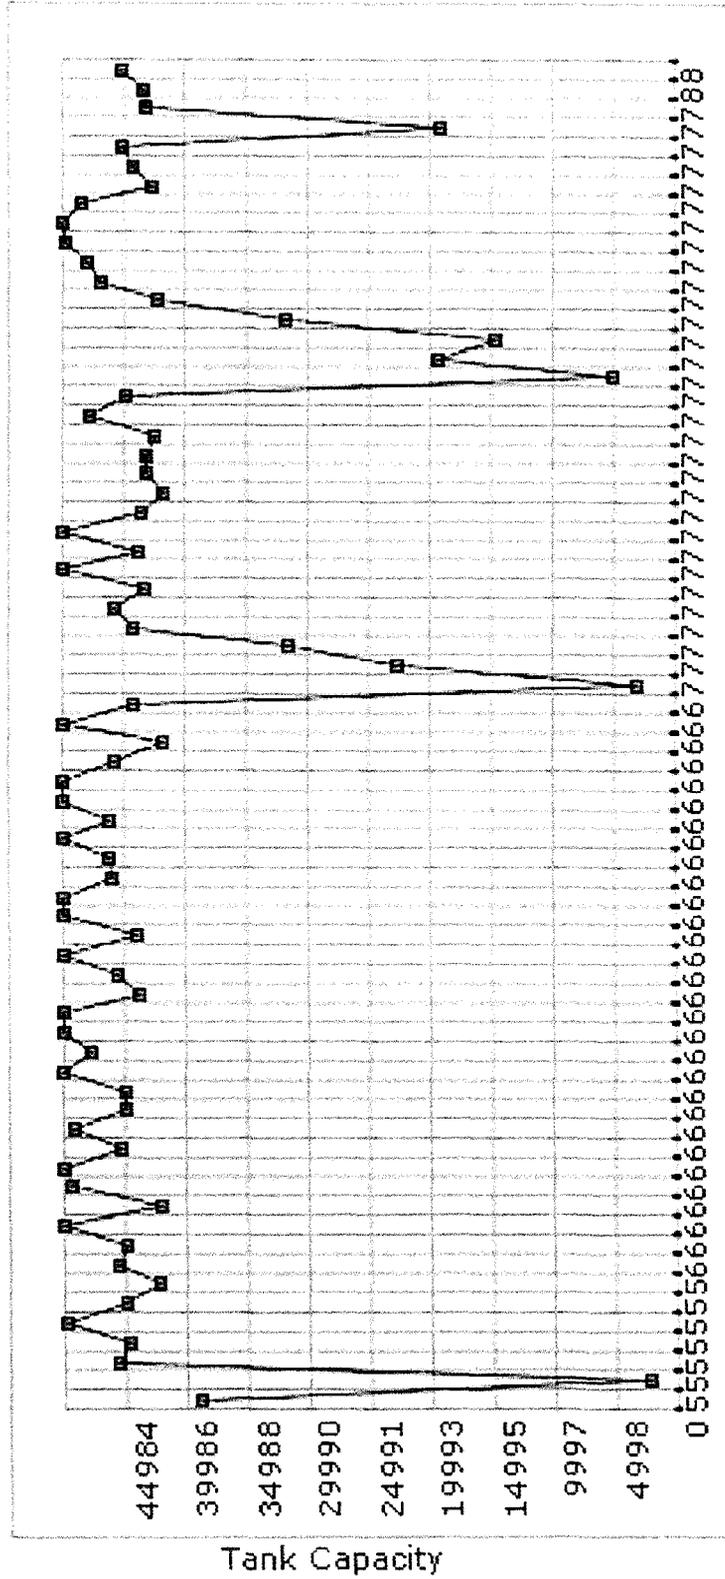
Circle City Water Co. – RMU Device; Daily Reads at ~ 0500 Hours
- May 23 through August 2, 2005

RMU's also provide a wealth of other important operating data. For example, the first and second RMU's provide graphical historical content of the water storage levels at the prescribed "read" times daily (see Exhibit 4 and Exhibit 5). This information also resolves customer disputes as to the dates of service interruptions based on low water storage levels. The RMU's also provide important operational data including tank capacity, high and low storage alarm levels, current water level, average daily use, and days to empty. The Internet site can also be prompted to provide total gallons used, average daily usage, maximum daily usage, average inventory, average fill volumes, last fill date and time, and a day-by-day schedule of tank level reads between prescribed dates (see Exhibit 6 and Exhibit 7).

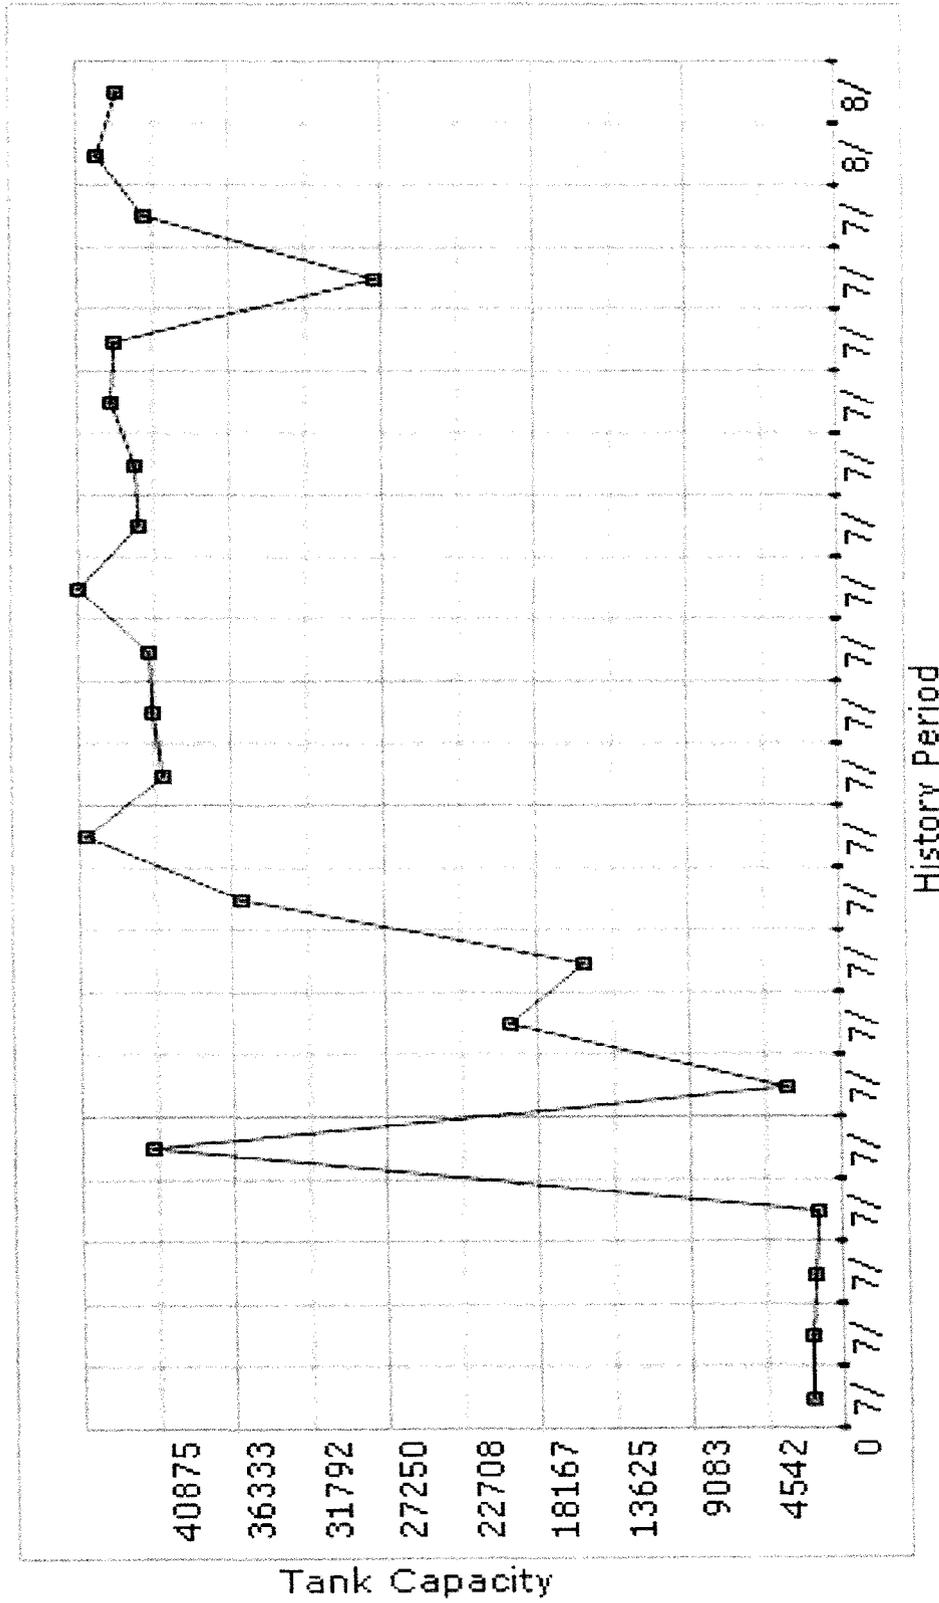
Circle City Water Co. – RMU Device #2; Daily Reads at ~ 1300 Hours
 - July 12 through August 2, 2005

Two RMU's are installed on the water storage tank at CCWCoLLC. The first RMU is scheduled to "read" water storage levels at approximately 0500 hours daily. This RMU was first installed on May 27, in response to and, after the first Incident Date. The second RMU is scheduled to "read" water storage levels at approximately 1300 hours daily. This RMU was first installed on July 12, in response to and, after subsequent Incident Dates. CCWCoLLC concluded that the repeated occurrence of low water levels due to electrical utility variances was sufficiently important to justify the installation of the second RMU so that better operational response could be provided.

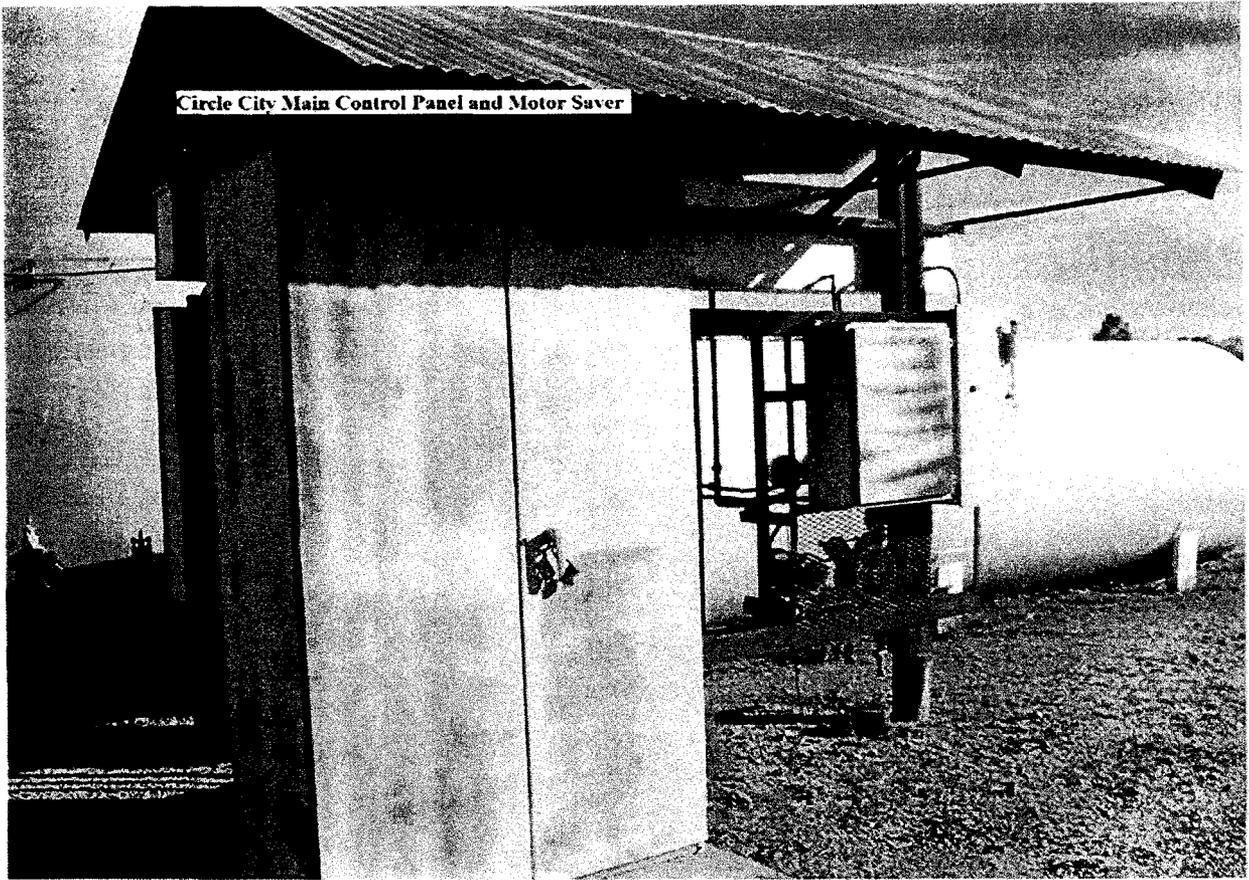
Circle City Main Control Panel and Motor Saver

³ A motor saver is the commercial, high voltage equivalent of a circuit breaker. When electrical utility operating ranges are below or above the normal operating range of the power demand of the system the motor saver "trips" itself into an "off" condition preventing damage to the electrical components connected to the system.

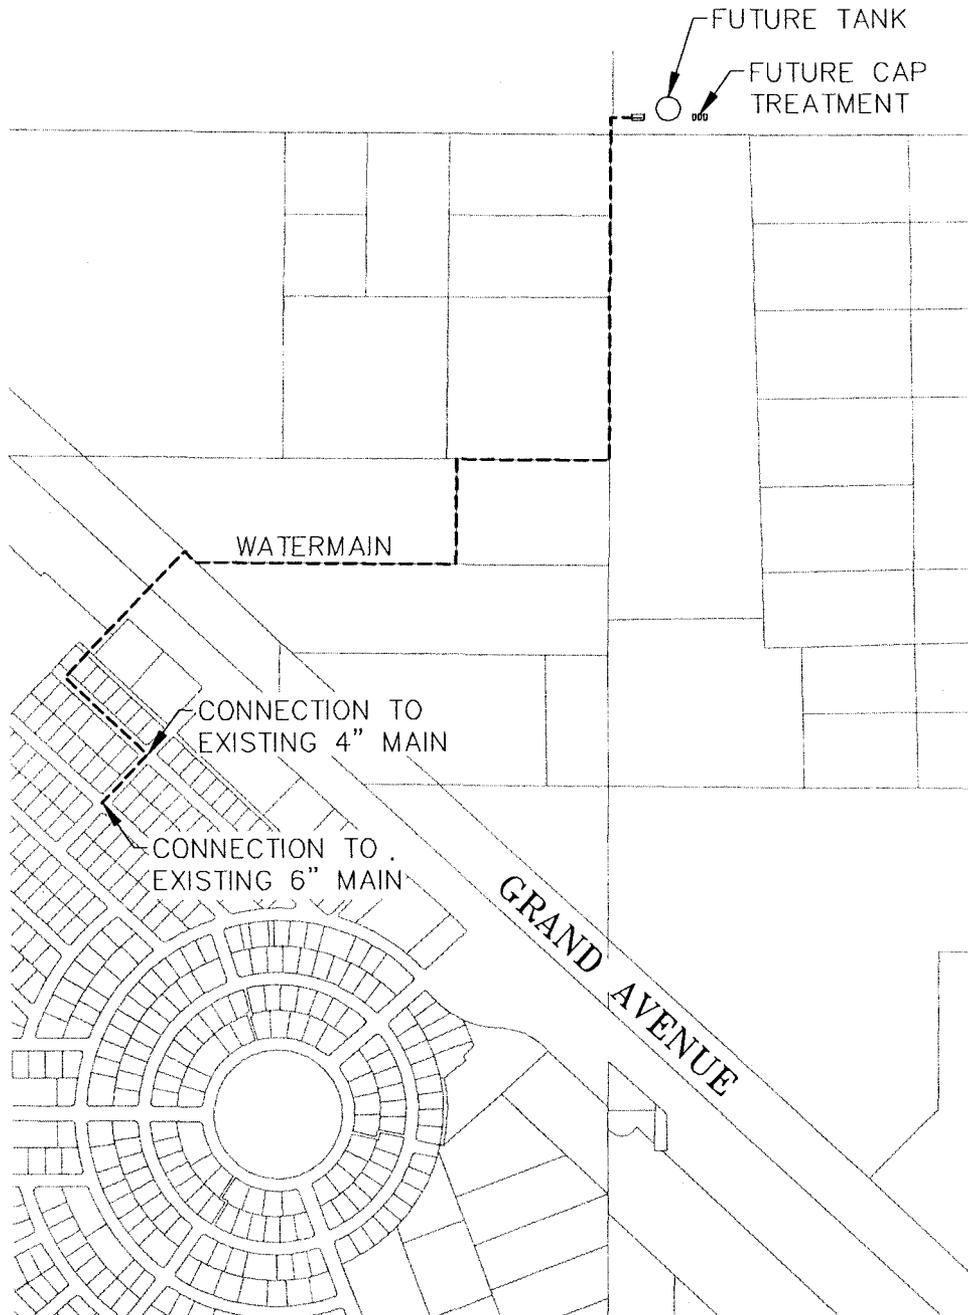
Appendix C Lake Pleasant 5,000/Circle City Interconnection Exhibit

LAKE PLEASANT 5,000/CIRCLE CITY INTERCONNECTION EXHIBIT
