**NOTICE OF FILING REVISED
WILLOW VALLEY WATER CO.
SIB ENGINEERING REPORT**

**Willow Valley Water Company
Water System Engineering Report for
System Improvement Benefit (SIB)**

August 2013

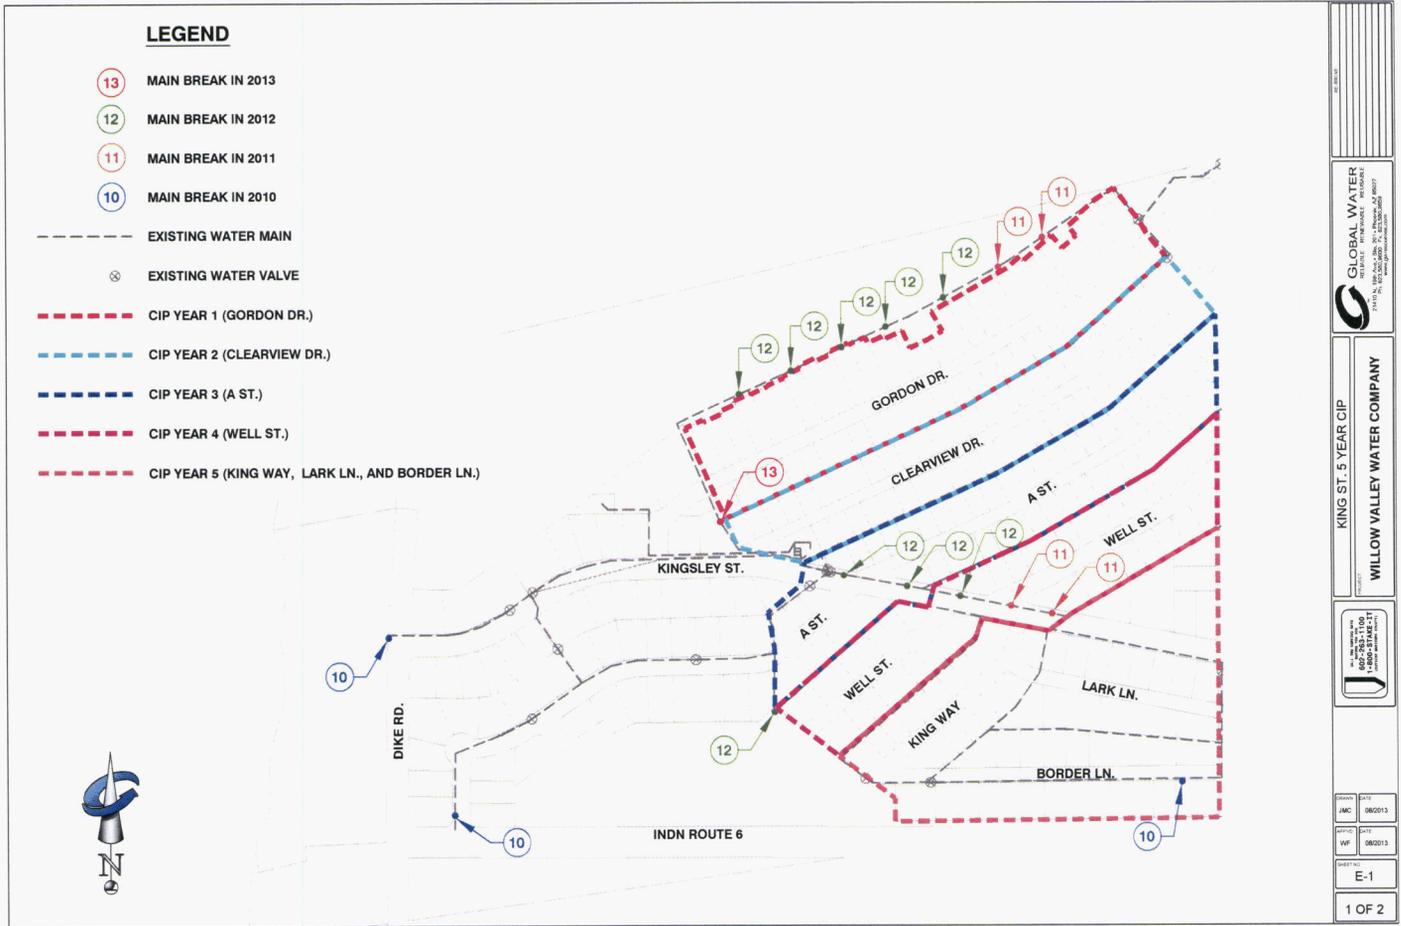
FIGURE 3

Figure 3 - Leak Identification Map- West Side of King Street

Two figures have been created to depict the locations of line breaks that have been recorded since 2010, as well as indicate the years the line breaks occurred. The King Street water distribution system has been split into two sections- the East side and the West side as to provide enhanced details of the schematic. This system represents the areas in the system where most leaks (line breaks) have been recorded, and the area has been identified as the top priority for the 5 year SIB replacement program. In the exhibit you will also notice the identification of the five year SIB plan, and specifically detailing the sections of line to be replaced in priority:

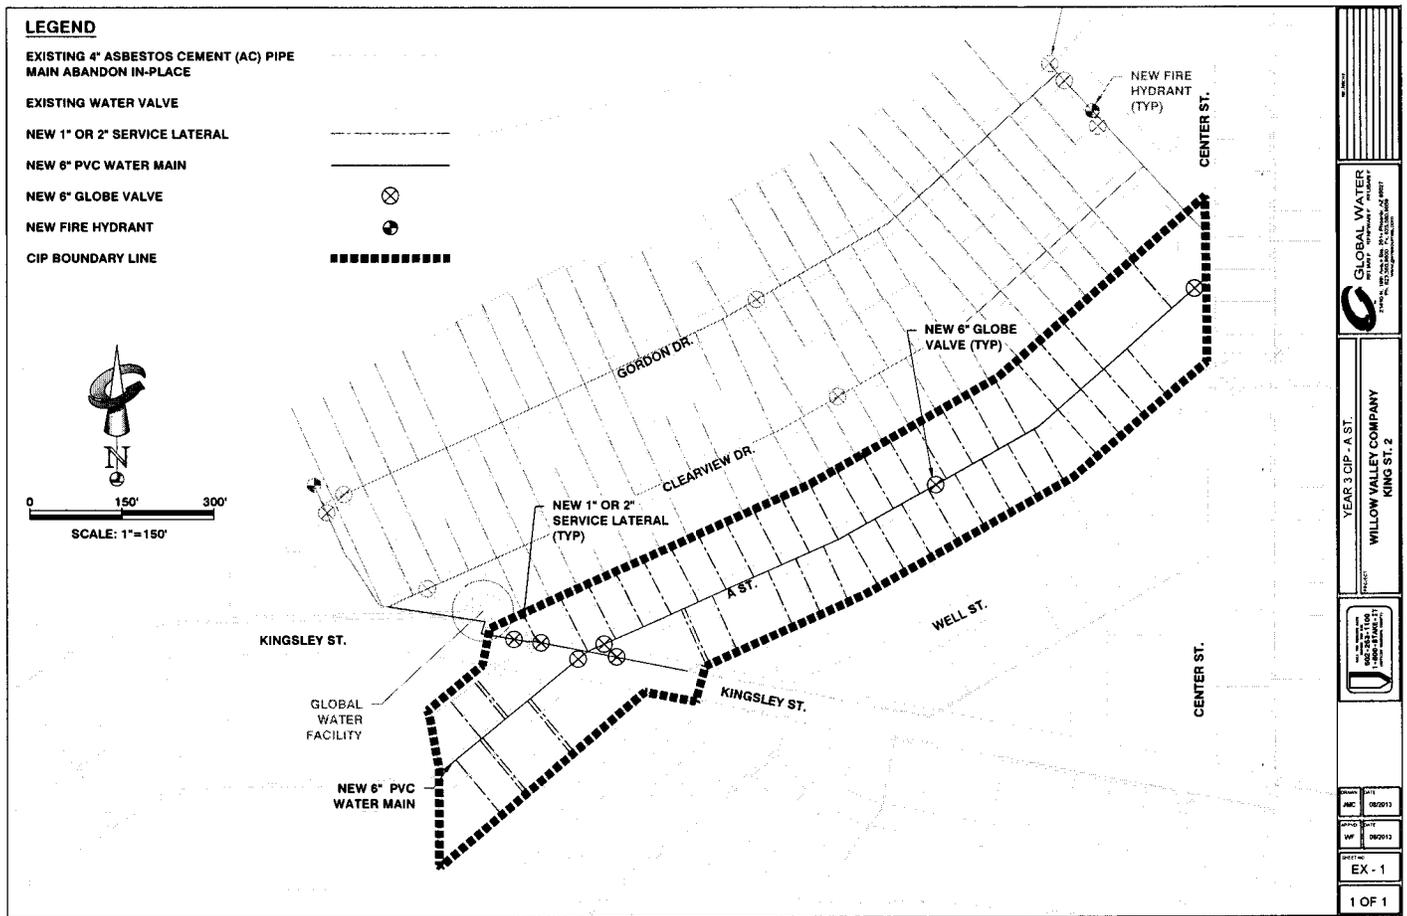
FIGURE 7

<p>GLOBAL WATER WATER MAINS & SERVICE LATERALS 1000 S. 1000 E. SUITE 200 TAMPA, FL 33606</p>	
<p>YEAR 3 CIP - A-ST. WILLOW VALLEY COMPANY KING ST. 2</p>	
<p>DATE: 08/2012</p>	<p>BY: [Signature]</p>
<p>DATE: 08/2012</p>	<p>BY: [Signature]</p>
<p>EX - 1</p>	
<p>1 OF 1</p>

- **Year 3 (2016) - A-Street Line Replacement-** Constructed in 1960s, this line replacement project was identified based on three critical criteria. First, the site accessibility to the water lines runs through the backyards of residential homes and at times under private property, which complicates accessibly for maintenance of equipment and emergency repair services and exposes a higher risk of property damage comparable to the other projects due to the fact that this water line services two rows of homes (See Figure –E1). Second, this main has been subject to three line breaks over the past two years. Making this line a costly asset to maintain, while increasing disruption of service to customers serve. The cost estimate for this line replacement is estimated at \$145,040 and is detailed in Figure 7.

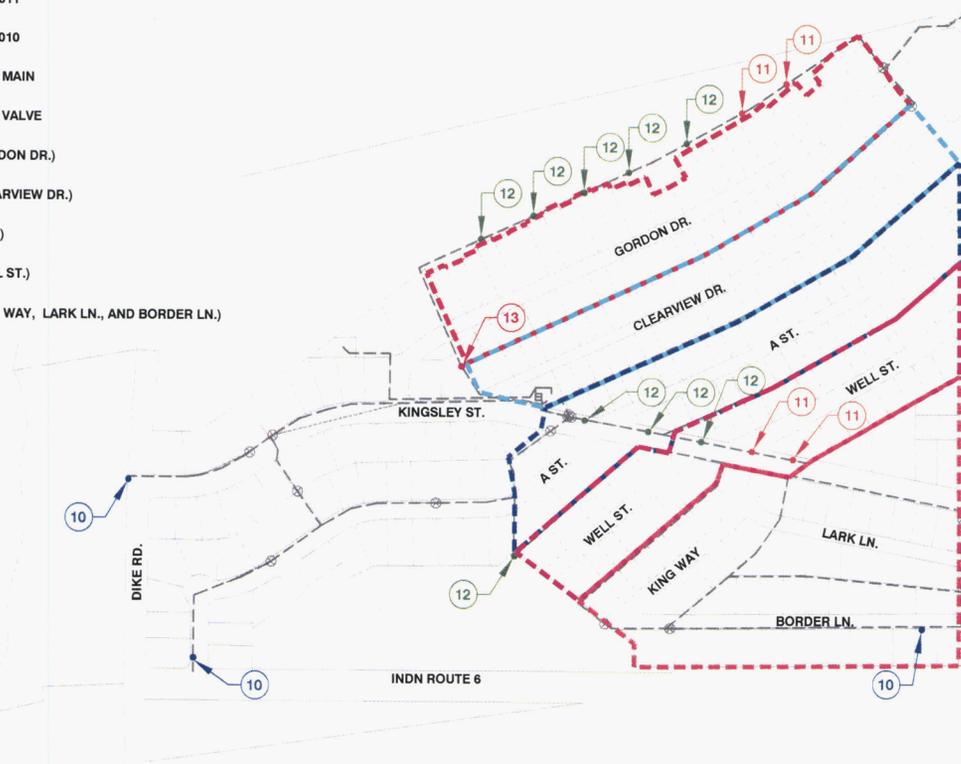
FIGURE 12

- - - CIP YEAR 1 (GORDON DR.)
- - - CIP YEAR 2 (CLEARVIEW DR.)
- - - CIP YEAR 3 (A ST.)
- - - CIP YEAR 4 (WELL ST.)
- - - CIP YEAR 5 (KING WAY, LARK LN., AND BORDER LN.)

3.3 SIB Water Main Replacement Map
