Allegheny Energy Supply Company, LLC
Docket No. L-00000AA-01-0116
Case No. 116

Duke Energy Arlington Valley Facility II
Decision No. 64495
Docket No. L-00000P-01-0117
Case No. 117

A NEW EARTH FISSURE
NEAR WINTERSBURG,
MARICOPA COUNTY, ARIZONA

Arizona Geological Survey
Open-File Report 01-10

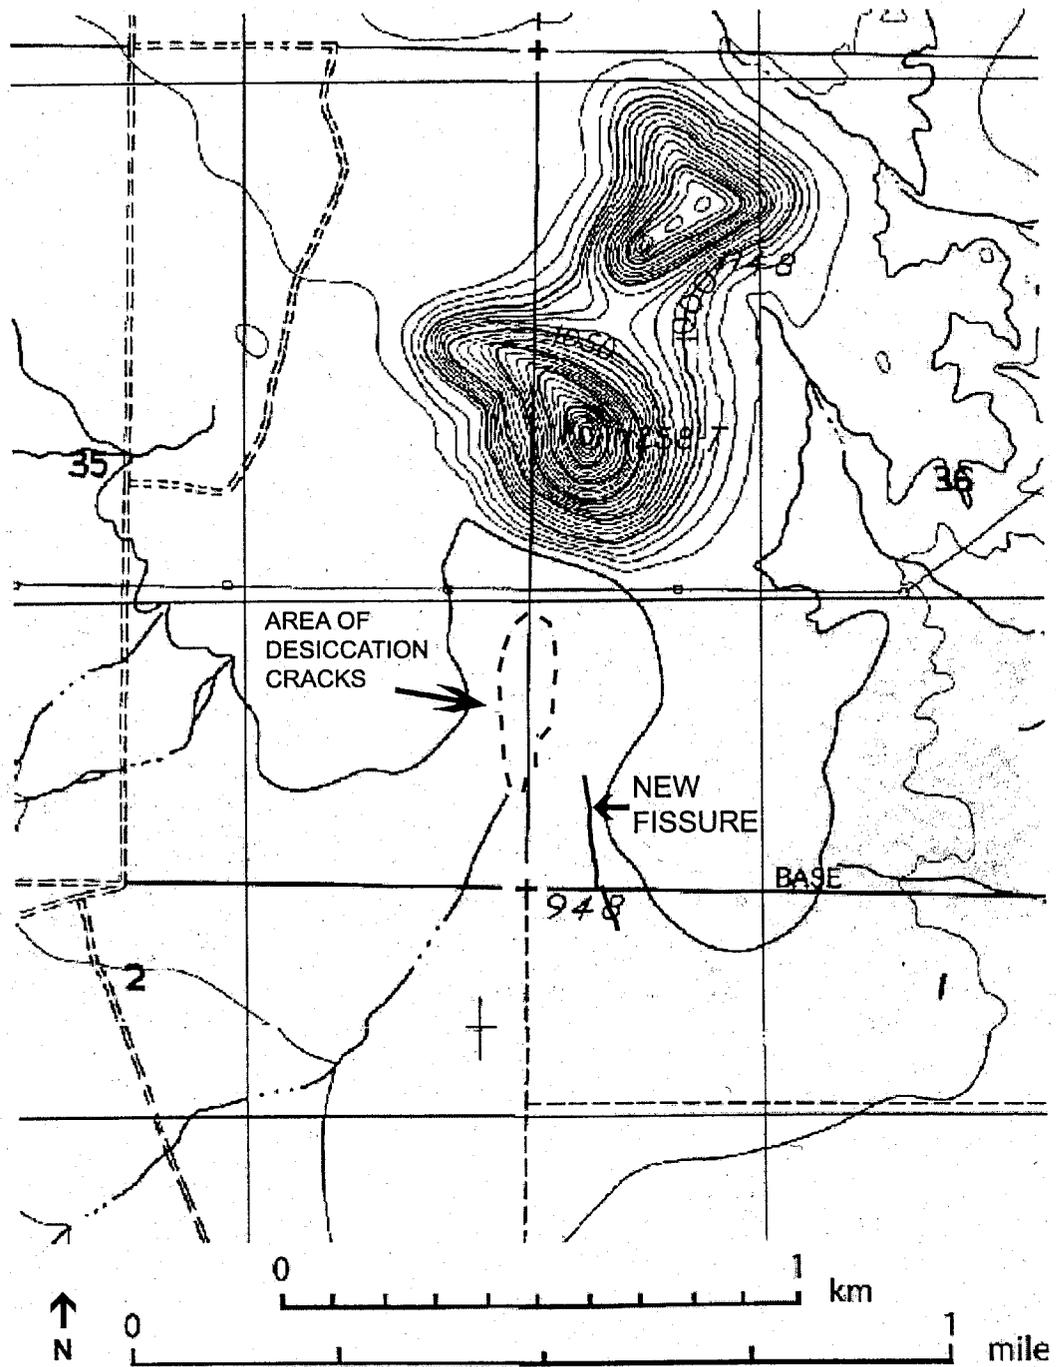
A new earth fissure has been reported southeast of Wintersburg, about 75 km (50 miles) WSW of Phoenix (Figure 1). The fissure was reported to AZGS in early September and was visited several times through early November. Field mapping was done with a hand-held GPS. This fissure appeared over the past summer, probably during a heavy rainstorm in July. The earth fissure and adjacent desiccation cracks are plotted on a topographic base (Figure 2) and an aerial photo base (Figure 3).

Figure 2. Topographic map showing location of new earth fissure and area of Desiccation cracks. Hill at top of map is 3 miles southeast of Wintersburg. (Base from Wintersburg and Arlington 7.5-minute quadrangles)

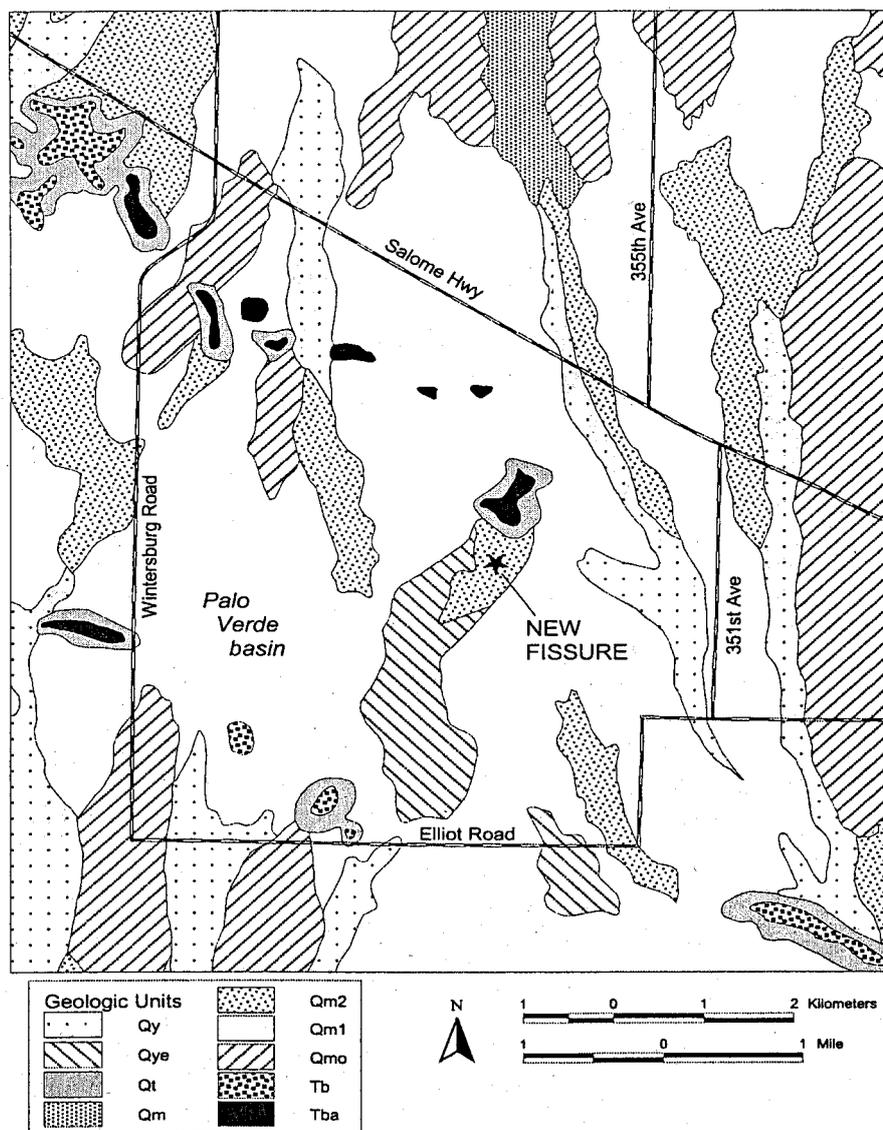
The site of the new fissure is immediately south of a small hill three miles southeast of Wintersburg. A ring of similar small hills defines the tiny Palo Verde basin, with the new fissure near its eastern margin. Figure 17 is a generalized geologic map of the Wintersburg area, based on the mapping of Demsey (1989) and Reynolds and Skotnicki (1993). Geologic units are described in Tables 1 and 2.

Figure 17. Geologic map of the Wintersburg area. Units described in Tables 1 and 2.

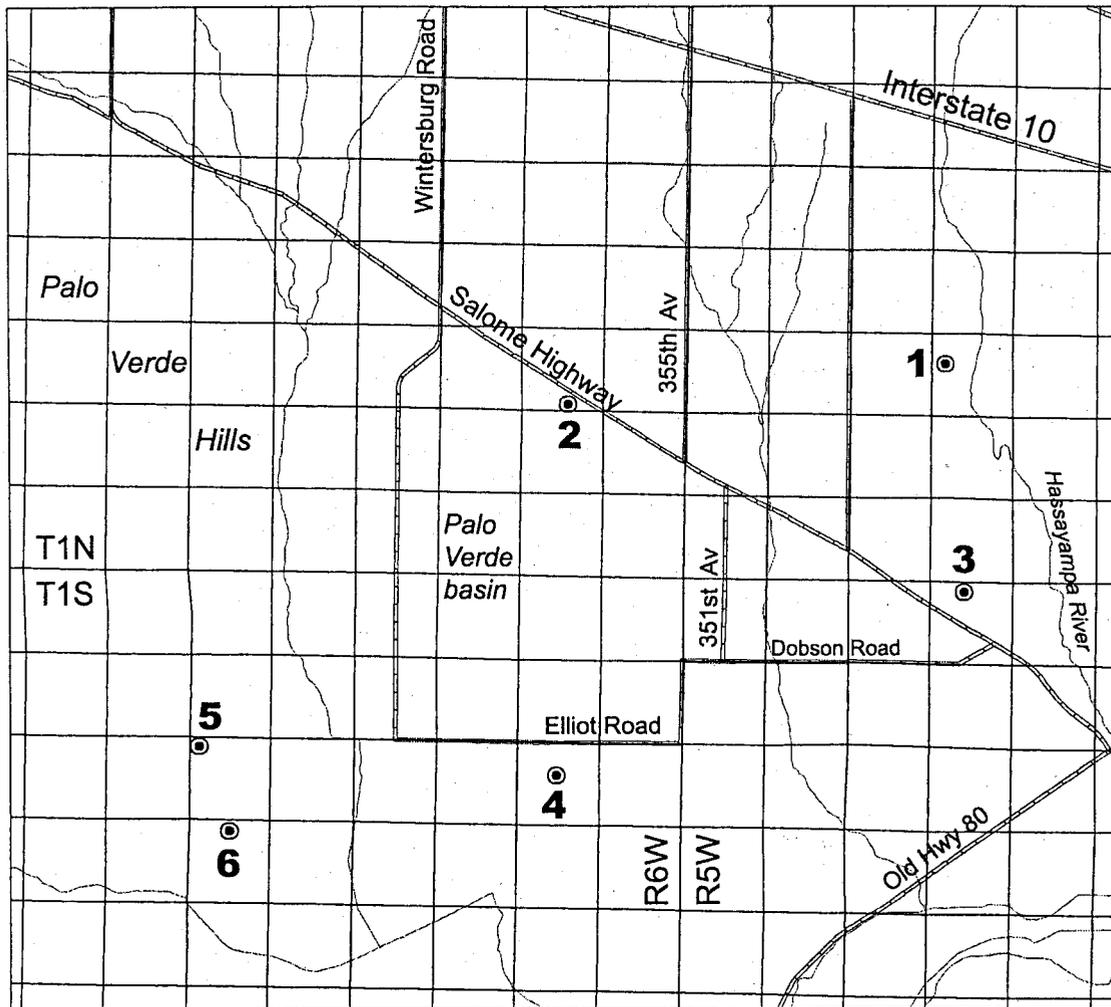
Groundwater levels in the vicinity of the fissure have been measured for many years. Long-term records for six wells in the region were obtained from the Arizona Department of Water Resources. Well locations are plotted in Figure 18. Water levels seem to be fairly steady in the area immediately surrounding the fissure. Plots of water levels over several decades in three wells (Figure 19, a-c) north and east of the fissure show little sign of groundwater decline. Three wells (Figure 19, d-e) southwest of the Palo Verde Hills do record groundwater decline trends on the order of 100 feet (neglecting the lowest "outlier" points on the plots) from the 1950s to about 1980. Groundwater declines of similar magnitude have been responsible for subsidence and earth fissures in other Arizona basins. Since 1980, however, groundwater levels in these three wells have recovered to almost the 1950s levels.

Figure 18. Location of wells with long-term water level measurements.

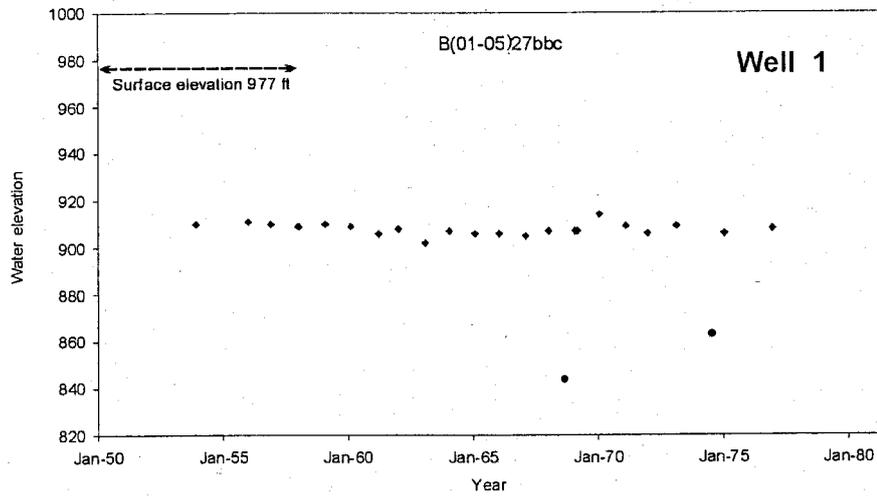
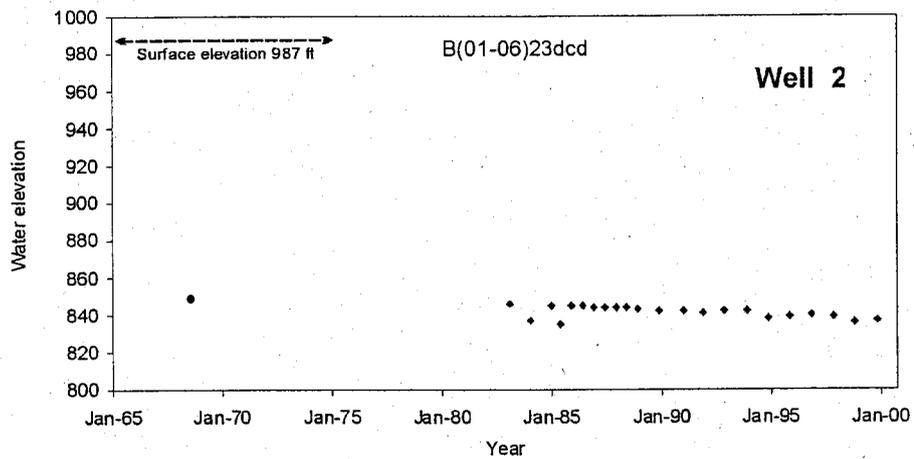
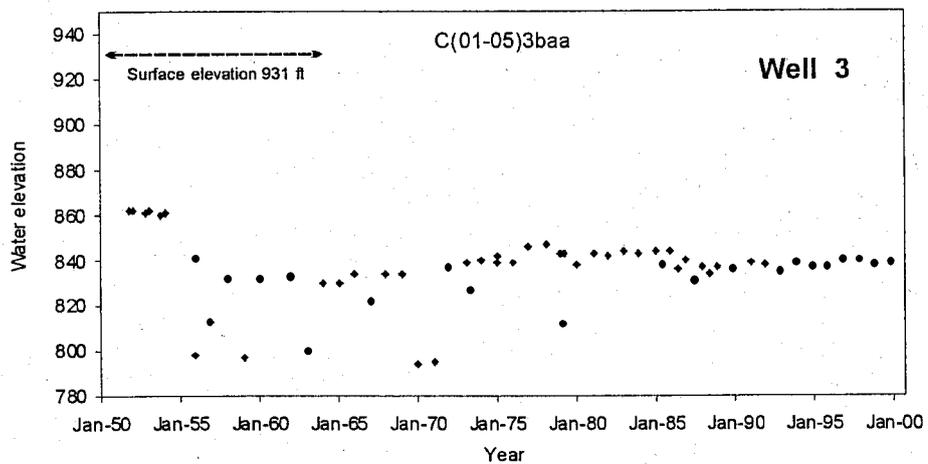
Figure 19. Water level measurements in selected wells near the Palo Verde basin.

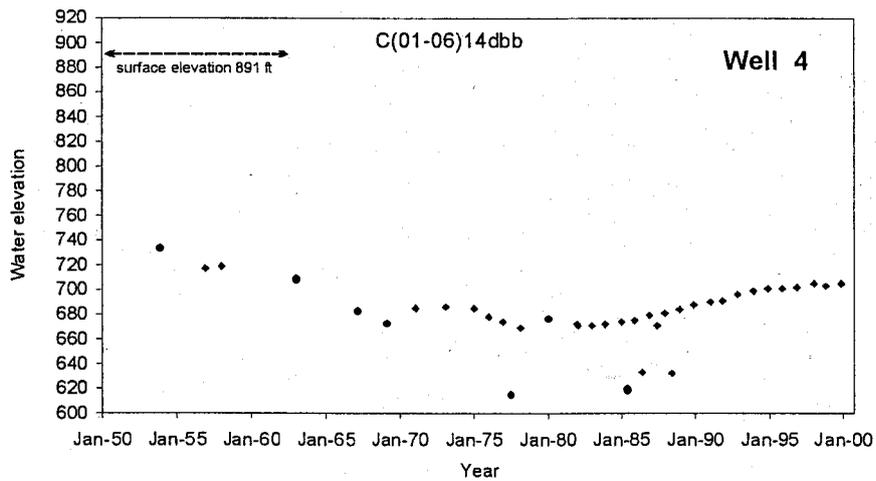
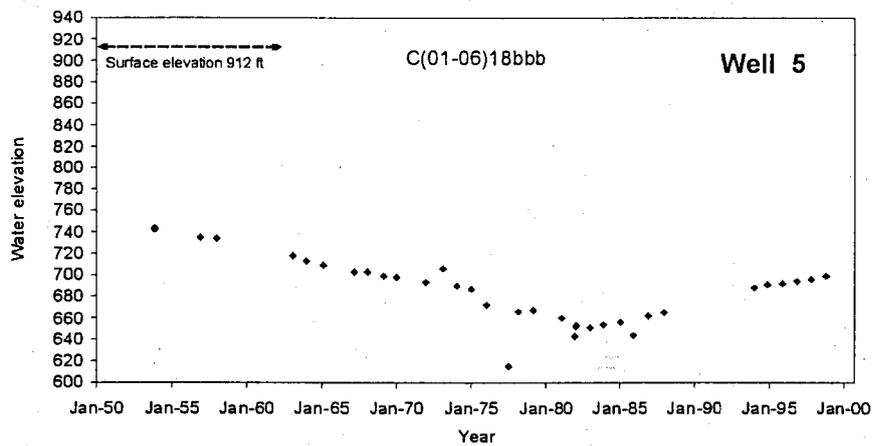
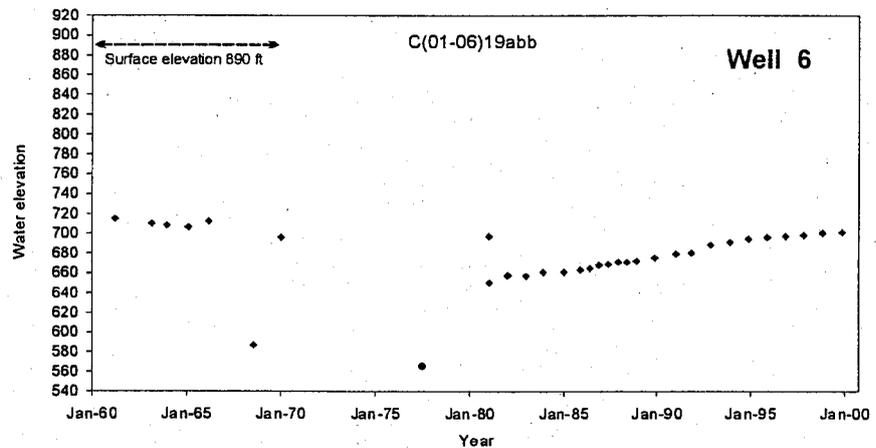
Figure 19 (continued). Water level measurements in selected wells near the Palo Verde basin.
