Stephen Norris Inc.

Re: Recent Pipe Failures On Current System

EXPLANATION OF PHOTOS

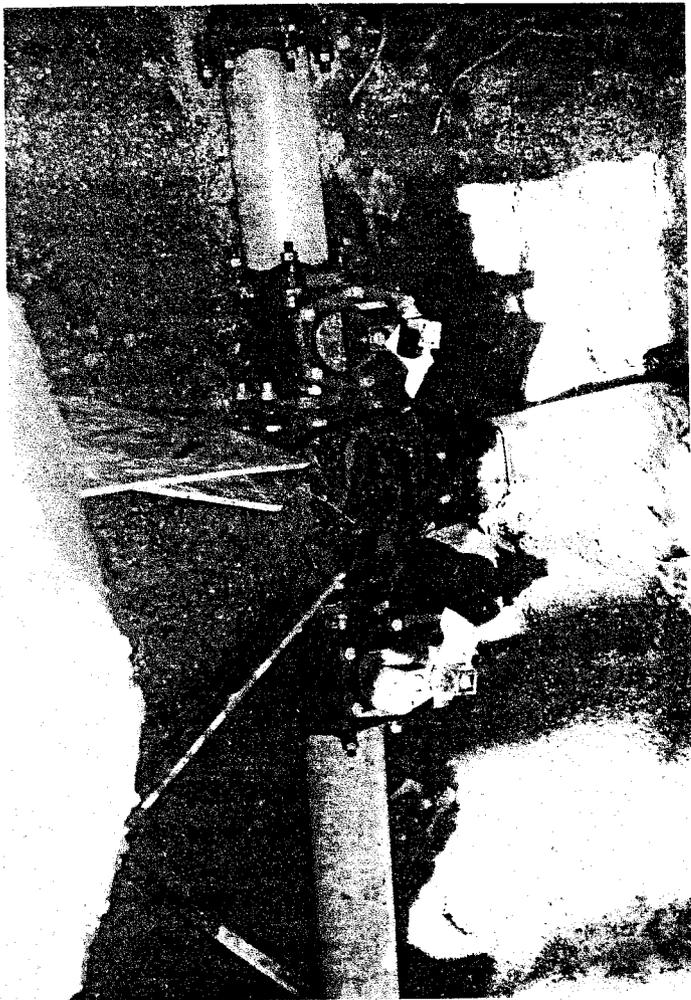
- #8. Removed transite pipe with hairline crack, indications of leakage.
- #9. Newly installed "T" coupling, with new isolation valves.
- #10. Another view showing pressure block (kicker).
