A NEW EARTH FISSURE
NEAR WINTERSBURG,
MARICOPA COUNTY, ARIZONA

Arizona Geological Survey
Open-File Report 01-10

Raymond C. Harris
Arizona Geological Survey

November 2001

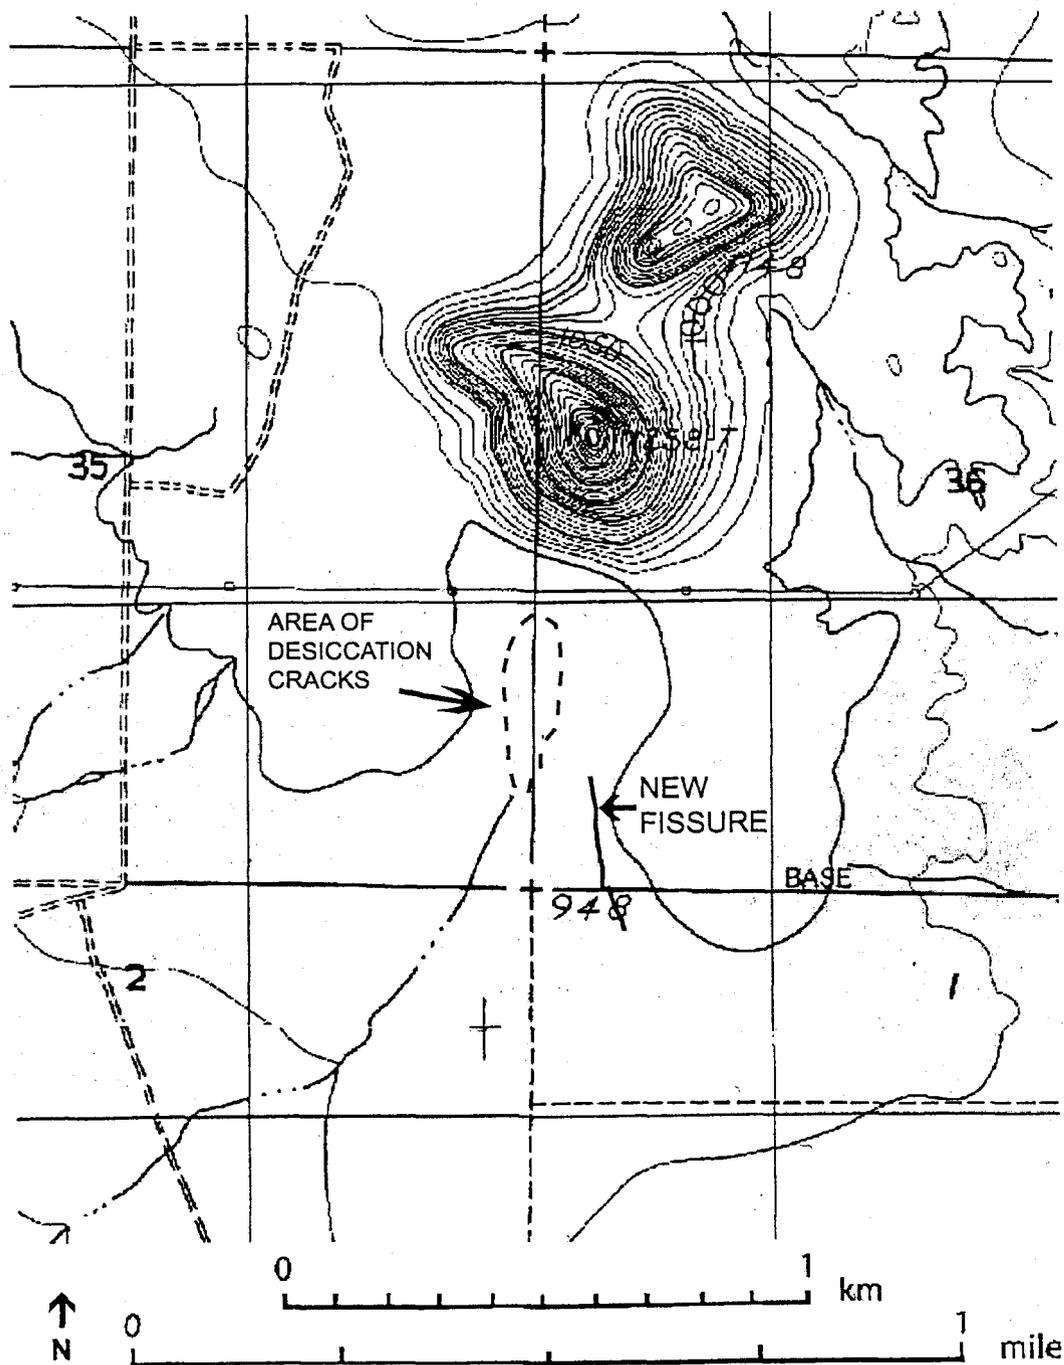
Figure 2. Topographic map showing location of new earth fissure and area of Desiccation cracks. Hill at top of map is 3 miles southeast of Wintersburg. (Base from Wintersburg and Arlington 7.5-minute quadrangles)

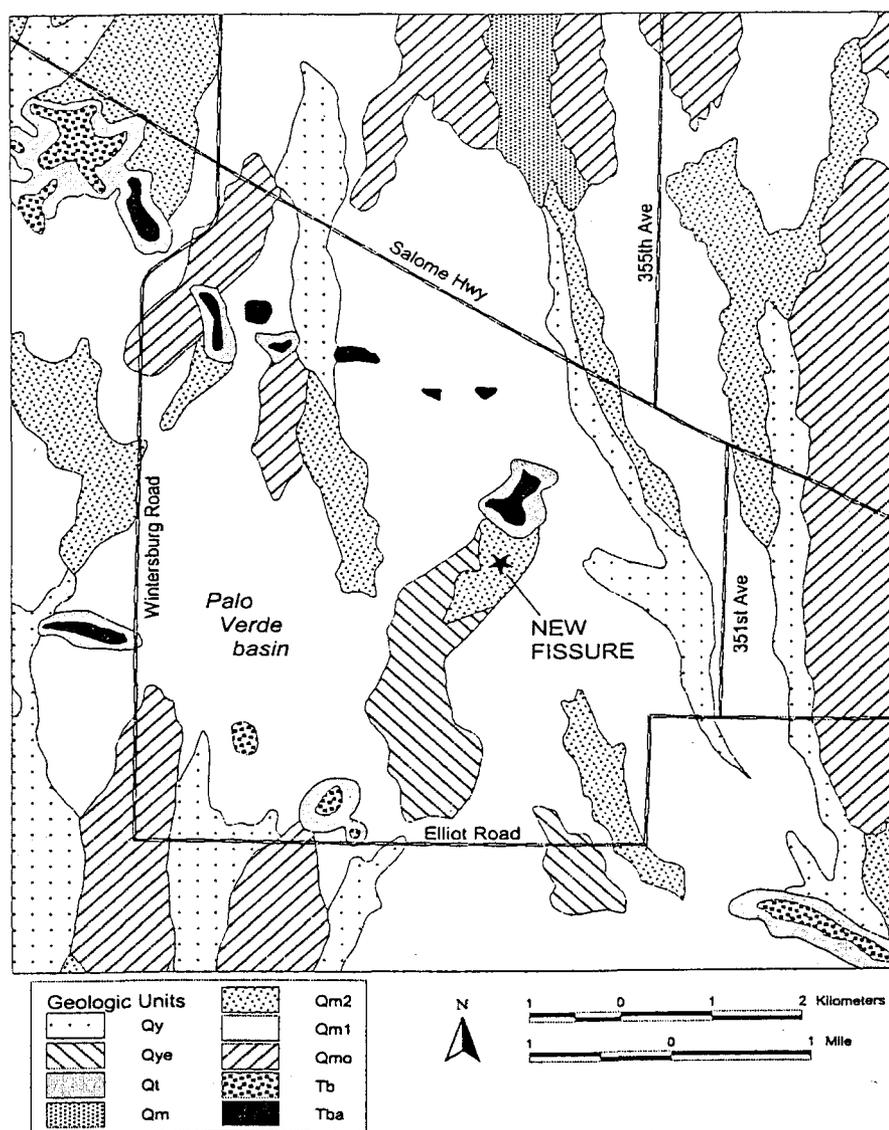
The site of the new fissure is immediately south of a small hill three miles southeast of Wintersburg. A ring of similar small hills defines the tiny Palo Verde basin, with the new fissure near its eastern margin. Figure 17 is a generalized geologic map of the Wintersburg area, based on the mapping of Demsey (1989) and Reynolds and Skotnicki (1993). Geologic units are described in Tables 1 and 2.

Figure 17. Geologic map of the Wintersburg area. Units described in Tables 1 and 2.

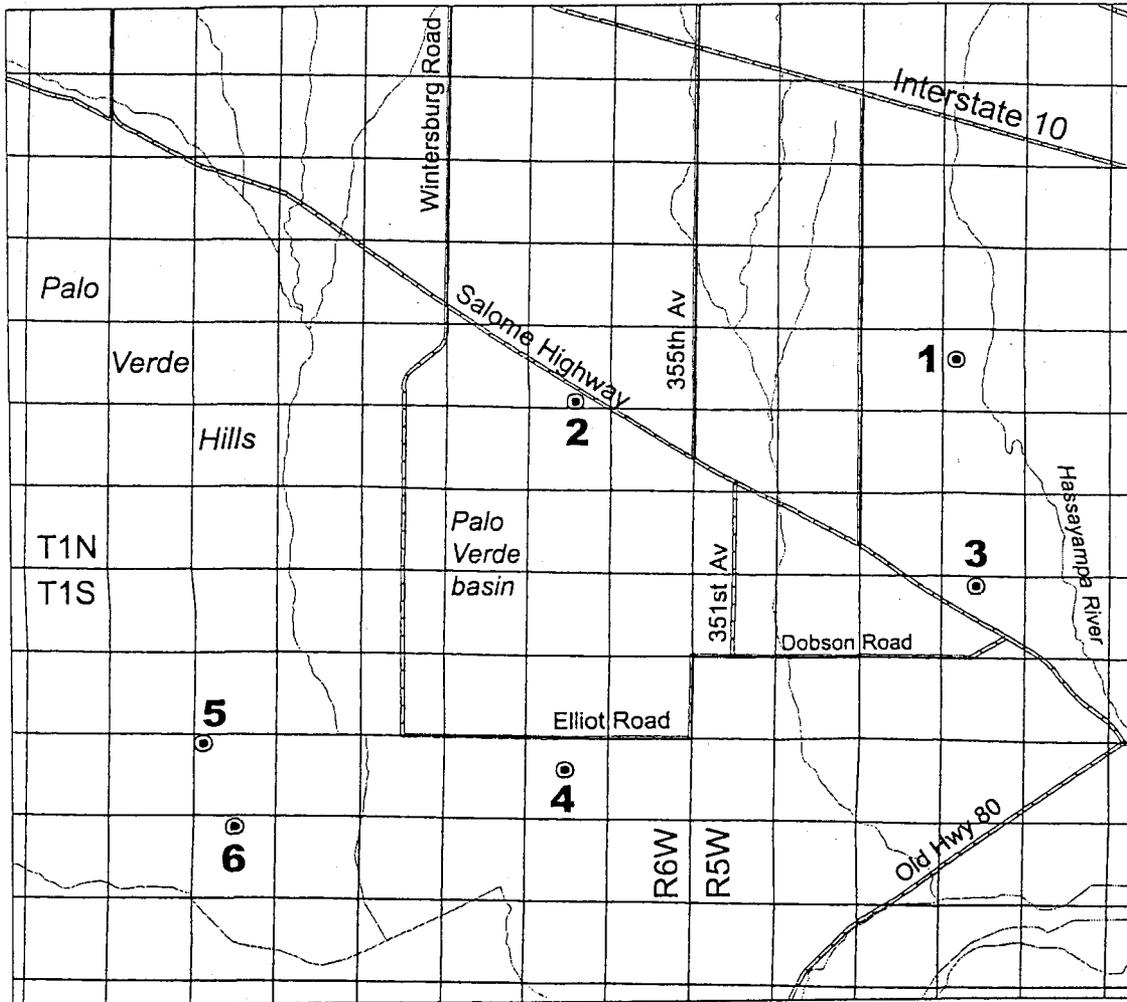
Groundwater levels in the vicinity of the fissure have been measured for many years. Long-term records for six wells in the region were obtained from the Arizona Department of Water Resources. Well locations are plotted in Figure 18. Water levels seem to be fairly steady in the area immediately surrounding the fissure. Plots of water levels over several decades in three wells (Figure 19, a-c) north and east of the fissure show little sign of groundwater decline. Three wells (Figure 19, d-e) southwest of the Palo Verde Hills do record groundwater decline trends on the order of 100 feet (neglecting the lowest "outlier" points on the plots) from the 1950s to about 1980. Groundwater declines of similar magnitude have been responsible for subsidence and earth fissures in other Arizona basins. Since 1980, however, groundwater levels in these three wells have recovered to almost the 1950s levels.

Figure 18. Location of wells with long-term water level measurements.

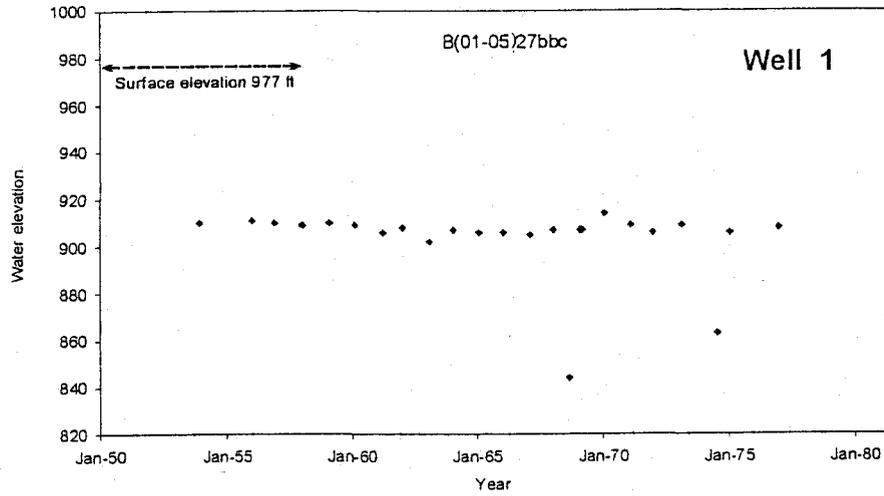
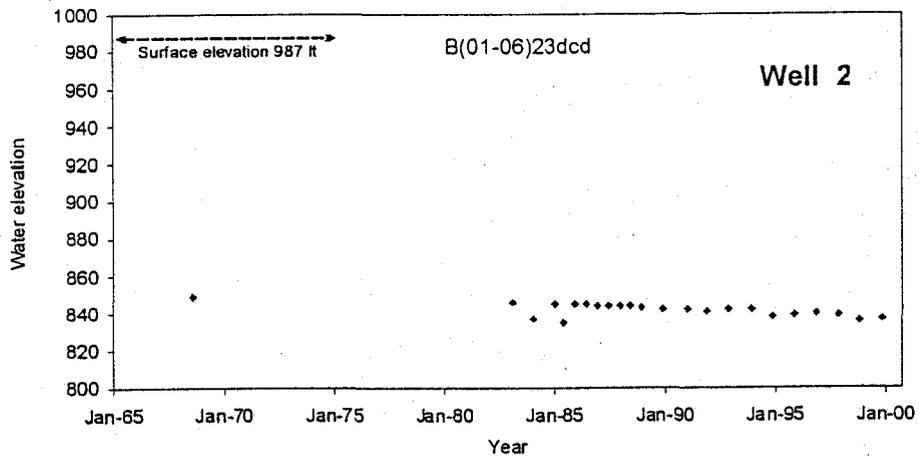
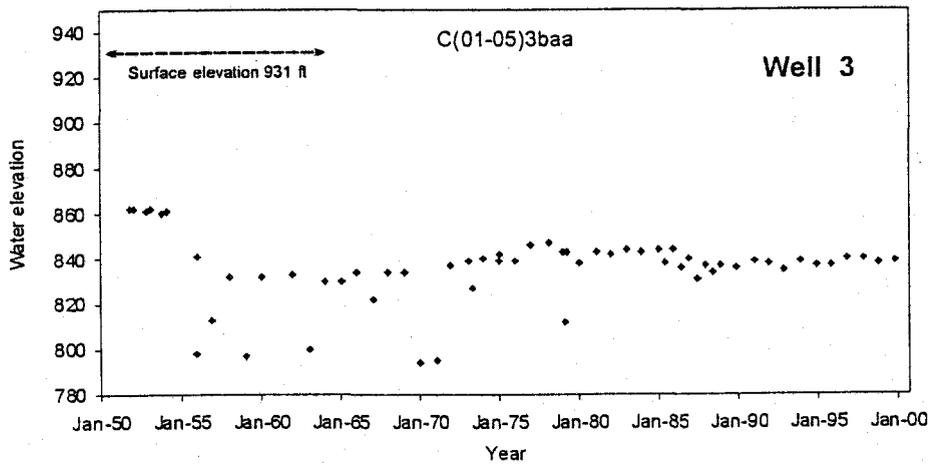
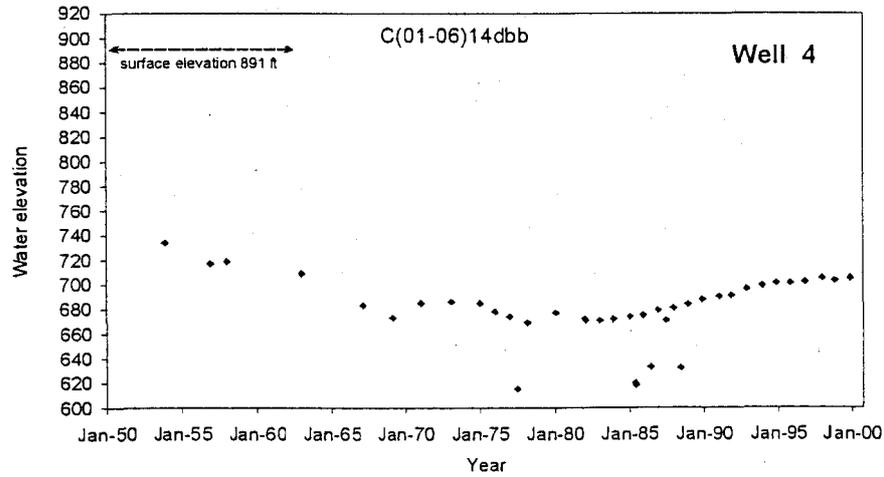
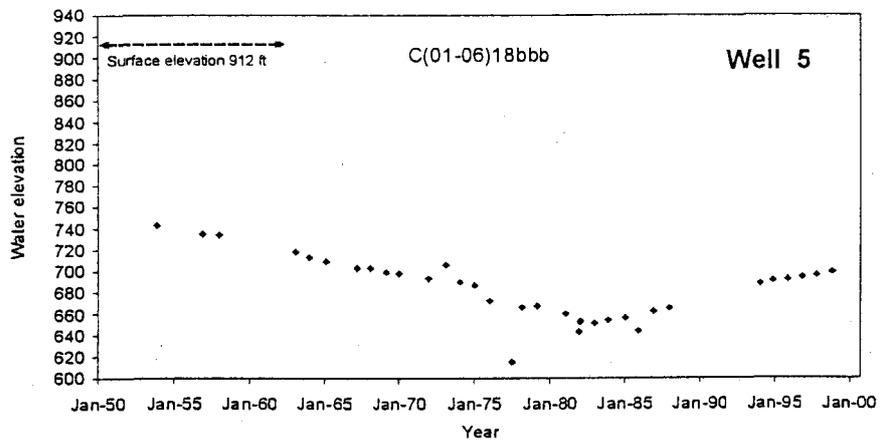
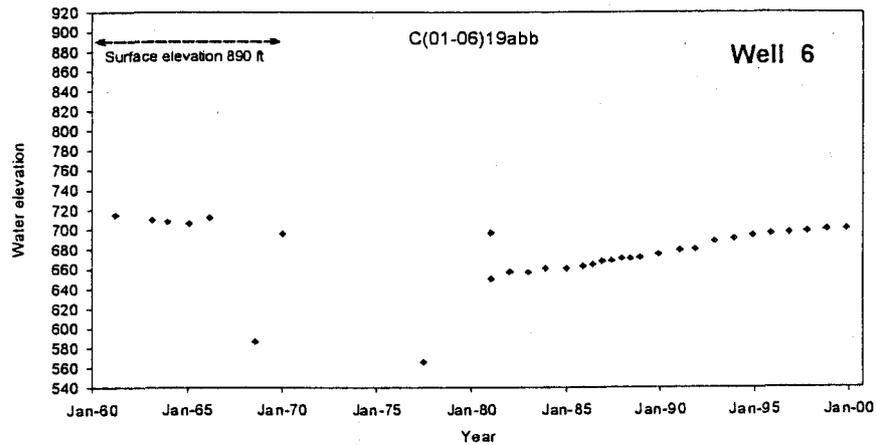
Figure 19. Water level measurements in selected wells near the Palo Verde basin.

Figure 19 (continued). Water level measurements in selected wells near the Palo Verde basin.
