**RESPONSE TO INSUFFICIENCY  
LETTER**

FACILITIES ASSESSMENT REPORT

LIVCO SEWER COMPANY  
CONCHO, ARIZONA

March 2013

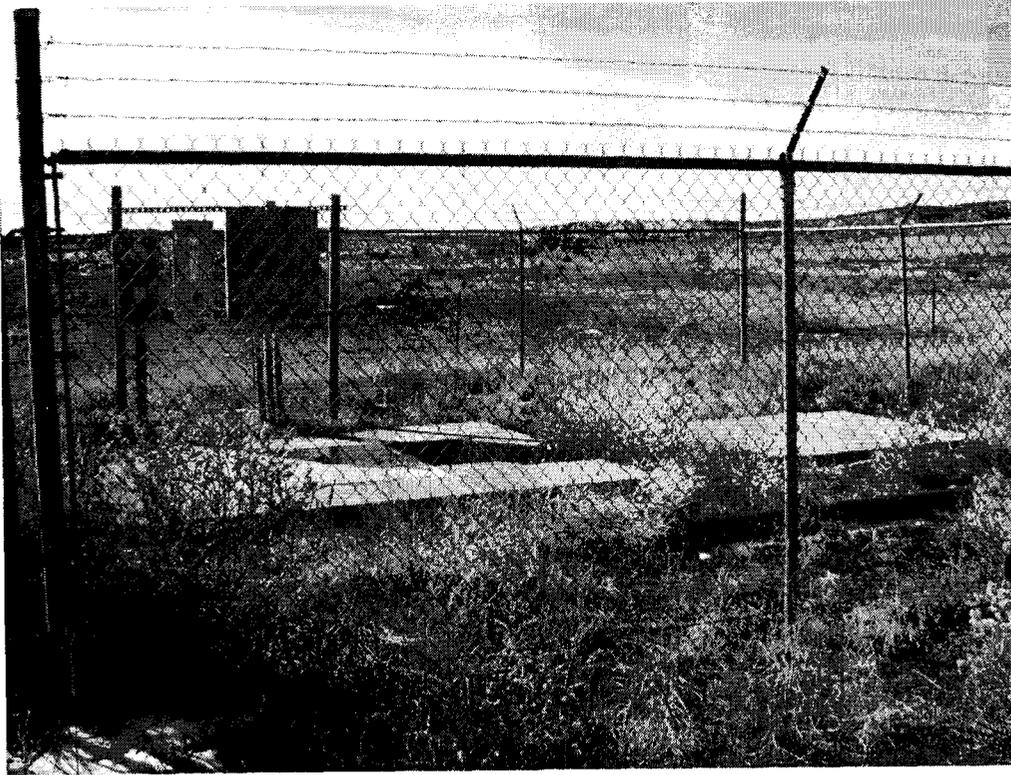
**Figure 17. Exterior of Main Lift Station**

The Main Lift Station is located west of Concho itself and on the south side of County Road 5020 (Snowflake Highway). This lift station accepts flows from the Golf Course Lift Station, which is approximately 359 feet higher in elevation than the Main Lift Station. The sewer is delivered to the Main Lift Station via force main and gravity line. The Main Lift Station has an eight foot (8') diameter wet well with two (2) 20 HP pumps. The Main Lift Station has an eight-inch (8") diameter force main and sends flows to the treatment facility site. Generally, the lift station is in fair condition. The lift station is configured with a wet well chamber as well as a separate valve vault for the force main. Figure 17 shows a photo of the exterior of the lift station.
