Docket #(s): Sw-02563A-14-0058

**NEW APPLICATION**

Docket Nos. SW-02563A-14-0058

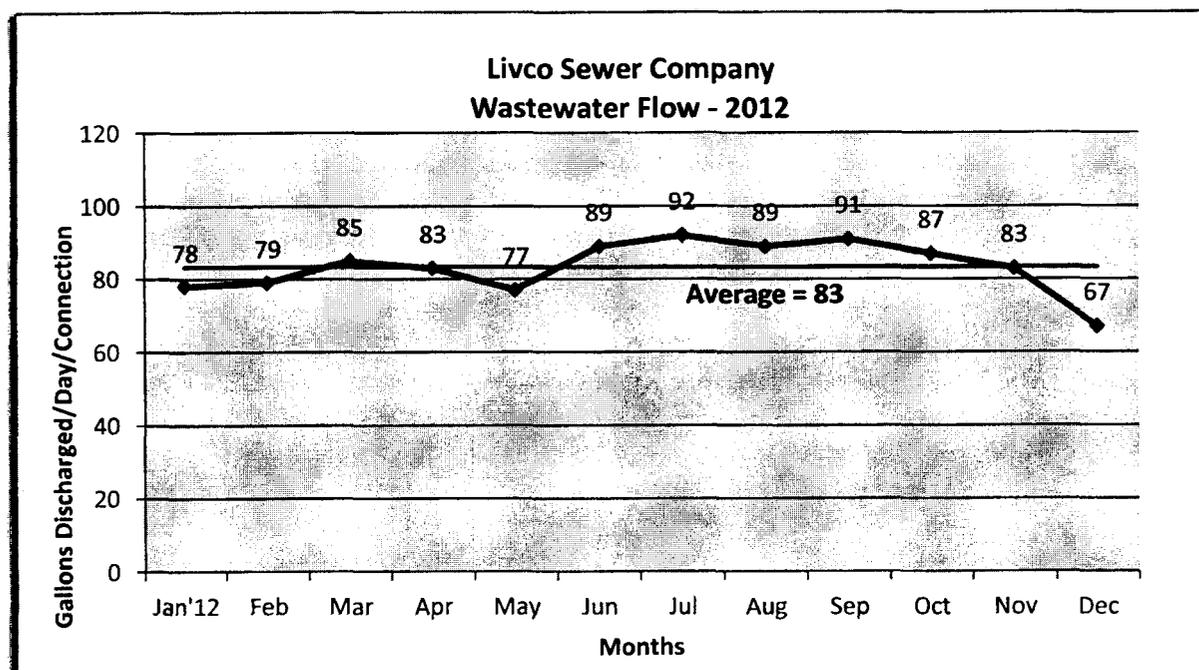
Figure 1. Wastewater Flow

However, according to Livco's 2012 Annual Report, actual wastewater production from each of the 29 connections averaged approximately 83 gpd, and ranged from 67 gpd and 92 gpd in December 2012 and July 2012, respectively (see Figure 1). Based on those figures, the treatment facility is actually processing wastewater at an average of only 2,405 gpd and leaving approximately 17,595 gpd of additional capacity for wastewater treatment. The 17,595 gpd of excess capacity potentially equates to approximately 211 additional connections.
