RE: ENGINEERING AMENDED REPORT ANALYZING QUALITY OF SERVICE MATTERS RELATED TO THE ARIZONA PUBLIC SERVICE COMPANY RATE CASE APPLICATION, DOCKET NO. E-01345A-03-0437

Attached is an engineering report documenting a Utilities Division quality of service assessment of the Arizona Public Service Company's ("APS") electric system for the calendar years 2000 through 2003. It is intended for use as a Commission Staff reference document in the pending APS rate case, Docket No. E-01345A-03-0437. Engineering finds no reason to recommend consideration of quality of service mitigation measures as part of the pending APS rate case based upon the results of the assessment. However, Engineering does recommend that the Commission continue to monitor APS' quality of service:

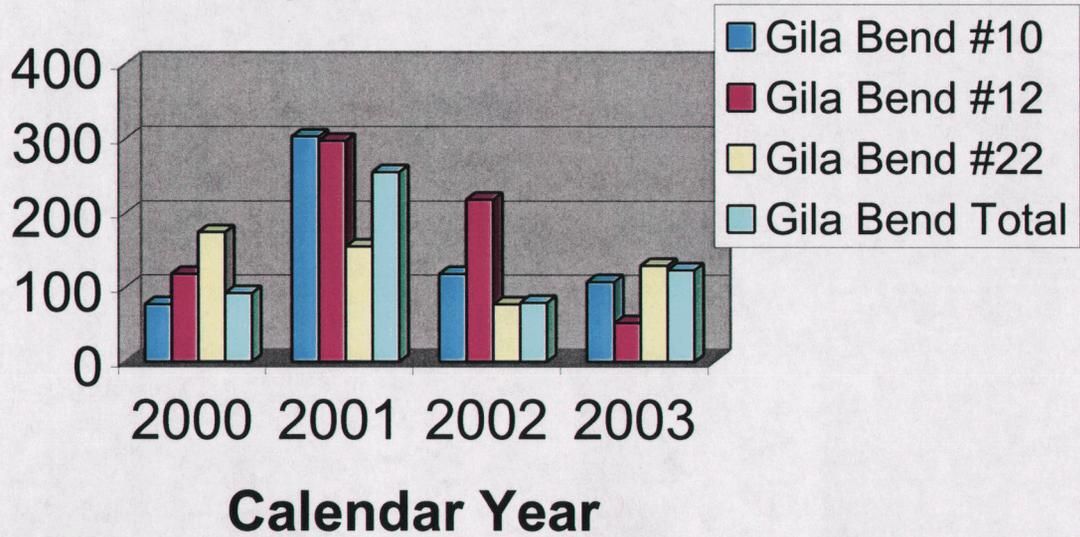
### CAIDI (Avg. minutes per outage) Gila Bend Distribution Service by Feeder Circuit

CAIDI by Feeder Circuit - Gila Bend\* (Avg. minutes per outage)

2000	2001	2002	2003
Gila Bend #10	77	303	118	107
Gila Bend #12	118	297	218	52
Gila Bend #22	174	155	77	129
Gila Bend Total	92	255	79	123

Engineering is also aware of a major storm that caused extended service interruption to APS customers served by Gila Bend Substation in July of 2001. Therefore, Engineering requested reliability indices information from APS regarding Gila Bend Substation. Those reliability indices are provided as Exhibit 4. As a result of the lengthy storm outage in 2001, customers on two Gila Bend Substation feeder circuits experienced an average of approximately 300 minutes of outage per interruption. The reliability indices for all Gila Bend feeder circuits improved significantly in 2002 and 2003. While more favorable weather may have been a contributing factor there were also some major system improvements. A 500 kV and 230 kV interconnection was placed in service at the Gila River Power Plant within several miles of Gila Bend in 2002. The net effect of this interconnection was a reinforcement of the transmission service to the Gila Bend Substation area.
