TO: Docket Control  
 Arizona Corporation Commission

RE: IN THE MATTER OF THE INQUIRY INTO THE OPERATIONAL PRACTICES  
 OF LITCHFIELD PARK SERVICE COMPANY (DOCKET NO. SW-01428A-07-0602)

# Palm Valley WRF 37-191 Process Schematic

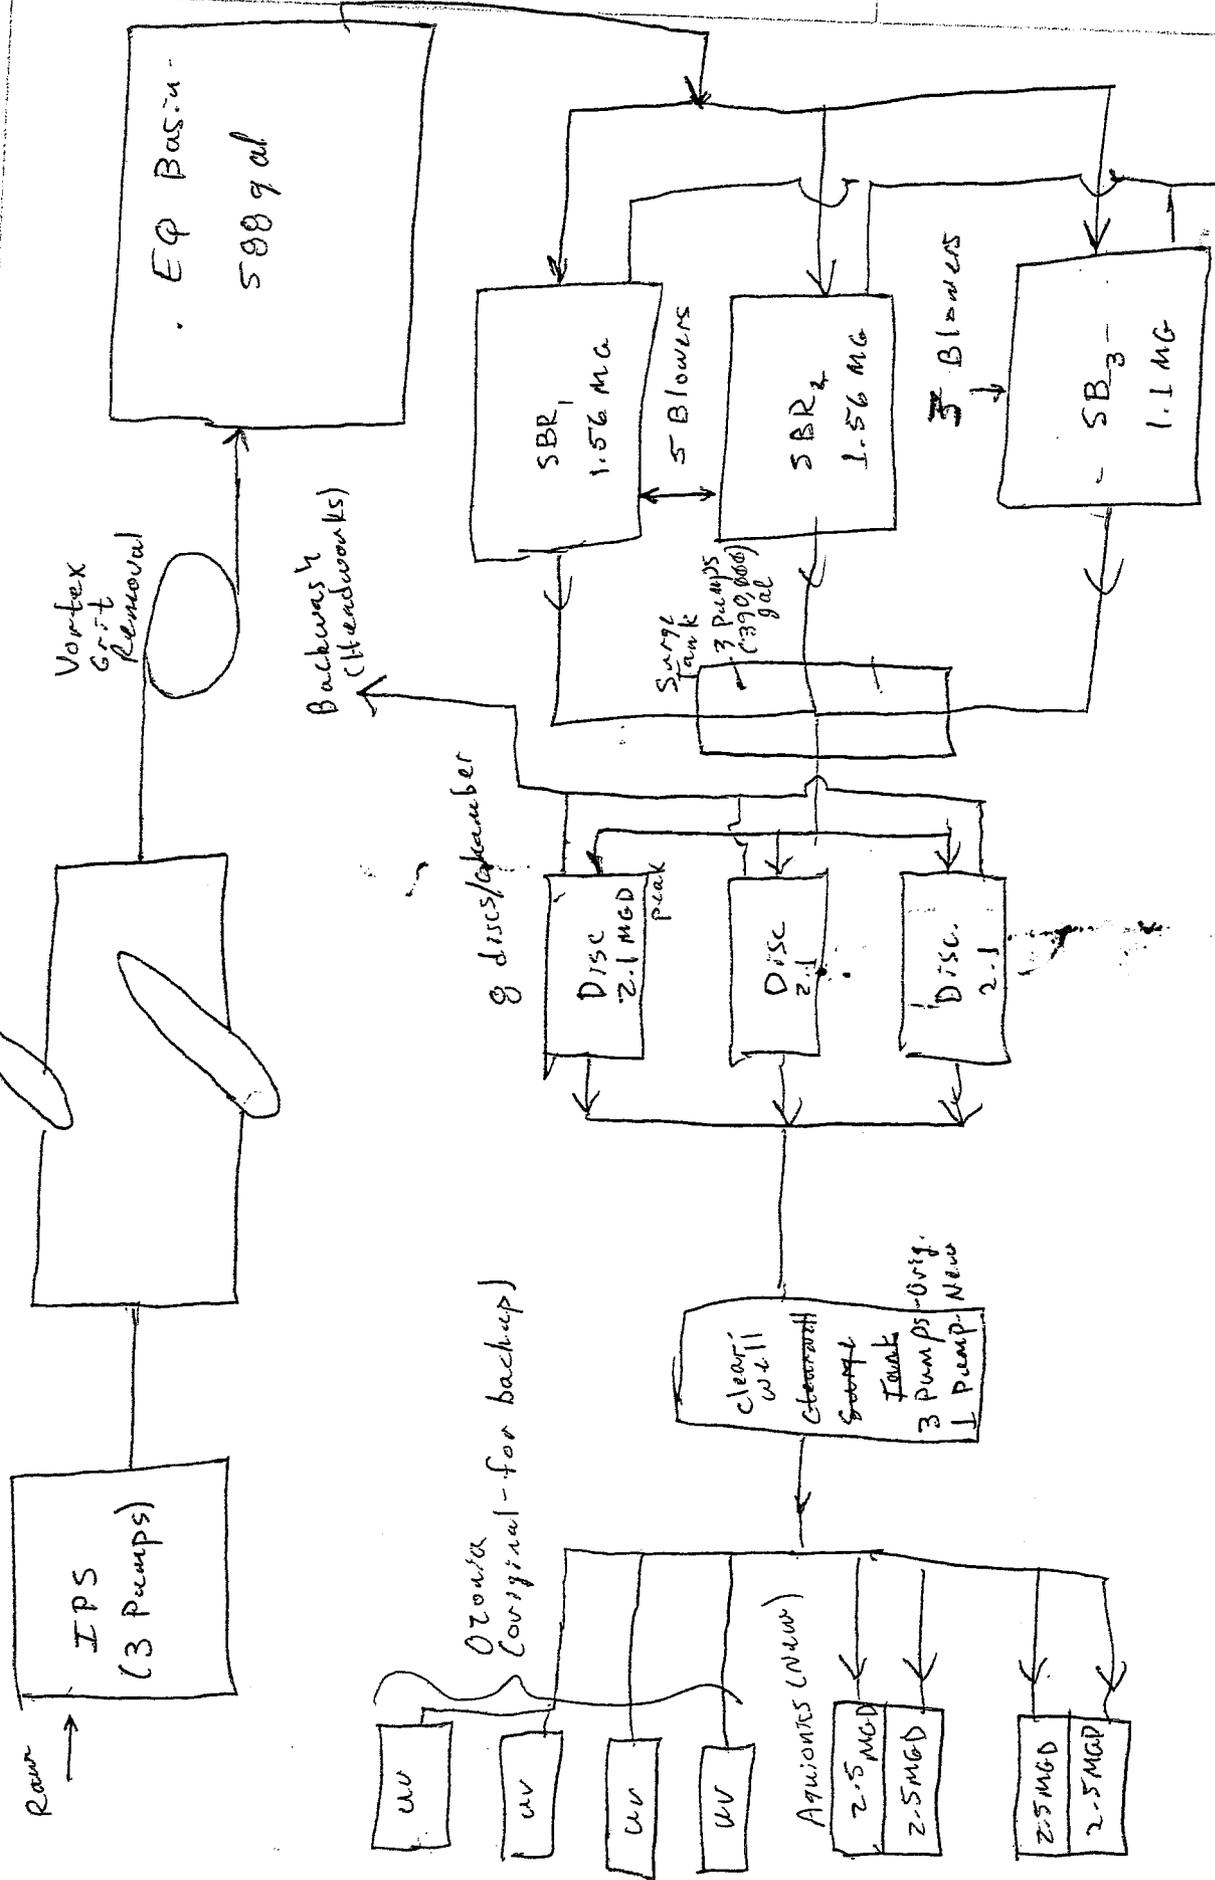
Fine Screens  
(Star Screens)

WAS  
(solids B/dg)  
(3) aerated holding  
tanks  
(220 gal each)
